Australian Transport Safety Bureau

# Aviation Safety Investigator

## Indonesian NTSC releases Adam Air final report

# Investigation briefs

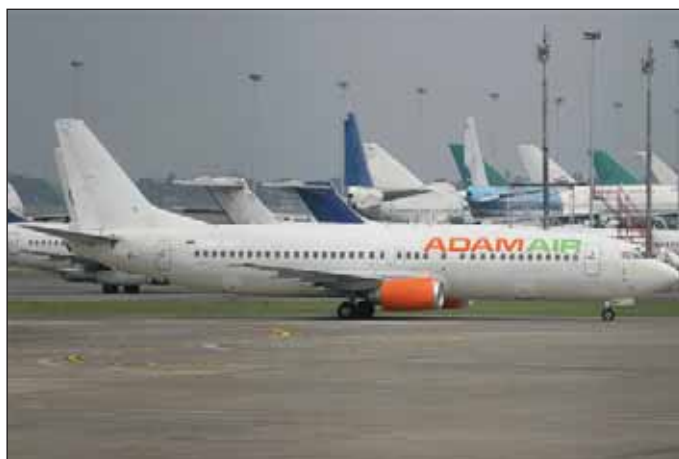
The DFDR analysis showed that the aircraft was in cruise at FL 350 with the autopilot engaged. The autopilot was holding 5 degrees left aileron wheel in order to maintain wings-level. Following the crew's selection of the number-2 (right) IRS Mode Selector Unit to ATT (Attitude) mode, the autopilot disengaged. The control wheel (aileron) then centered and the aircraft

The DFDR data showed that even after the aircraft had reached a bank angle of 100 degrees, with the pitch attitude approaching 60 degrees aircraft nose down, the pilot did not roll the aircraft wings level before attempting pitch recovery in accordance with standard procedures.

The aircraft reached 3.5g, as the speed reached Mach 0.926 during sustained

nose-up elevator control input while still in a right bank. The recorded airspeed exceeded V<sub>div</sub> (400 kcas), and reached a maximum of approximately 490 kcas just prior to the end of recording.

Flight recorder data indicated that a significant structural failure occurred when the aircraft was at a speed of Mach 0.926 and the flight load suddenly and rapidly reversed from 3.5g to negative 2.8 g. This g force and airspeed are beyond the design limitations of the aircraft. The aircraft was in a critically uncontrollable state at that time.

This accident resulted from a combination of factors including the failure of the pilots to adequately monitor the flight instruments, particularly during the final 2 minutes of the flight. Preoccupation with a malfunction of the Inertial Reference System (IRS) diverted both pilots' attention from the flight instruments and allowed the increasing descent and bank angle to go unnoticed. The pilots did not detect and appropriately arrest the descent soon enough to prevent loss of control.

During the investigation the NTSC issued a number of recommendations to the Directorate General Civil Aviation (DGCA) and AdamAir relating to IRS maintenance and training of flight crews in IRS and aircraft upset recovery. ■

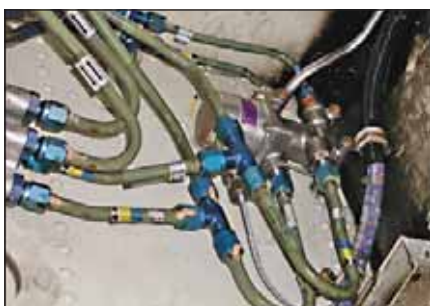
The flight crew became aware of the system failure when they selected the landing gear to extend during the approach sequence. Shortly after, the low oil pressure caution light for the number-two hydraulic engine pump illuminated. The crew established that the nose and right main landing gear doors had remained open and the left gear door had closed after all the gears had been extended.

The investigation determined that a solenoid-sequence valve failed, which resulted in the loss of pressure and quantity of hydraulic fluid from the aircraft's number-two hydraulic system. At the time of the failure the valve had accumulated 13,093.35 hours service and 16,458 flight cycles since new. Failure of the solenoid-sequence valve was due to the fracture of three of the four bolts that had clamped the two halves of the component together. Each of the fractured bolts had failed due to metal fatigue from exposure to in-service cyclic stresses that had developed during the operation of the aircraft's hydraulic system.

The defective unit was replaced and the aircraft was returned to service. ■

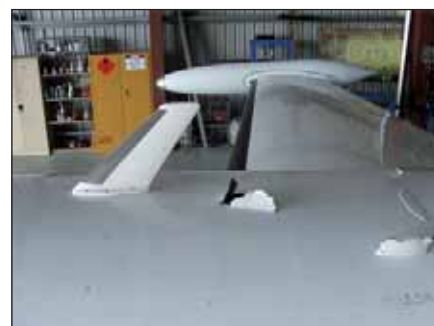
An inspection of the aircraft revealed a hole in a top rear fuselage skin panel. The examination revealed that approximately 60% of the panel had been damaged by exfoliation corrosion. Close examination of the most severely effected regions revealed a substantial reduction in skin thickness.

The damage was most severe at the primary site of rupture, in the centre of the panel.

The panel was clad with a corrosion resistant pure aluminium alloy sheet; however, the aluminium cladding was removed on the chemical milled areas. Over time, the coating protecting the chemical milled areas had deteriorated, leading to the corrosion on the panel.

The panel was located in an area that was not considered susceptible to corrosion, so there were no detailed inspections required for the area.

As a result of this occurrence, the manufacturer has issued a notice to all 1124 Westwind aircraft operators informing them of the event and the corrosion that was found. The operator has carried out an inspection of the area on their entire fleet of 1124 Westwind aircraft. Where corrosion was present, the operator replaced the panel. The operator has also included an inspection of the area in their Corrosion Control Program. ■
