# Stickshaker activation involving a Boeing 717-200, VH-NXM

Brisbane Airport, Queensland, 27 May 2015

AO-2015-056

Final – 22 December 2015

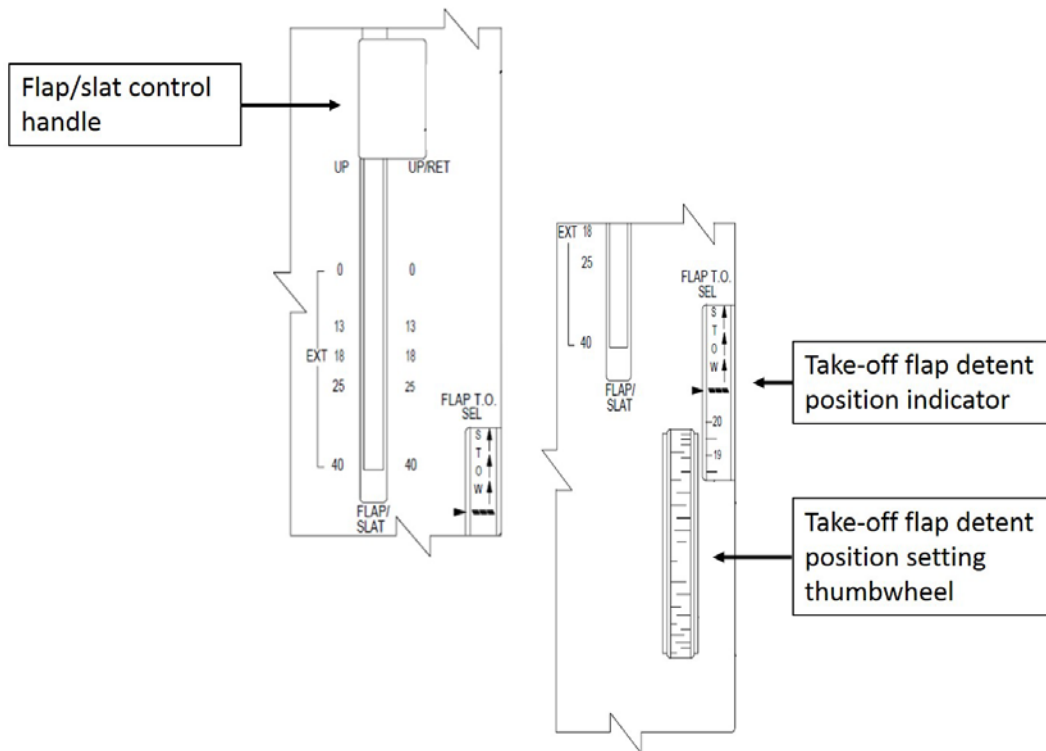
Figure 2: Flap and slat control

Within moments of stickshaker activation, the PM noticed that the flap/slat control handle was set to the UP/RET position (flaps up/slats retract). Upon noticing the position of the handle, the PM immediately called 'flaps', and moved the flap/slat control handle to the previously determined take-off setting position.

Following the incident, the crew deduced that the PM must have selected the flap/slat control handle to the UP/RET position soon after take-off, rather than raising the landing gear handle. The crew's deduction was based upon the configuration of the aircraft before, and immediately after, stickshaker activation. The crew were confident that before take-off procedures had been completed correctly, and that the flaps and slats had been correctly set. The crew also noted that had they commenced the take-off without the flaps and slats set, they would have received an aural warning alerting them accordingly – there was no such aural warning on this occasion.

- The PM indicated that, even though the flap/slat control handle needs to be lifted in order to move it forward from the 0/EXT position to the UP/RET position, the handle can be moved through the 0/EXT position in a single motion.

When retracting flaps/slats to UP/RET, pause at the UP/EXT position until the flaps indicate UP on the PFD prior to retracting the slats. Never move the flap/slat handle to UP/RET in one motion.

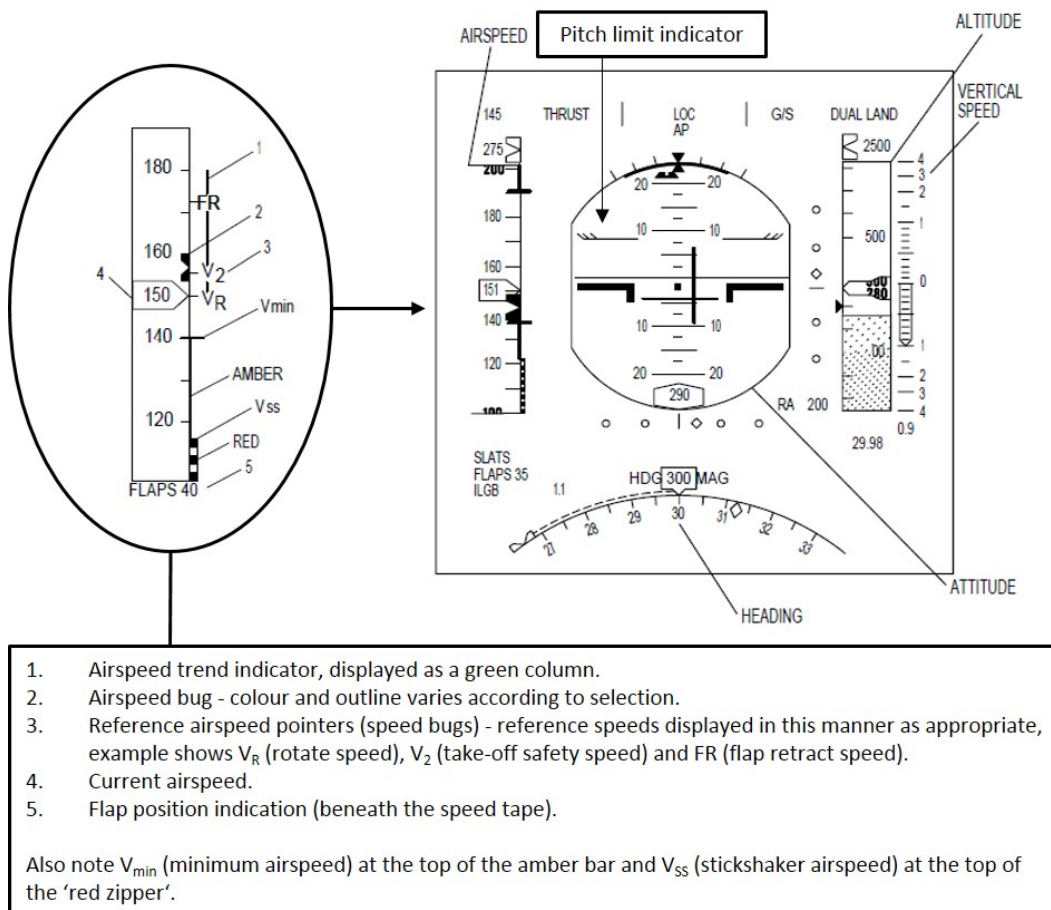
**Figure 3: Primary flight display and description of relevant airspeed indications**

The airspeed range for activation of the stickshaker is displayed as a 'red zipper' on the lower part of the airspeed indicator (Figure 3).  $V_{SS}$  marks the top of the red zipper. When the airspeed is below  $V_{SS}$  the pitch limit indicator (which provides an indication of the angle-of-attack margin to the activation of the stall warning system) changes colour from cyan to red, to provide an additional alert to the crew. Additionally, the digits (and the outline box surrounding the digits) representing the current airspeed indication turn red if the airspeed falls below  $V_{SS}$ .
