Near collision involving a Schweizer 269, VH-JXO, and a Military Lockheed AP-3C

at Edinburgh Airport, South Australia, on 31 August 2015

ATSB Transport Safety Report
Aviation Occurrence Investigation
AO-2015-101
Final – 22 December 2015

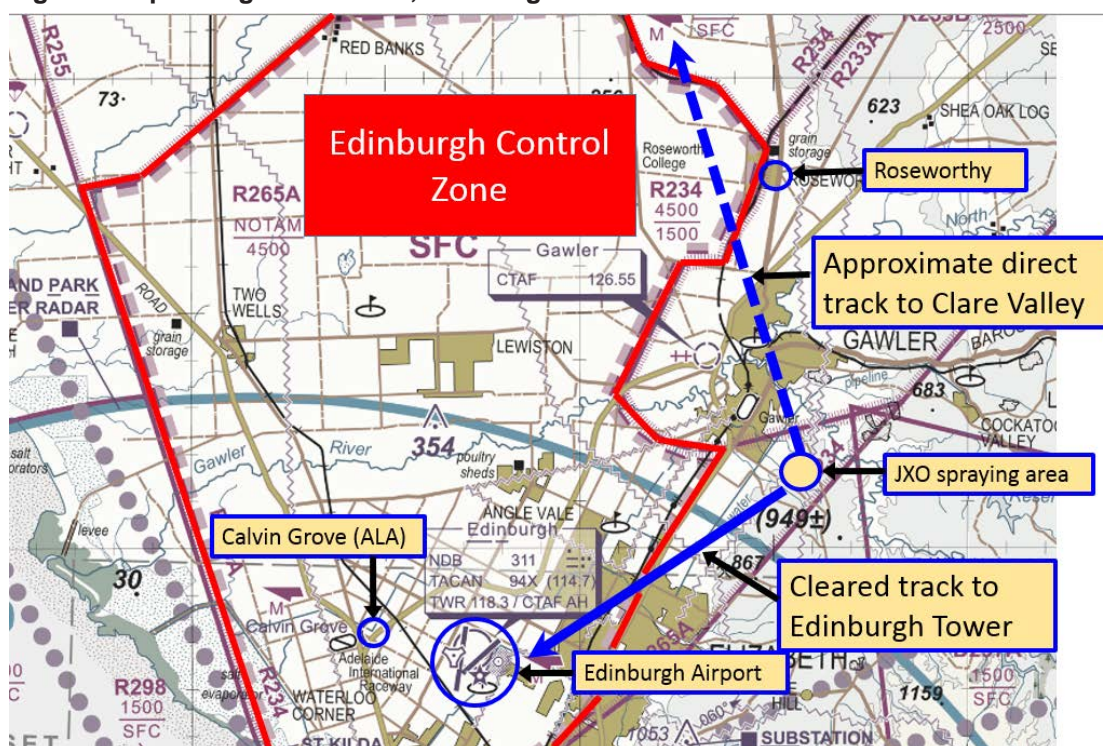
Figure 2: Operating area of JXO, Edinburgh Control Zone and relative tracks

At about 1504, the pilot of JXO called Edinburgh Tower air traffic control, and requested a clearance to track to ‘Clare’ (Clare Valley), South Australia. In order to track direct to Clare Valley, which was about 45 NM to the north-northwest, the pilot needed a clearance through a corner of the Edinburgh control zone (Figure 2).

The tower (TWR) controller 1, mistook the pilot’s request to ‘Clare’ for ‘Calvin Grove’, and cleared the pilot of JXO to track direct to Edinburgh Tower, not above 1,000 ft in order to be able to visually separate the helicopter with the arriving Orion and another aircraft conducting circuit operations at the airfield. The pilot complied with the instruction, even though this was not the direction requested, nor the clearance expected. However, being new to the area and concerned about the direction of the clearance, the pilot attempted, unsuccessfully, to contact their company via UHF radio to ask for advice.

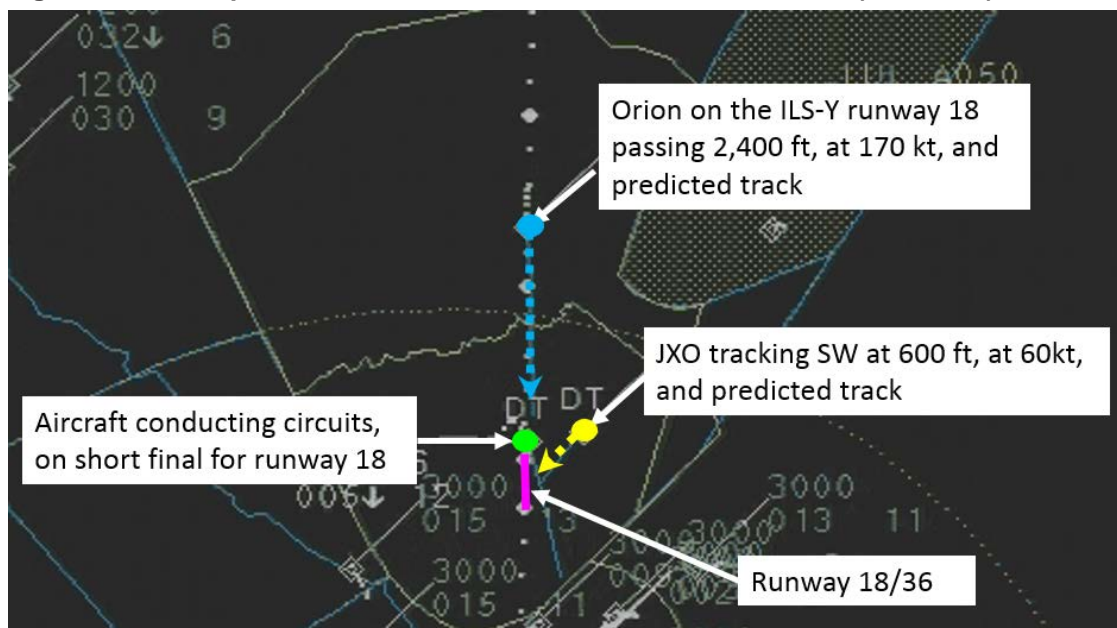
Figure 3: Aircraft positions when JXO was cleared to Calvin Grove (time 1512)

At about 1512, the Orion was passing 2,400 ft, on a 6.5 NM final and travelling at 170 kt. JXO was at 600 ft and travelling at 60 kt (Figure 3). Based on the expected tracking of the three aircraft, the TWR controller 2 assessed that JXO would safely cross the runway centreline in front of the Orion, and behind the aircraft conducting circuits (then on a short final). Consequently, the TWR controller 2 cleared JXO to track to Calvin Grove. The pilot heard the call and responded, but the radio was still selected to transmit on UHF not VHF, so the controller did not receive a response. The pilot was flustered and expecting an onwards clearance to Clare Valley, consequently had turned right to track northwards to Clare Valley.

While attempting to establish communications with JXO, the TWR controller 2 monitored JXO's tracking using binoculars. About the time of the radio check, JXO appeared to turn right, then fluctuate between north-westerly and westerly headings. Due to the small size of JXO and its distance from the tower, its exact tracking was difficult to determine visually. Furthermore, the tower radar situation data display (SDD) did not provide a true representation of the helicopter's tracking, due to its slow speed. The SDD did indicate that JXO had tracked further north than cleared, which increased the closure rate between the helicopter and the Orion.

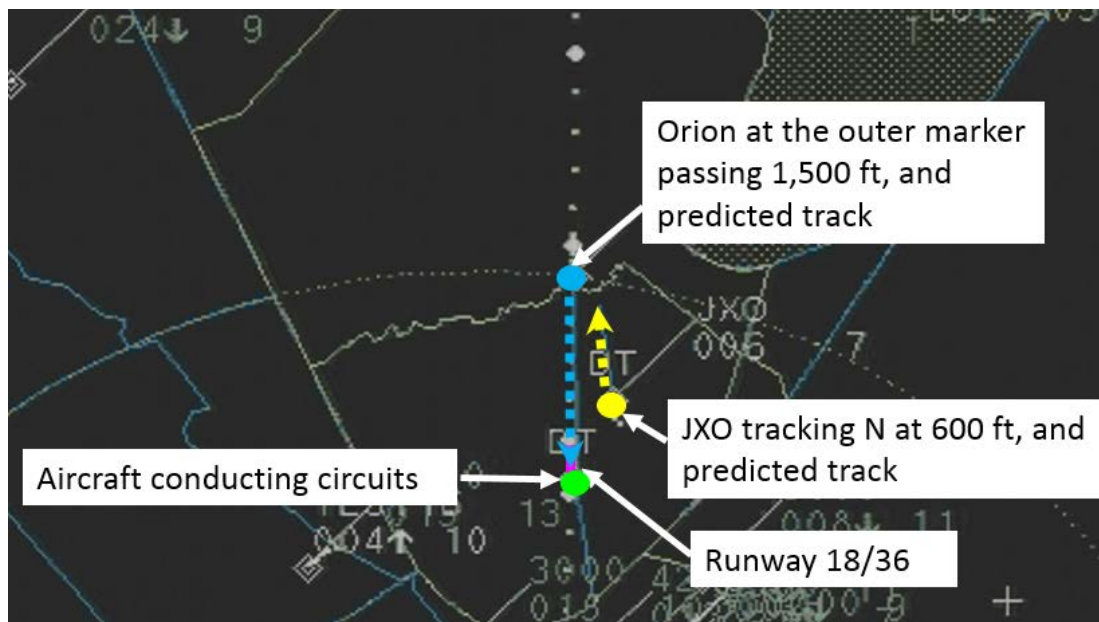
Figure 4: Orion at the outer marker (time 1513)

At about 1513, the pilot of the Orion reported at the outer marker on the ILS (4.2 NM from the runway threshold), and the TWR controller 2 cleared the Orion to land (Figure 4). JXO was then tracking north-northwest, about 3 NM from the Orion, and converging. The TWR controller 2 was then apprehensive about JXO's tracking. Although the crew of the Orion had heard the controller's attempts to contact JXO, as the controller had not provided them with directed traffic information, they were unaware of JXO's position, and assumed it was not a consideration for their tracking.

After the Orion crew reported at the outer marker, it became apparent to the controller that visual separation would be lost. However, due to the proximity and relative tracks of the helicopter and the Orion, it was then impossible to introduce an alternative separation standard such as vertical displacement⁴ or assigning separation responsibility to the pilot.

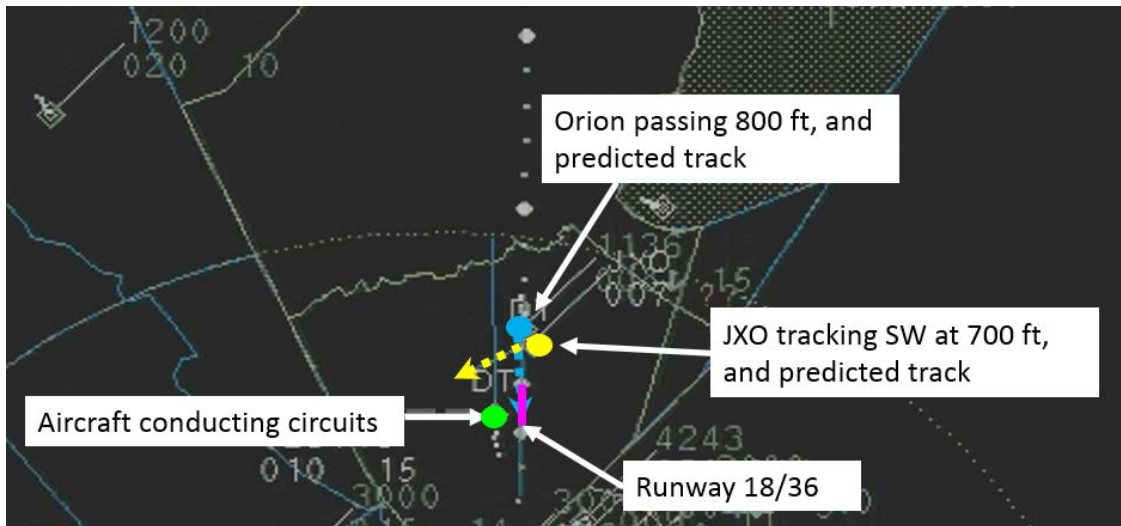
Figure 5: Relative positions when ATC advised JXO of the Orion (time 1514)

Immediately following the pilot of JXO's response, the TWR controller 2 asked whether the pilot had the 'P3' (Orion) in sight, advising that it was then in the pilot's 1 o'clock³ position at about 2 miles. The pilot queried the aircraft type, and the TWR controller 2 advised that the 'P3 Orion' was now at about 1 mile in the pilot's 2 o'clock position. The pilot was initially unable to sight the Orion, as it was below, to the right, and behind the helicopter, and therefore not in the pilot's 1 or 2 o'clock position (Figure 5). The pilot then saw the Orion's shadow on the ground and sighted the Orion. The pilot of JXO responded having the aircraft in sight, and the TWR controller 2 directed the pilot to pass behind that aircraft.

The clock positions provided to the pilot of JXO were incorrect and delayed the pilot's ability to sight the Orion. The preferred compromised separation recovery technique is to provide a bearing and distance of the other aircraft to the pilot, which was available from the radar SDD.

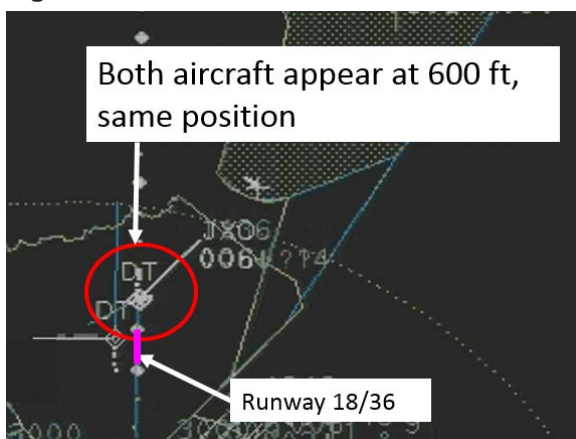
Figure 6: Aircraft collocated on radar SDD

By the time the controller completed that transmission, JXO had passed overhead the Orion. On sighting the Orion, the pilot of JXO had immediately initiated a climb to avoid a collision, and estimated the Orion passed about 100 ft below. On hearing the controller pass the Orion as traffic to the pilot of JXO, the Orion crew immediately became concerned about the helicopter's proximity, and looked for it. The co-pilot (non-flying pilot) of the Orion sighted JXO, assessed there was a risk of collision, and called 'go low, go low, go low'. The captain (flying pilot), also sighted JXO, and increased the rate of descent to pass beneath the helicopter. The Orion crew estimated that JXO passed about 50 ft directly above the Orion, and were concerned it may collide with the Orion's vertical tail fin. On the radar SDD, at 1514:25, both aircraft appear in the same position at 600 ft (Figure 6).

The combination of incorrect application of visual separation, ATC priorities, and the decision not to amend the Orion's tracking, led to a loss of separation between the Orion and JXO, including a loss of wake turbulence separation.

The Department of Defence has released a Standing Instruction that mandates annual compromised separation recovery training for all air traffic controllers.
