# Weather related event involving a Bombardier DHC-8, VH-XFQ

Leinster Airport, Western Australia, 23 June 2015

**ATSB Transport Safety Report**  
Aviation Occurrence Investigation  
AO-2015-067  
Final – 28 January 2016

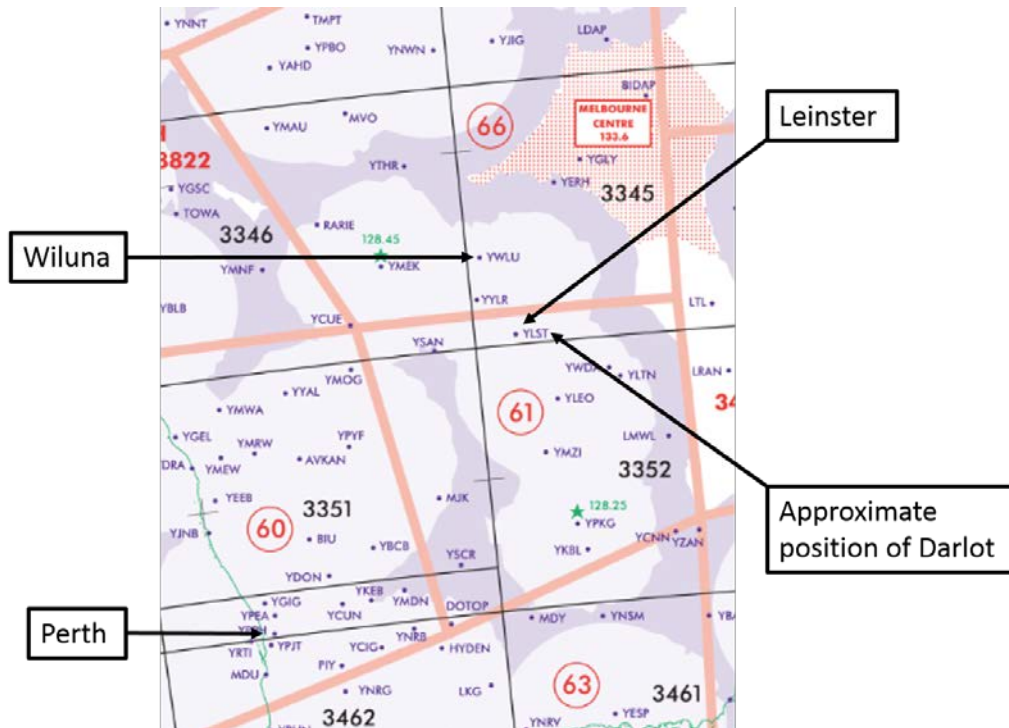
**Figure 3: Extract from Planning Chart Australia showing relevant locations and ARFOR area boundaries**

The captain also reviewed relevant area forecasts (ARFOR)<sup>8</sup> in preparation for the flight, in order to build an appreciation of the overall weather picture. This included the ARFORs for areas 61 and 66 (Figure 3). In broad terms, the ARFORs indicated that the crew could expect low cloud and fog in area 61, and the southern part of area 66, until 0900. Beyond 0900, some cloud was still forecast in both areas, but with a higher base and unlikely to have any operational implications for the flight.

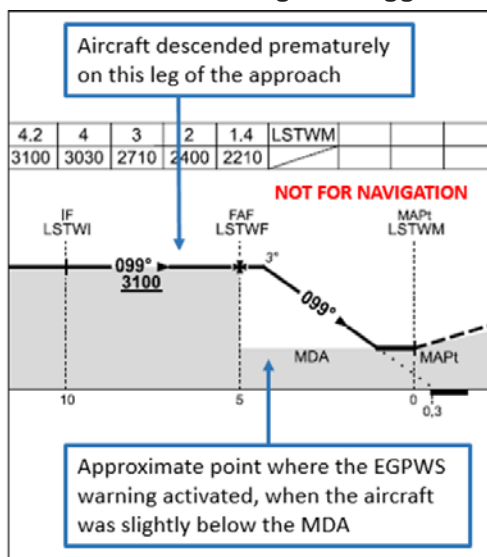
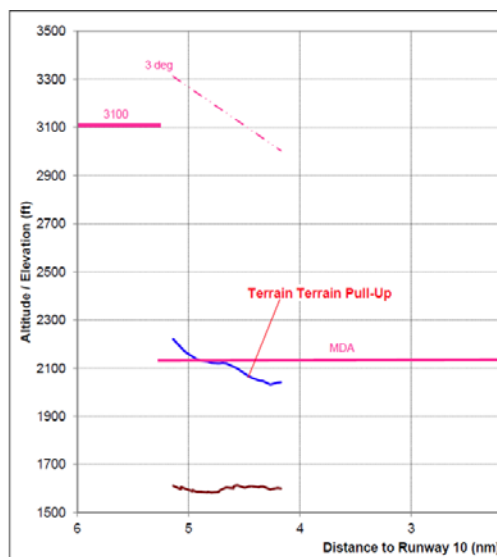
**Figure 6: Excerpt from approach chart and vertical profile of the aircraft (in part) showing where EGPWS warning was triggered**

During the RNAV (GNSS) approach to runway 10 at Leinster, the crew received an EGPWS ‘terrain terrain pull-up pull-up’ warning. They responded to that warning by commencing a missed approach. At the time the crew received the EGPWS warning, they were clear of cloud and could see the ground beneath, but there was wispy low cloud ahead, partially obscuring their view of the runway environment. The crew were assessing the conditions ahead, and the feasibility of safely continuing the approach, when the EGPWS warning activated. The crew elected to make a missed approach with go-around power, rather than conduct a terrain escape manoeuvre,<sup>13</sup> given that the missed-approach flight path of the aircraft was visually clear of terrain and obstacles.

Subsequent analysis of the flight data by the operator revealed that during the RNAV (GNSS) approach to runway 10, the crew descended prematurely to the relevant Minimum Descent Altitude (MDA).<sup>14</sup> In doing so, the crew descended beneath the 3,100 ft altitude constraint between the intermediate fix (LSTWI) and the final approach fix (LSTWF) (Figure 3). The crew overflew LSTWF just above the MDA, and then levelled momentarily at the MDA. Soon after, a brief and shallow descent developed, at which time the EGPWS warning was triggered. At the time the EGPWS warning was triggered, the aircraft was about 4.5 NM from the runway, and the radio altimeter indicated that the aircraft was slightly less than 500 ft above the underlying terrain.

The crew commented that a number of factors in combination probably contributed to their descent below the altitude constraint between LSTWI and LSTWF. These factors are broadly summarised as follows:

- Management of the approach profile was probably compromised to some extent by the manner in which the approach was conducted in visual conditions, but with the intent of complying with an instrument procedure. The attention of the crew during the approach was probably substantially drawn to ongoing assessment of how to effectively contend with the low cloud ahead.
