Pre-flight planning event involving a Boeing 737, VH-YIU

Christchurch Airport, New Zealand, 15 July 2015

ATSB Transport Safety Report
Aviation Occurrence Investigation
AO-2015-078
Final – 28 January 2016

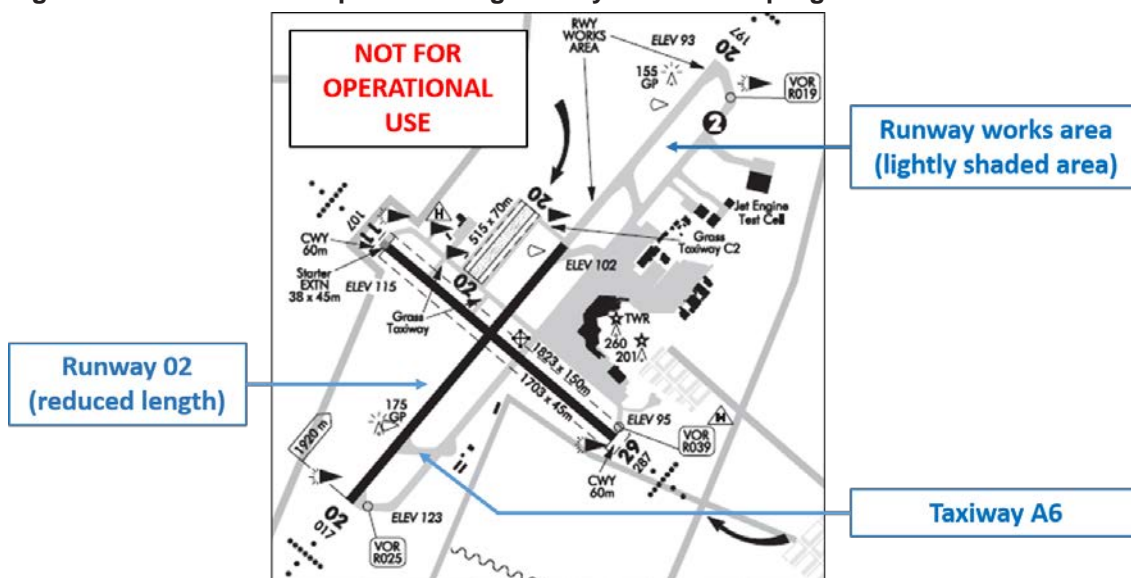
At about the time the aircraft was pushed back from the gate, air traffic control (ATC) advised the crew that there was a change in the ATIS⁵ and that runway 02 was operating at a reduced length. The reduction in runway length was associated with works in progress (WIP) that reduced the runway length available from 3,288 m to 1,920 m, with the northern 1,368 m of the runway closed (Figure 1).

Figure 1: Christchurch Airport showing runway 02 works in progress - north
