Partial engine failure involving a Gippsland Aeronautics GA-8, VH-FGN

near Busselton Airport, Western Australia, on 21 October 2015

ATSB Transport Safety Report
Aviation Occurrence Investigation
AO-2015-123
Final – 28 January 2016

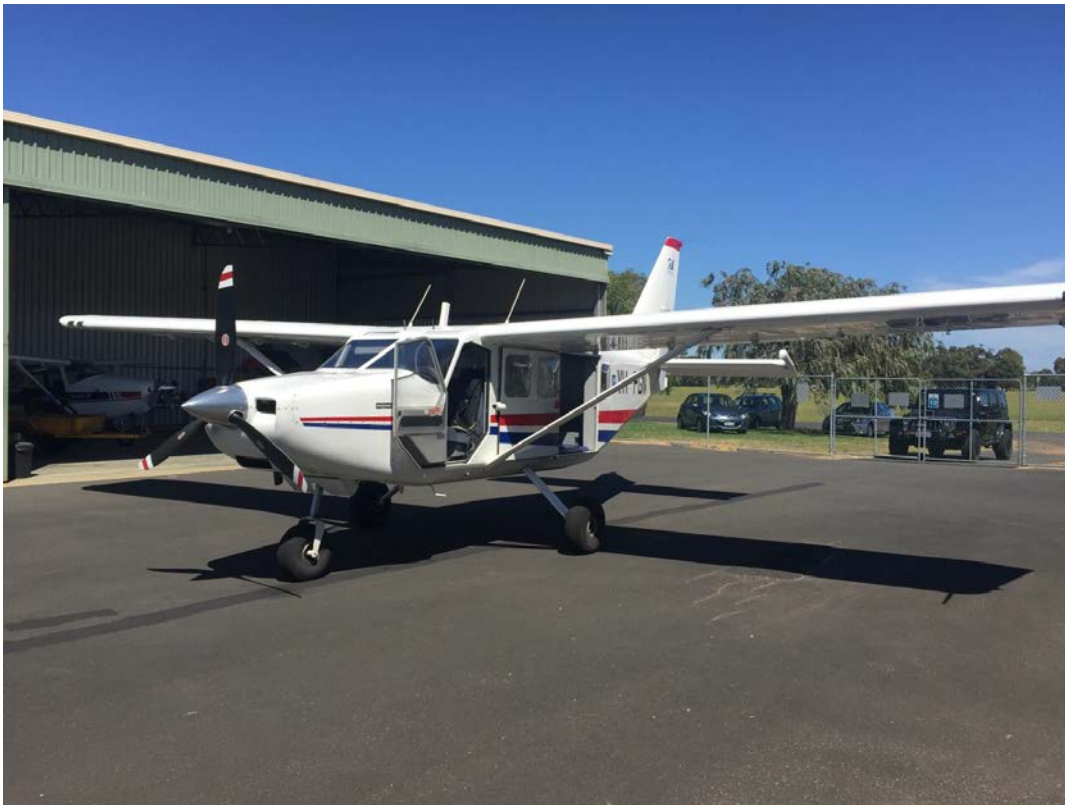
Figure 1: VH-FGN

On 21 October 2015, a Gippsland Aeronautics GA-8 aircraft, registered VH-FGN (FGN), was conducting parachute operations at Busselton Airport, Western Australia (Figure 1). Prior to commencing the day's operations, a company pilot conducted a pre-flight inspection of the aircraft, with no defects found.
