# Aircraft control issue involving a Liberty XL-2, VH-CZS

at Camden Airport, New South Wales, on 29 October 2015

**ATSB Transport Safety Report**  
Aviation Occurrence Investigation  
AO-2015-125  
Final – 28 January 2016

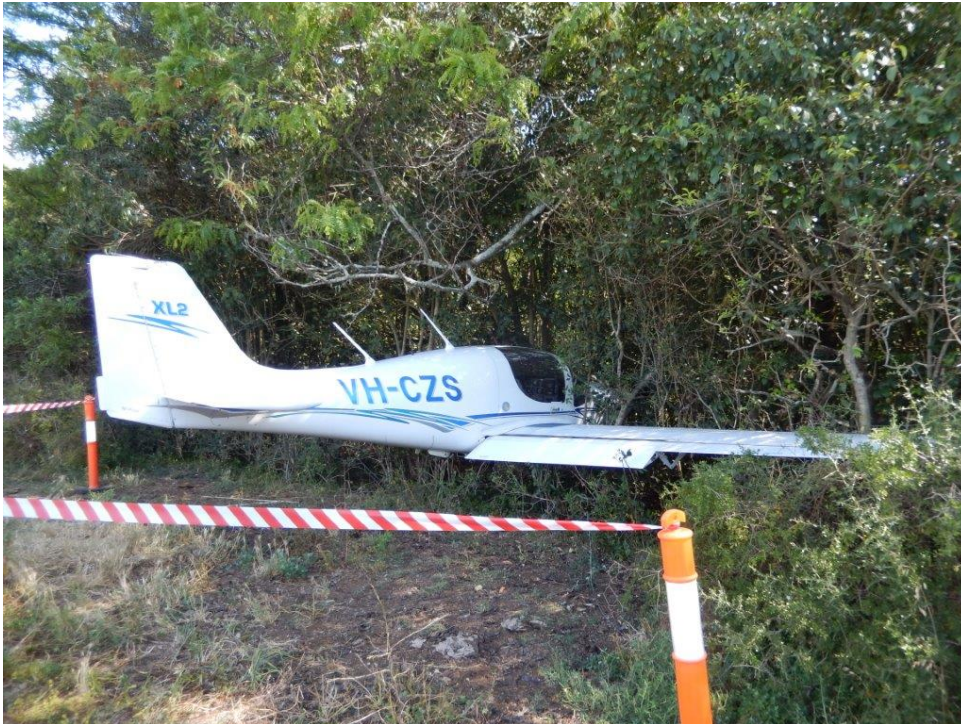
**Figure 1: Accident site**

During the landing roll, the aircraft collided with two fences and came to rest in a stand of trees. The pilot and instructor were uninjured, and the aircraft sustained substantial damage (Figure 1).

An engineer conducted a post-accident inspection of the aircraft, and did not find any obvious defect that may have contributed to the control issue.
