Australian Government
Australian Transport Safety Bureau

In-flight break-up involving de Havilland DH82A Tiger Moth, VH-TSG

300 m east of South Stradbroke Island, Queensland | 16 December 2013

ATSB Transport Safety Report
Aviation Occurrence Investigation
AO-2013-226
Final – 21 January 2016

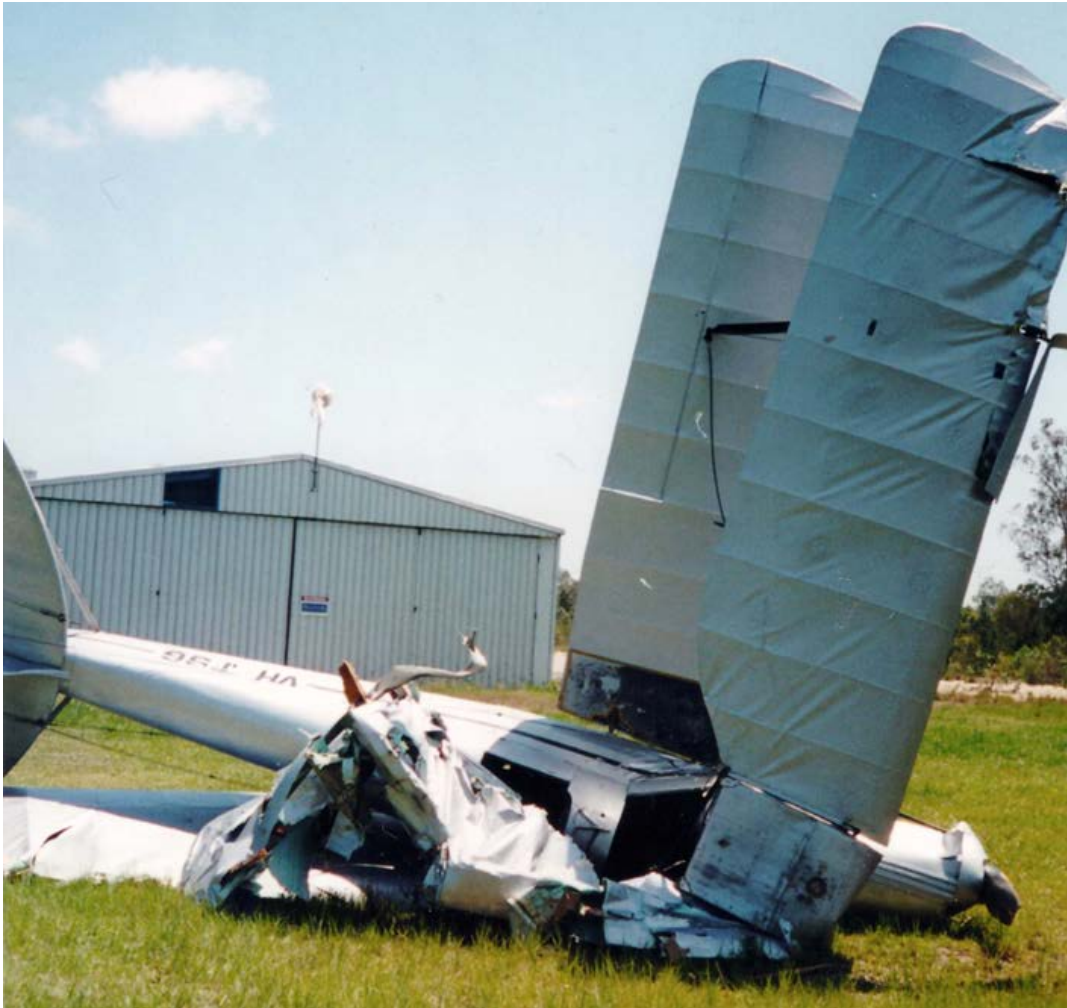
The second accident occurred on 21 November 2001. It was reported that the aircraft experienced a reduction in engine power after take-off from Albatross Field, Upper Coomera, Queensland. During the subsequent forced landing the aircraft collided with trees and was substantially damaged (Figure 8). The aircraft occupants were reported to have sustained minor injuries.¹¹

Figure 8: VH-TSG after recovery from bushland near Albatross Field following the accident in 2001

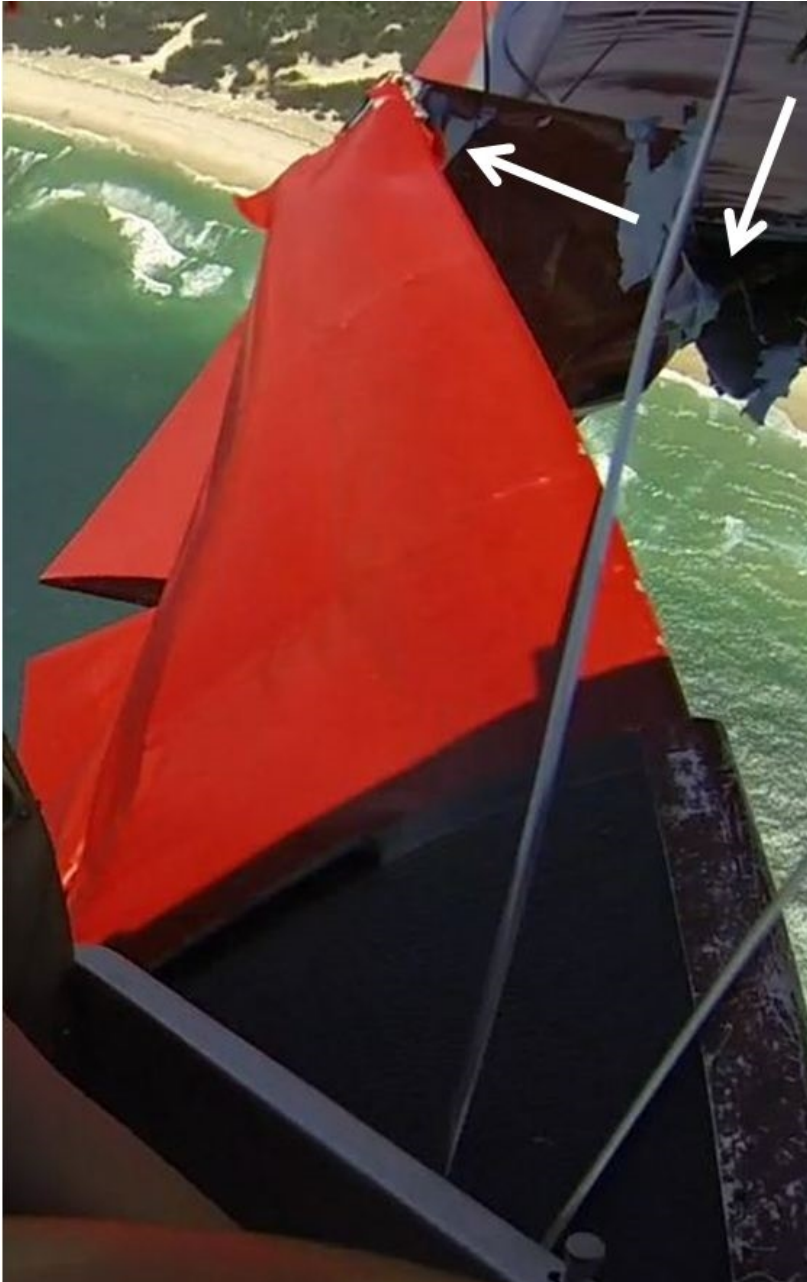
As the left lower wing moves rearwards and upwards, more of the wing structure comes into view. Figure 19 shows failure of the wing structure, initially at two main points along the front spar (indicated by the arrows):

The front spar between the mid-span failure and the inboard end appeared to be intact at that point.

Figure 19: +0.336 sec - front spar fractures

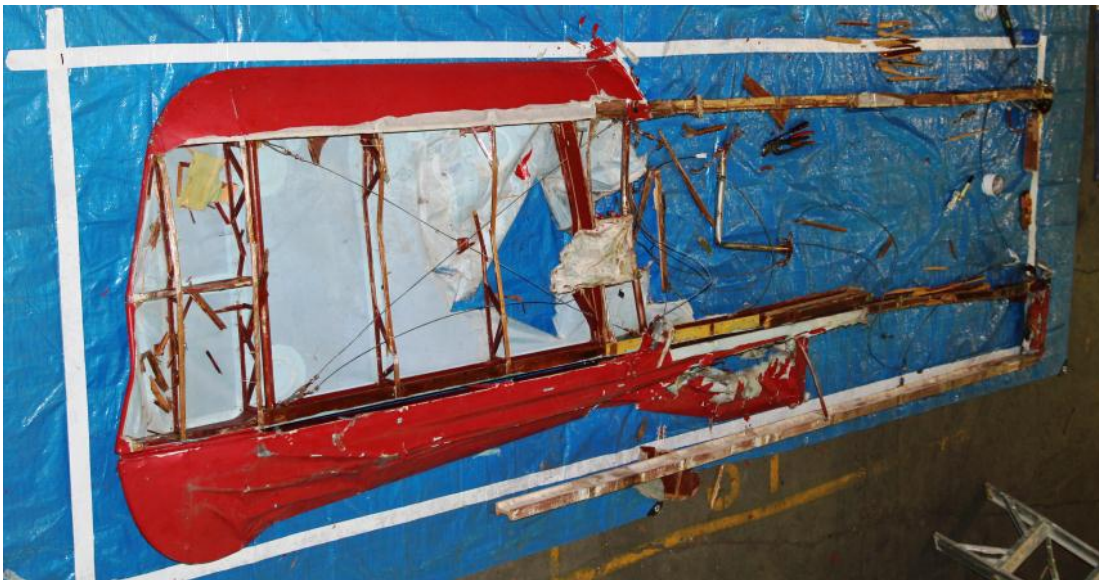
The wings were reconstructed with about 95 per cent of the main spar structures accounted for. The left wing flying wires and landing wires were still attached to their corresponding attachment points. The internal wing bracing wires were also intact. Figure 22 shows the partially reconstructed left lower wing.

Figure 22: Left lower wing looking at the upper surface

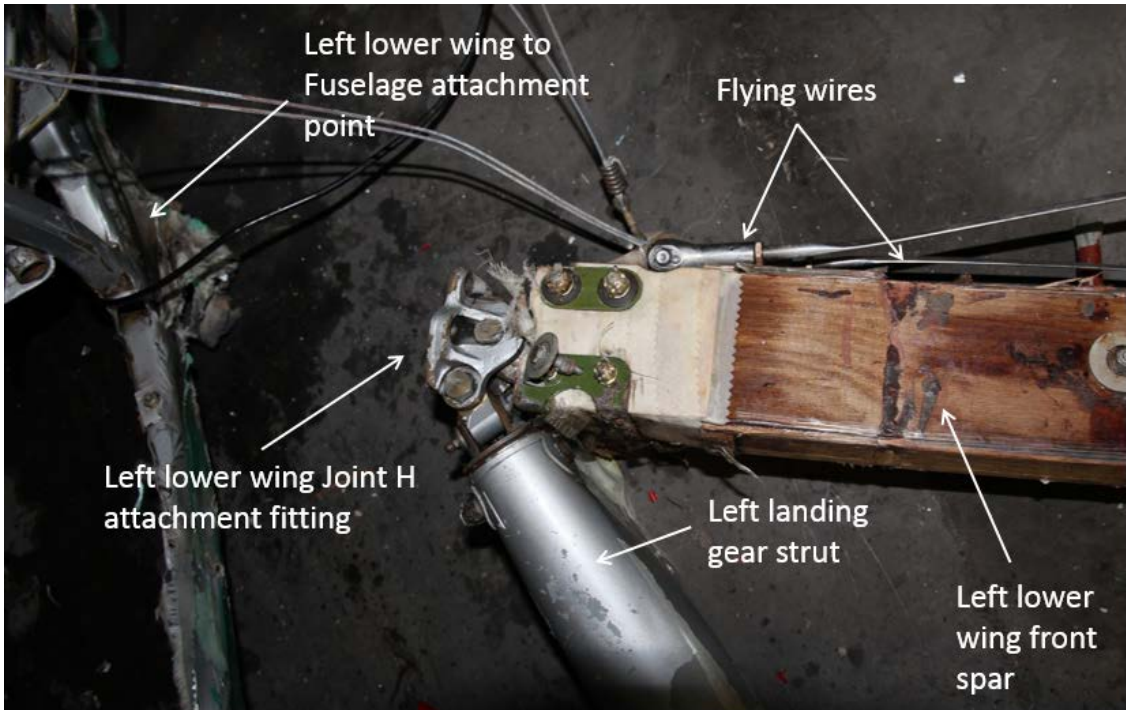
Figure 23: Left lower wing to fuselage attachment

The lower wing attachment point Joint H fittings were still attached to the wings, but had separated from the fuselage on both sides. Both lateral tie rods were fractured through the threaded section at the left wing attachment point. The remaining part of the threaded section and nut for each tie rod were not recovered. Figure 23 shows the left lower wing Joint H attachment fitting, left lower wing front spar and corresponding fuselage structure to which it is normally attached.

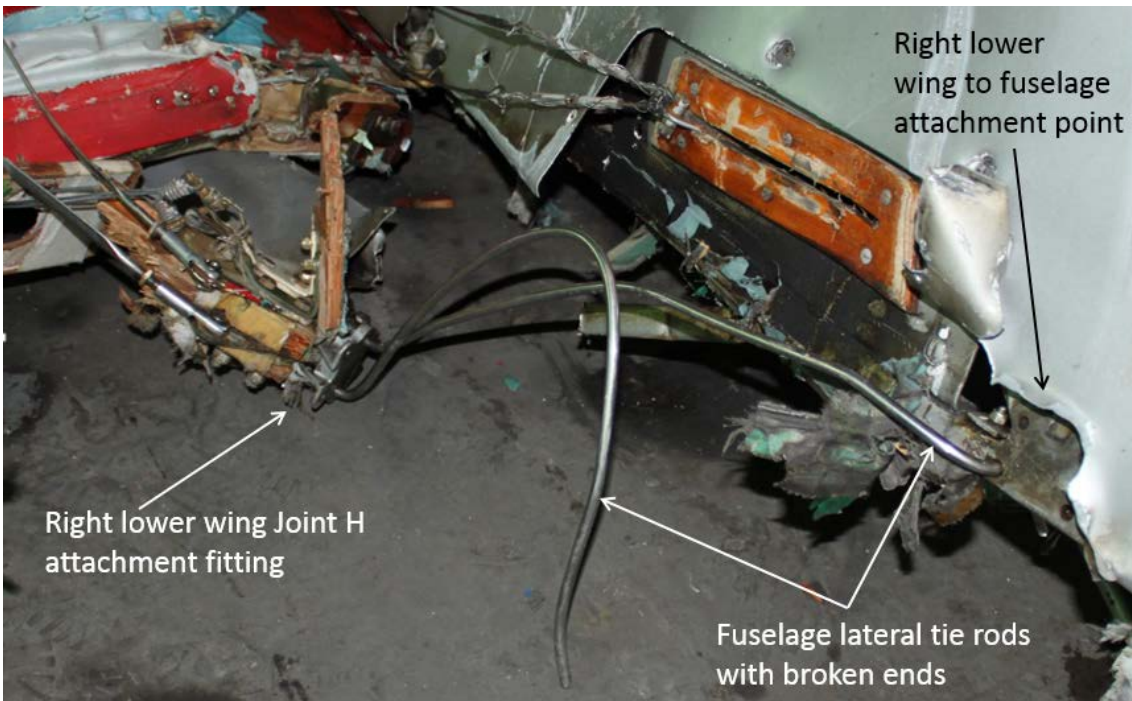
Figure 24: Right wing-to-fuselage attachment point

The remaining sections of the forward and aft tie rods had pulled through the fuselage and remained attached to the right lower wing Joint H wing attachment fitting (Figure 24).

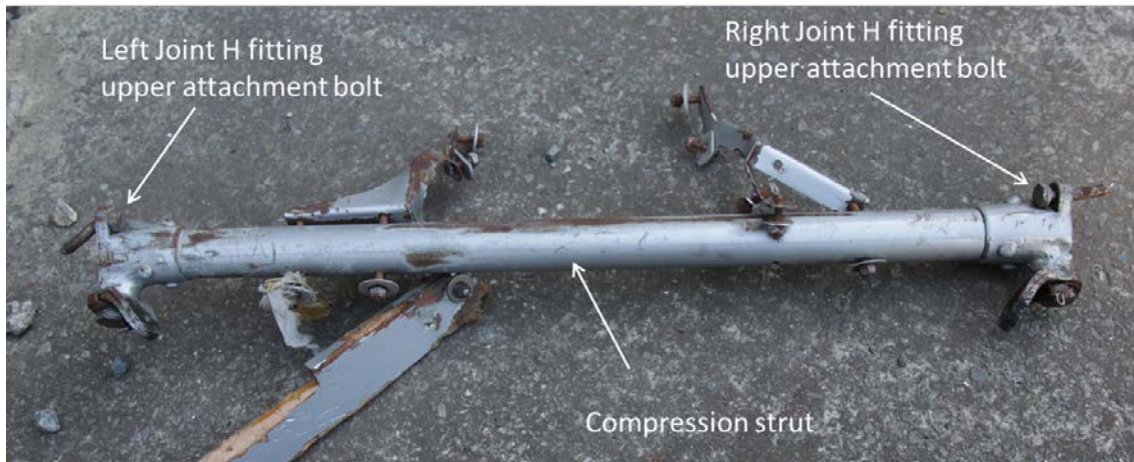
Figure 25: Compression strut viewed from the rear

The compression strut was removed from the wreckage and inspected with no pre-accident defects identified (Figure 25). Three of the four Joint H fitting upper attachment bolts were retained

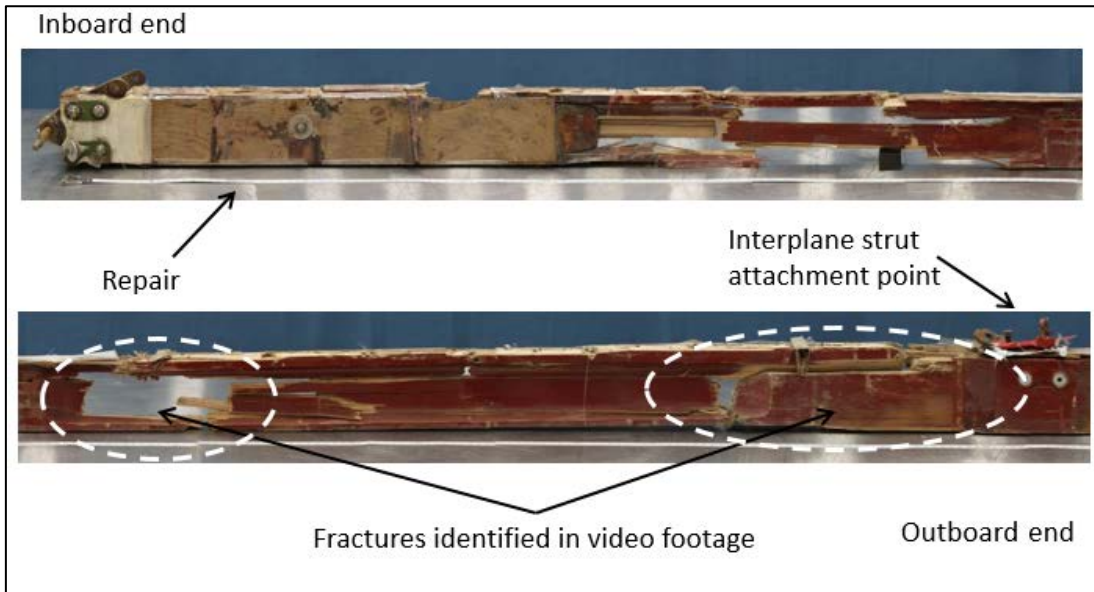
Figure 26: Inboard two thirds of the front face of the lower left wing front spar (showing fractures)

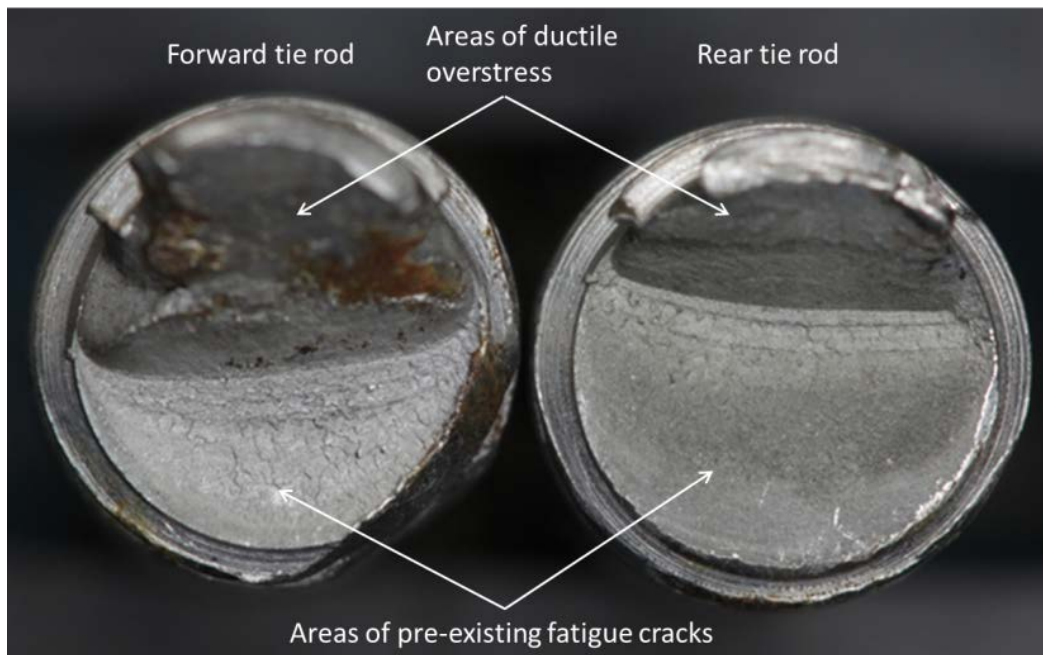
Figure 27: Fuselage lateral tie rod fracture surfaces showing the left side thread ends

A fatigue crack was also present in the threaded section of the right side of the forward tie rod. This tie rod had not completely fractured but the crack had propagated through about 40 per cent of its cross-section.

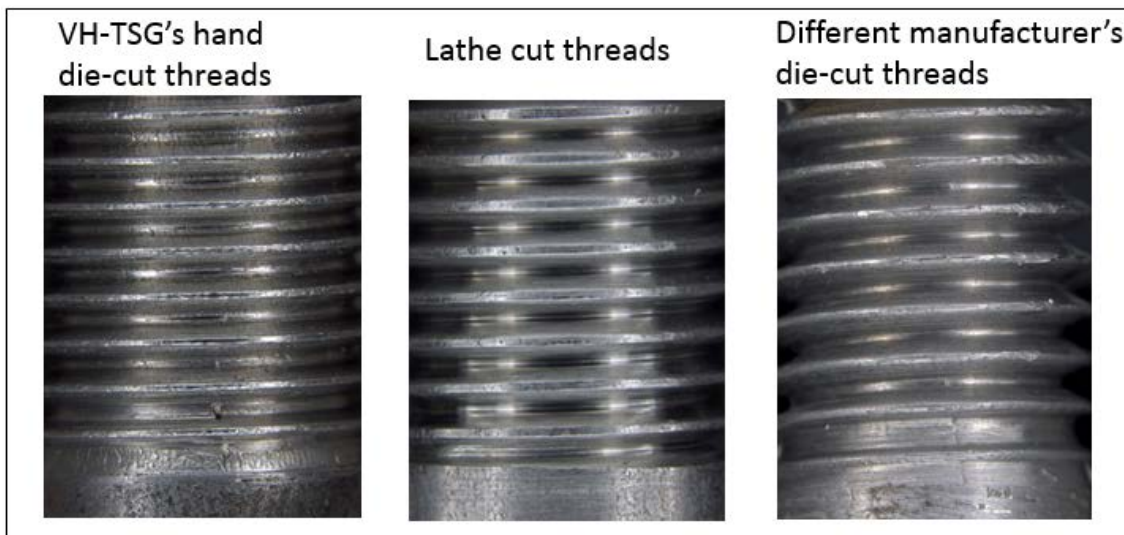
Figure 28: Two tie rods from the same Australian manufacturer and one from another manufacturer showing significant thread form differences

The material properties of the Australian manufacturer's tie rods were consistent with type 431 stainless steel. Hardness testing of tie rods from the same batch indicated that their strength conformed to the part drawing requirements. However, this was inconsistent with the material certification of the rod stock used to manufacture VH-TSG's tie rod batch. That material certification indicated tensile strength values approximately 5 per cent lower than the required minimum.

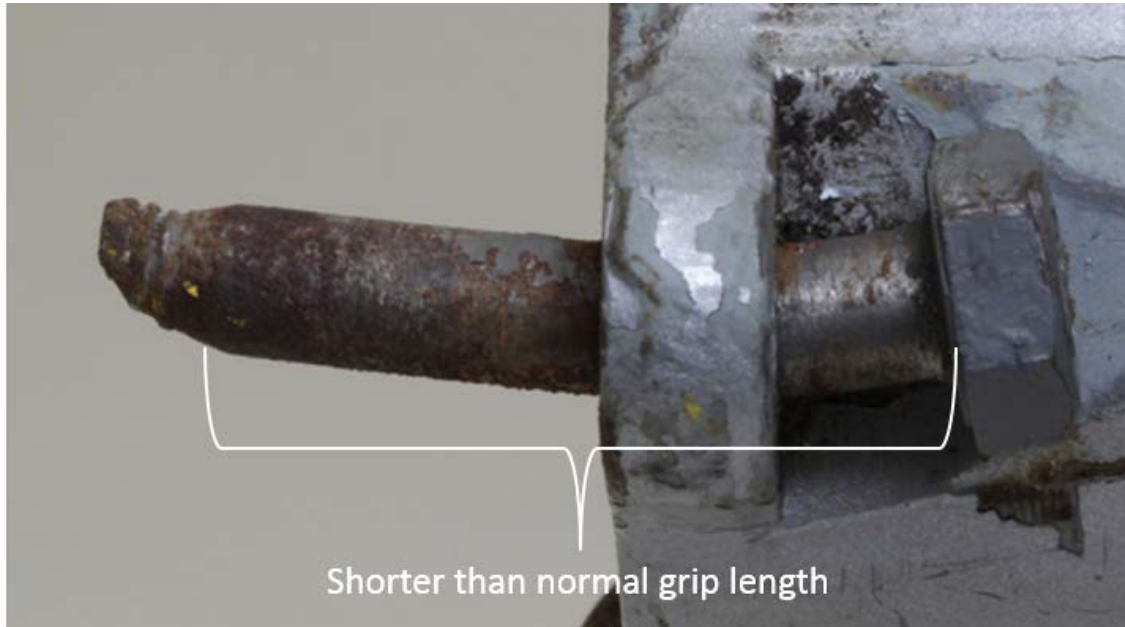
Figure 30: One of the non-standard upper attachment bolts fitted to VH-TSG showing the shorter-than-normal grip length

The insufficient grip length had the potential to adversely affect the shear loads imparted on the tie rods. Deformation in some of the associated holes of the Joint H fitting was consistent with indentations from the thread form on these bolts.

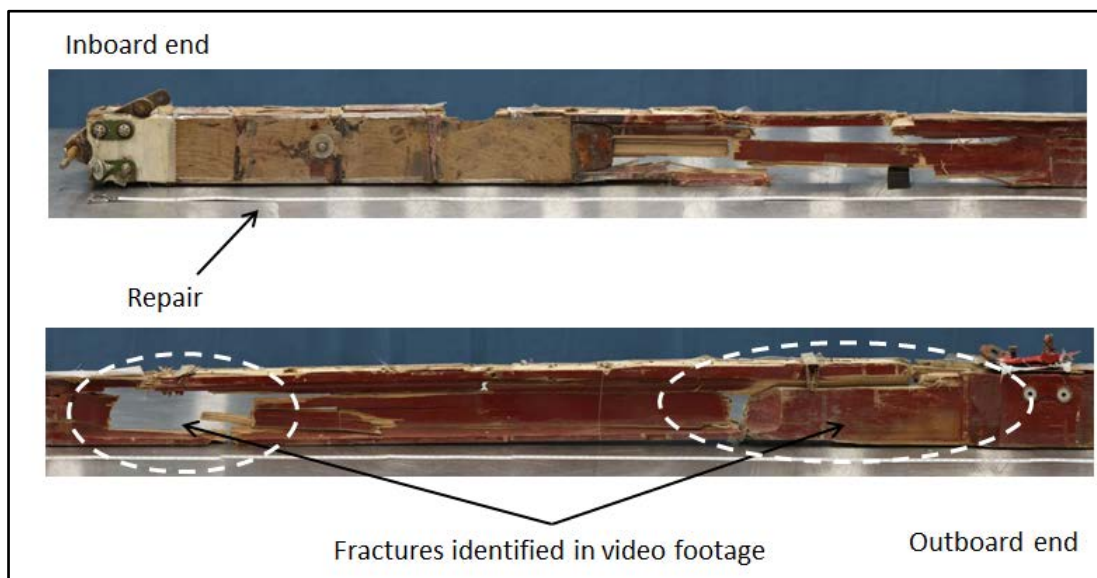
Figure A1: Left lower wing inboard two thirds of forward spar viewed from the front

There was some evidence of corrosion of the spar hardware (bolts, screws, brackets) and associated timber discolouration. However, there were no indications of any significant pre-existing defect, wood decay or rot in these areas or in the spar timbers more generally that would have contributed to premature failure of the spar. A moisture content test of the spar was

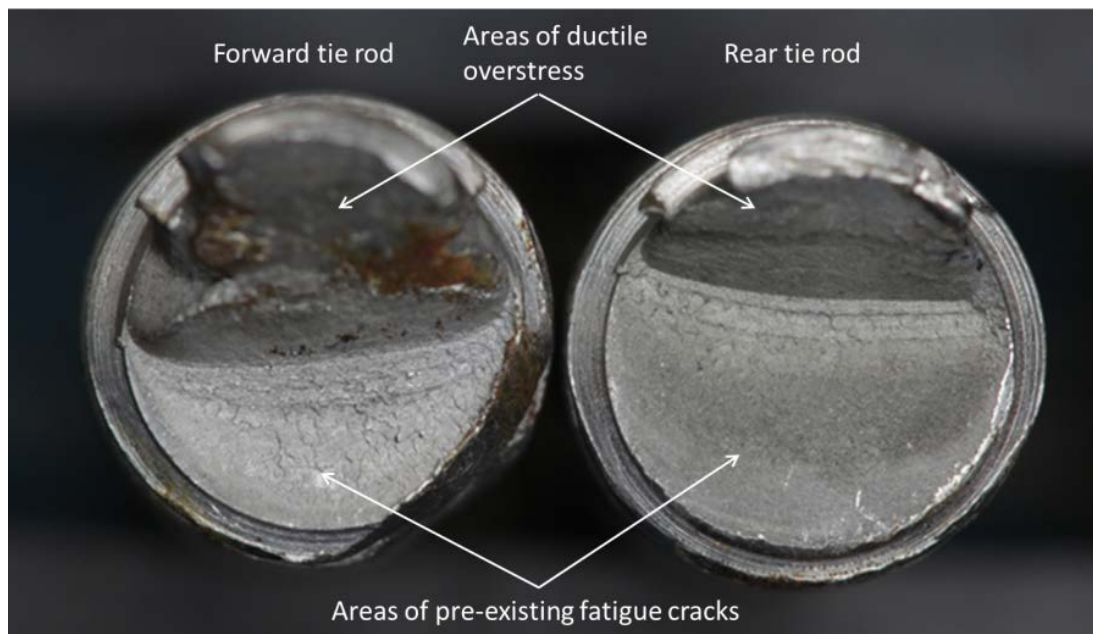
Figure A2: Fuselage lateral tie rod fracture surfaces showing the left side thread ends

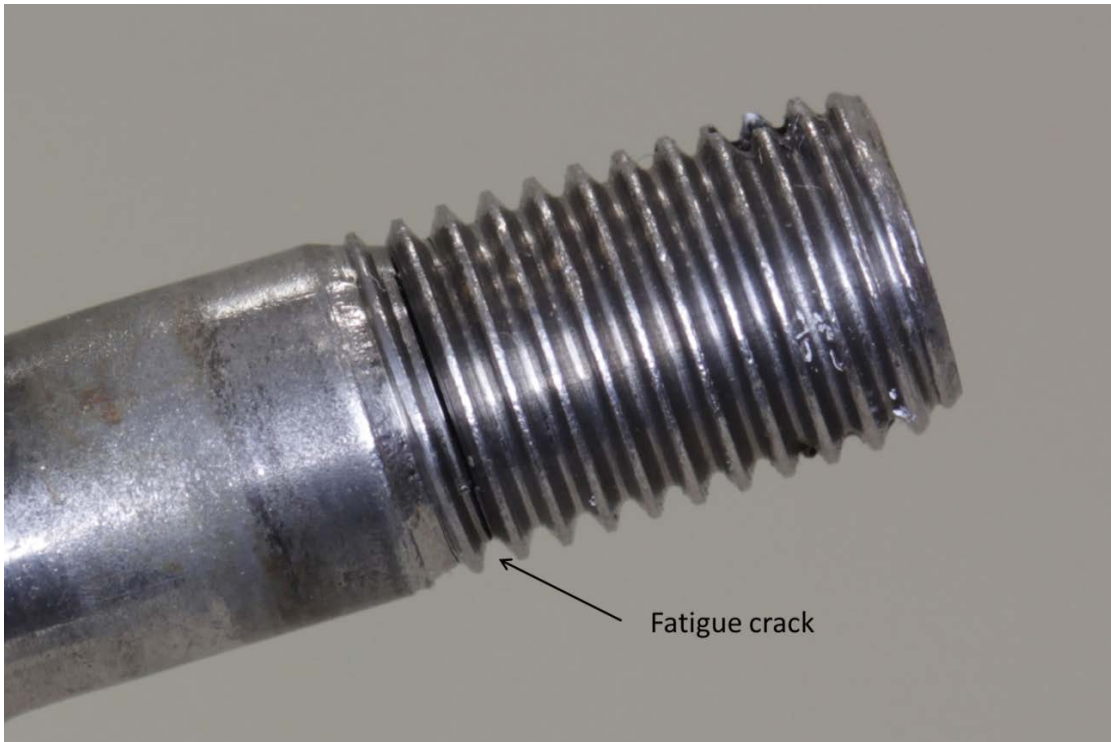
A fatigue crack was also present in the threaded section of the right end of the forward lateral tie rod. The crack had originated in the same thread-root area as the fractures on the left side, although the rod had not completely fractured in that area (Figure A3). The crack extended across about 50 per cent of the cross-sectional area. The crack origin was defined by a small, relatively smooth area of the fracture surface, originating at the root of the last fully-formed thread before the thread runout. The location of the crack origin was associated with mechanical scoring at the thread root, bounded by two irregularities (arrowed), all of which were artefacts of die-threading during manufacture (Figure A4 and Figure A5).

Figure A3: Forward fuselage lateral tie rod showing right side thread with fatigue crack

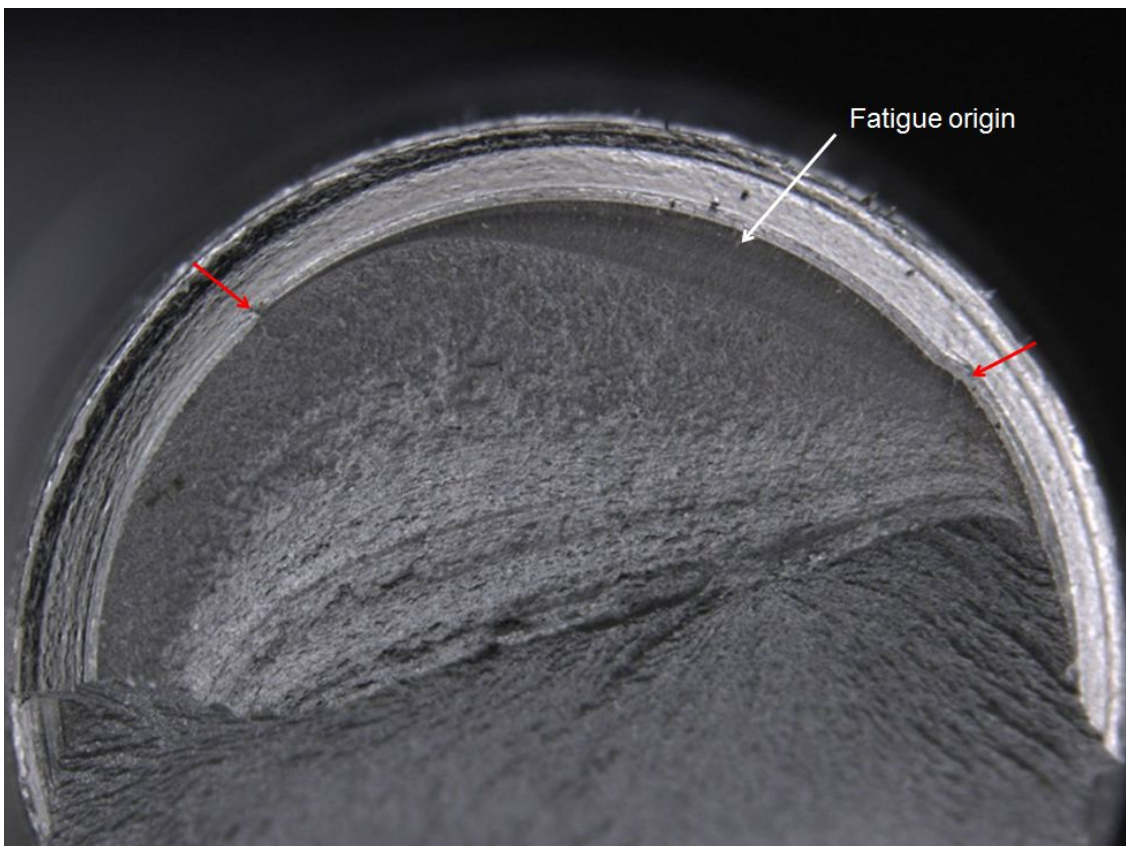
Figure A4: Fatigue crack in featured in Figure A3 opened to expose crack surface

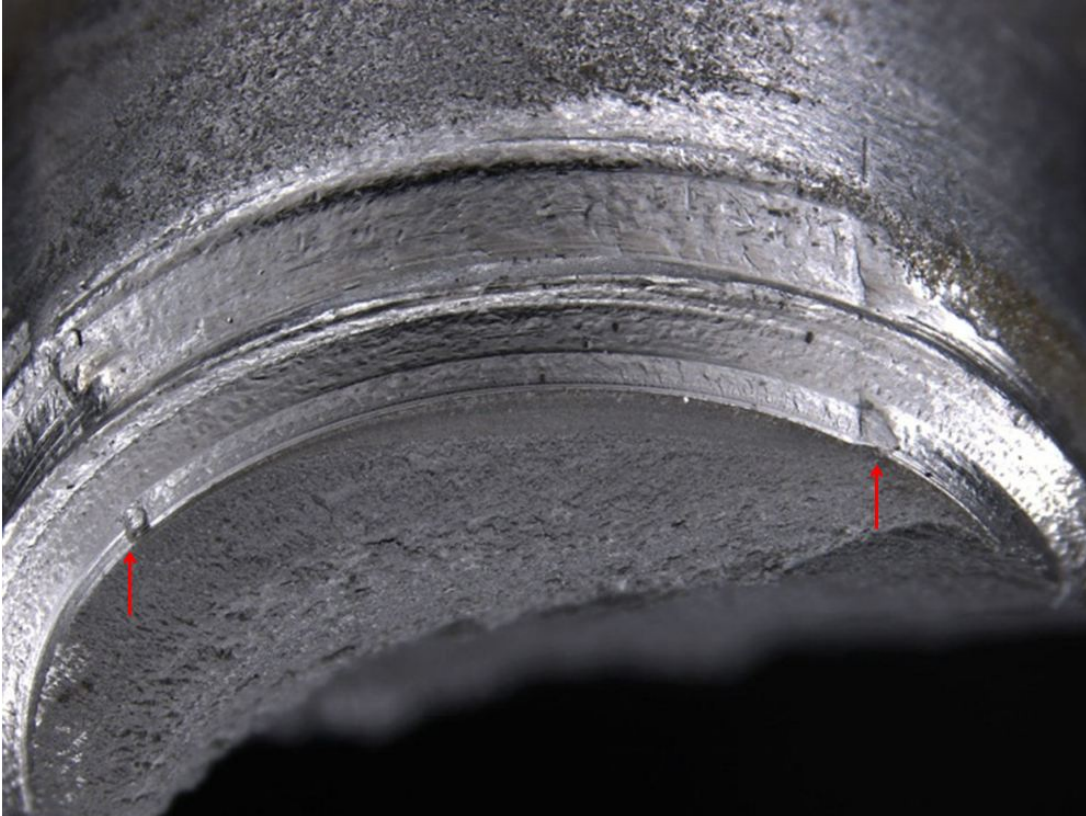
Figure A5: Thread irregularities at fatigue crack origin

The method of thread production was not specified on the JRA-776-1 (JRA) part drawing, whereas the original de Havilland drawing specified die-cut threads. The appearance of the threads on VH-TSG's tie rods was consistent with hand die-threading, which had resulted in galling and scoring on the thread flanks and at the thread root.

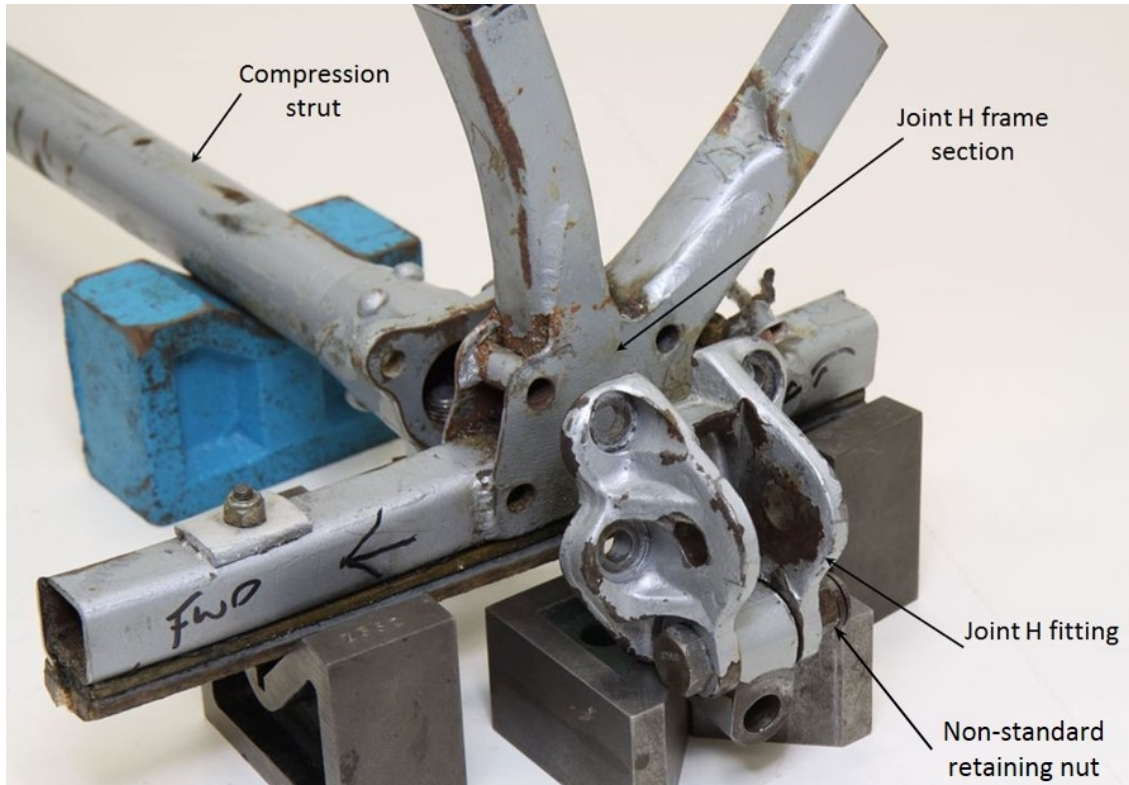
Figure A7: Left side Joint H components. Note that the retaining nut (immediately below the arrow associated with the ‘Joint H fitting’ label) is non-standard and should be a split-pinned, slotted nut

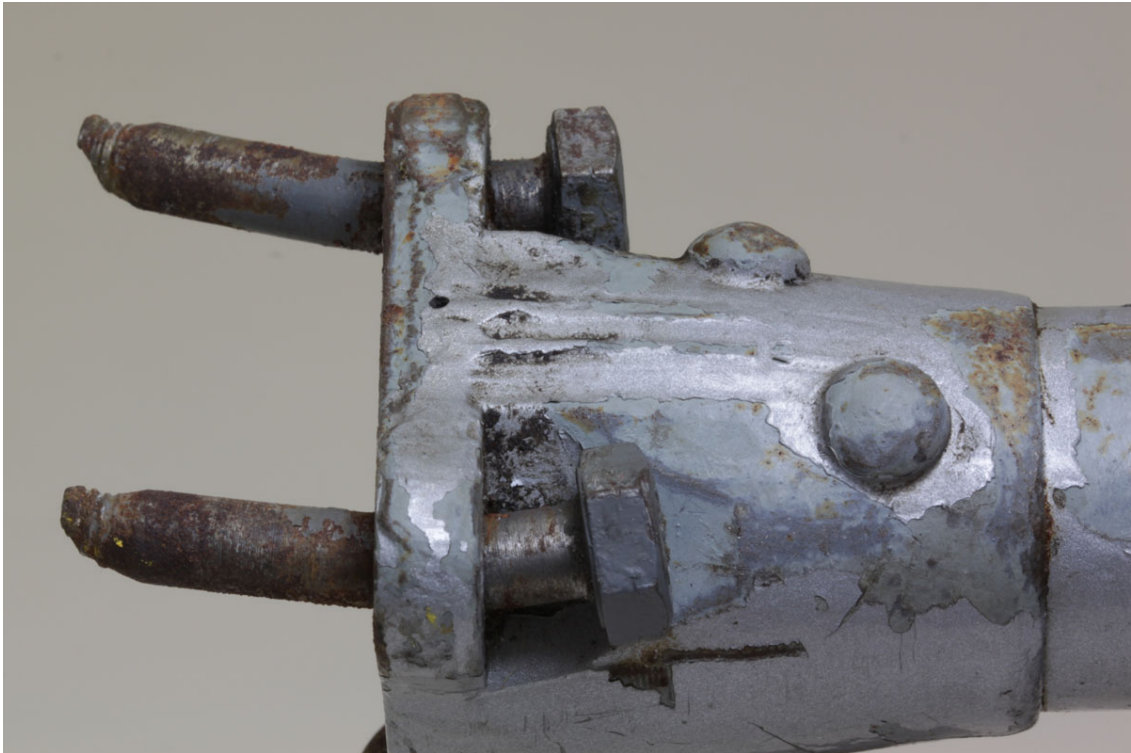
Figure A8: Fractured upper attachment bolts on right side of compression strut

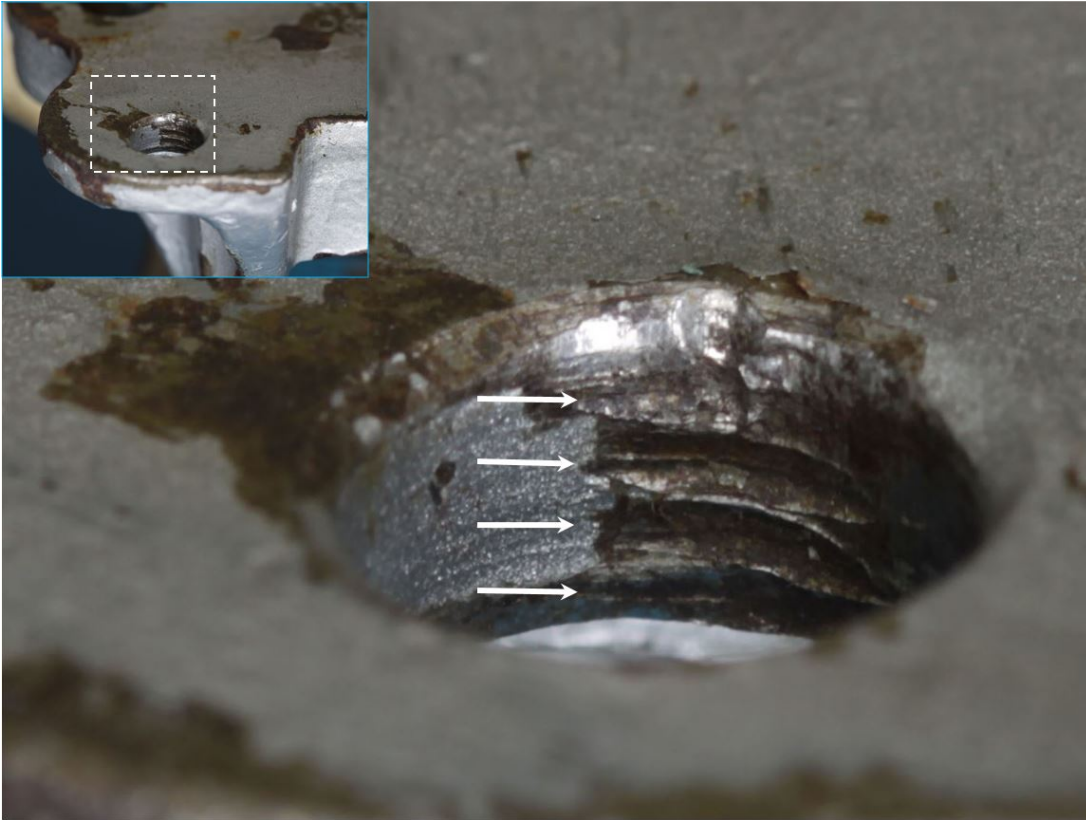
Figure A11: Joint H left forward fitting showing bolt thread indentations
