In-flight break-up involving Cicaré CH-7B, VH-SWQ

43 km north-west of Barcaldine Airport, Queensland | 12 May 2014

ATSB Transport Safety Report
Aviation Occurrence Investigation
AO-2014-086
Final – 5 February 2016

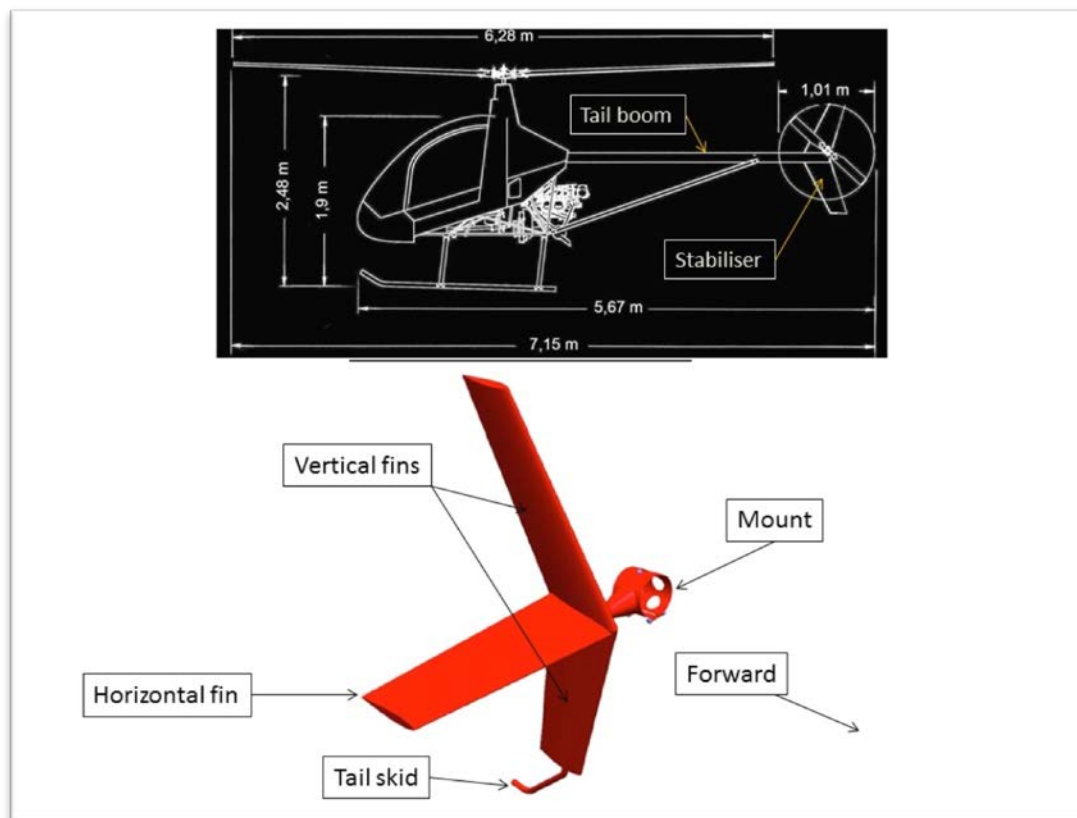
Figure 2: Stabiliser identification and location on the tail boom

The stabiliser assembly consisted of two vertical and one horizontal aerodynamic fins fitted to the rear of the helicopter tail boom. The fins generate aerodynamic forces during forward flight that keep the helicopter level and reduce the thrust required from the tail rotor. The manufacturer and Australian distributor advised that the CH-7B kits for Australia were supplied with the horizontal and vertical stabiliser assembly as a pre-fabricated component (Figure 2).

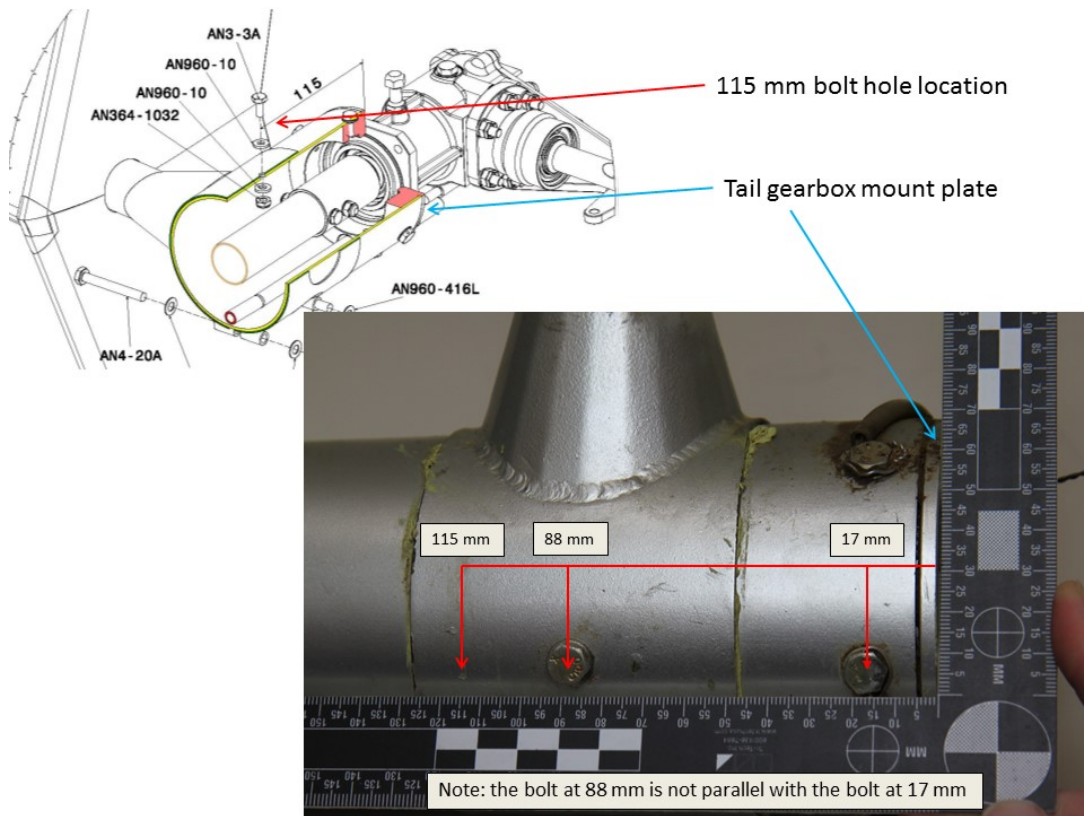
Figure 3: Stabiliser locator hole position dimensions

The relocation of the stabiliser assembly about 27 mm aft of design specifications had the potential to affect the aerodynamic and vibration characteristics of the helicopter. However, the manufacturer advised that 115 mm was now the fleet standard.

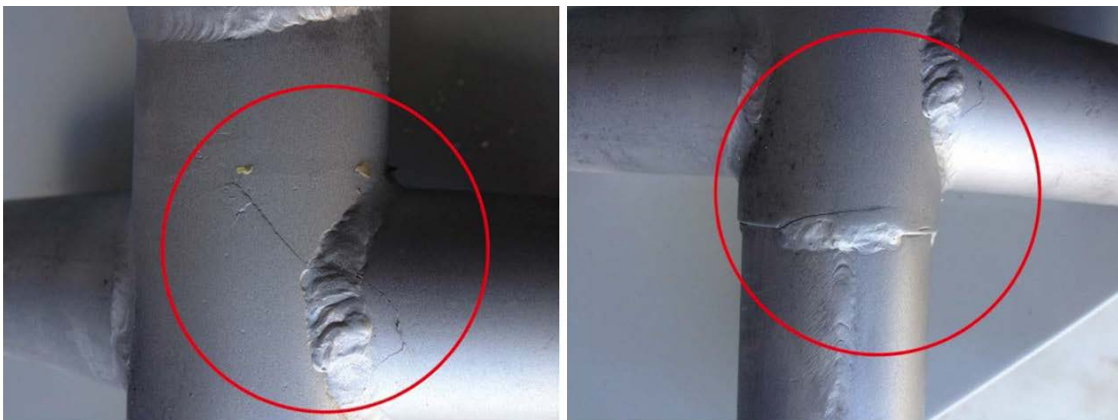
Figure 4: Cracks in the welded tube junction of the stabiliser mount

During the next periodic inspection, the pilot removed the stabiliser and the three fins, exposing significant cracking of the stabiliser fin mount tubing (Figure 4). In response, the pilot arranged for the stabiliser mount to be welded repaired by a local welder. That welder did not hold a CASA-issued aviation welding authority. Following repair, the pilot reassembled and refitted the stabiliser to SWQ.

In April 2014, after about 295 airframe hours (Table 1), further cracking of the tubing was noted while other maintenance was being conducted on SWQ. The pilot again arranged for the stabiliser mount to be welded at the same facility. The welder advised that they had carried out a dye penetrant crack check of the welded area following each repair with both checks indicating ‘a

There were no procedures in the maintenance manual for the disassembly of the fins from the stabiliser mount and no authorised repair scheme for the weld repair. Removal, welding and refitment of the stabiliser was not endorsed in the aircraft logbook for either repair.

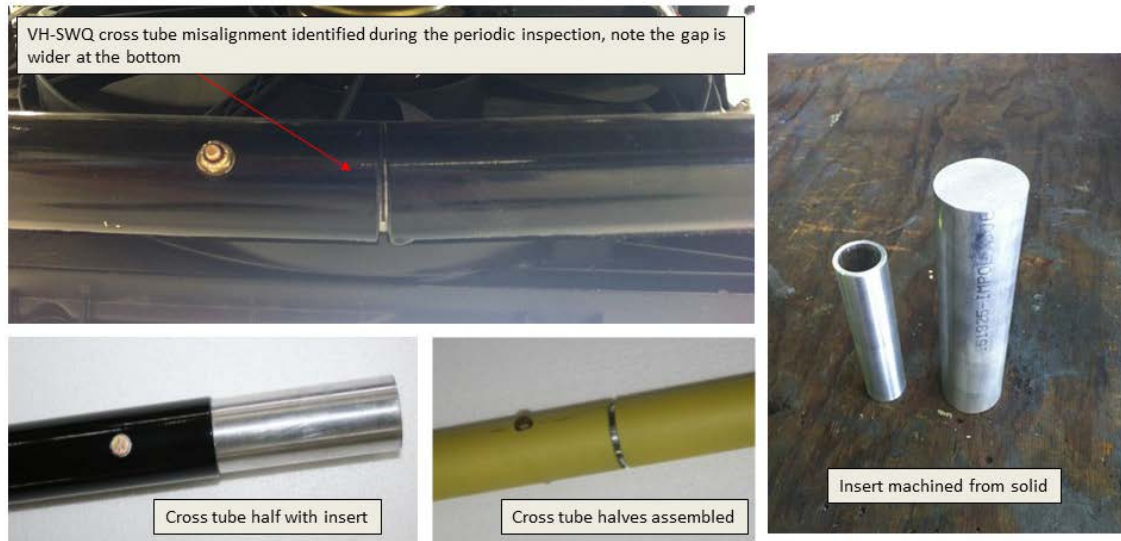
Figure 5: VH-SWQ cross-tube and inserts

The CH-7B helicopter skid-landing gear was fitted with a hollow aluminium insert inside the mid-join splice of the cross-tubes (Figure 5). In the event of a hard landing, the insert was designed to distort and provide visual identification of damage by misalignment of the cross-tube halves. As a hard landing has the potential to apply excessive forces into the airframe, the manufacturer’s maintenance manual contained inspection procedures that were to be conducted following such an event.

During a periodic inspection on 4 September 2013, a LAME noticed that the rear cross-tube mid-join splice was misaligned consistent with a previous hard landing. A replacement insert was subsequently machined by the maintenance organisation using dimensions supplied by the manufacturer on 29 October 2013. No record of a hard landing inspection or the insert manufacture and replacement was identified in the aircraft’s logbook. The ATSB was provided with documented detail of the repair. However, it indicated that the repair was conducted 2 weeks prior to receiving the insert dimensions from the manufacturer. The LAME later advised that the repair certification contained a typographical error. The certification was intended by the LAME to record the repair as being carried out about 2 weeks after the dimensions were received from the manufacturer.

The circumstances of the apparent heavy landing and the reason for the apparent discrepancy in the maintenance documentation could not be determined. The original owner of SWQ advised that they had not experienced any heavy landings in the helicopter.

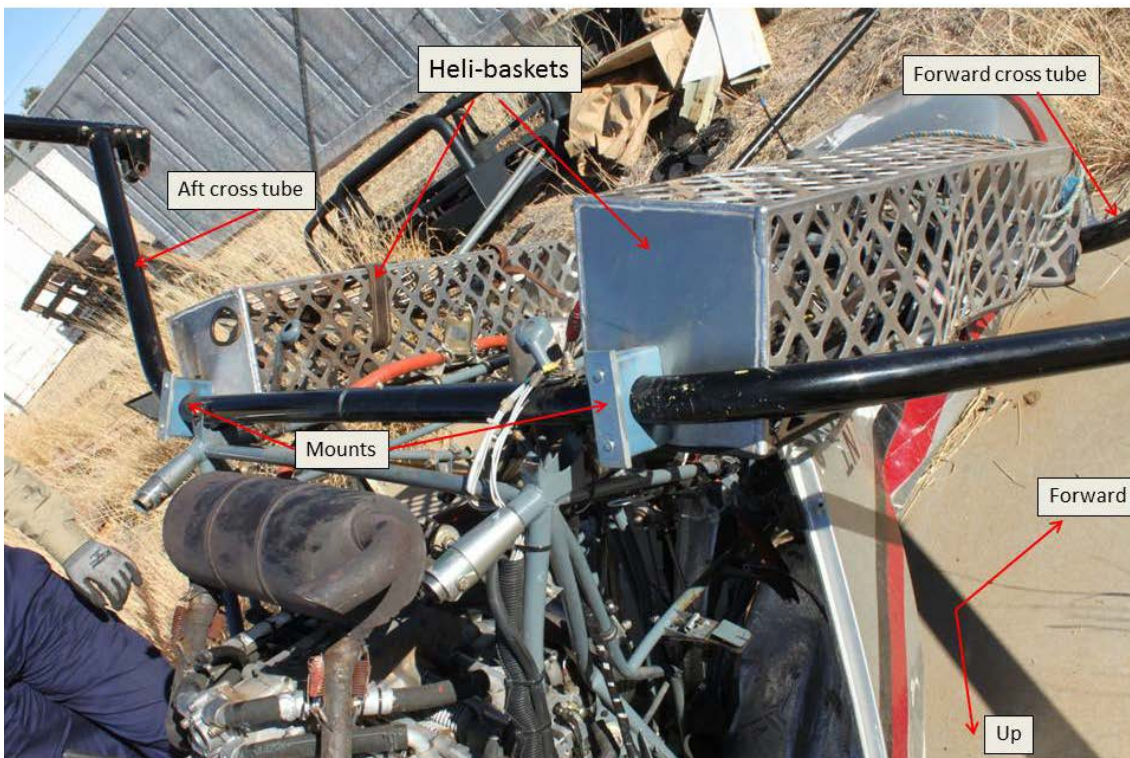
Figure 6: Heli-baskets

The aircraft logbook contained no endorsement or information on these baskets and the ATSB could not determine who fitted the baskets.

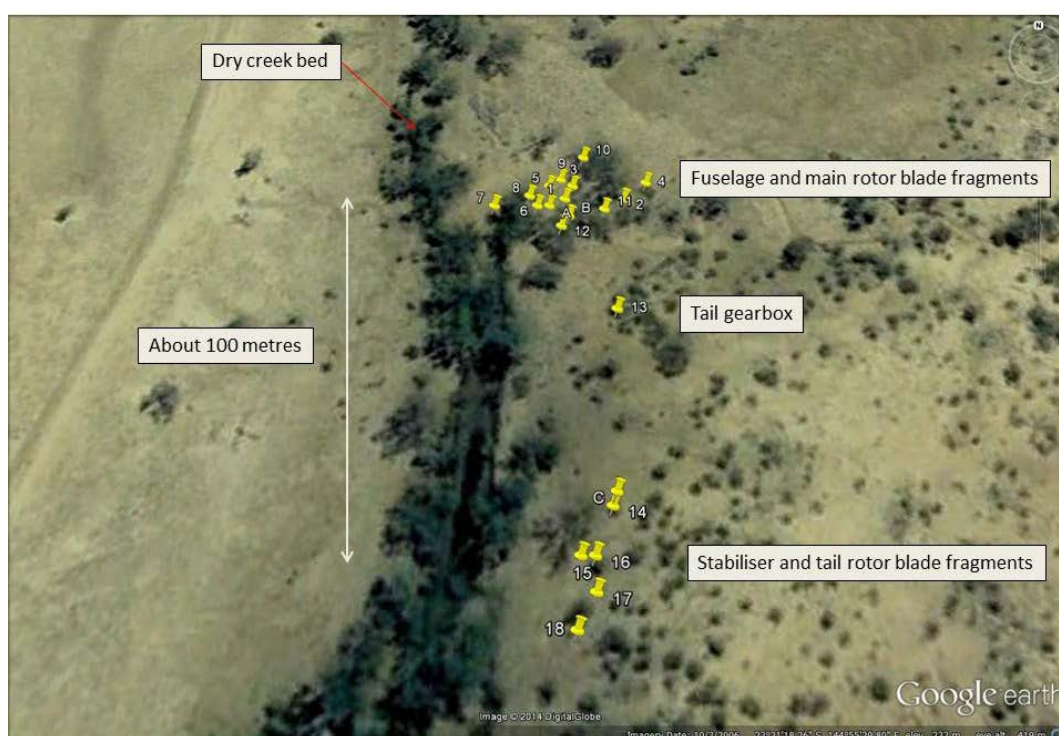
Figure 7: VH-SWQ accident site and wreckage distribution

The stabiliser assembly and several tail rotor blade fragments were the first items found in the accident trail, in an area about 25 m to the east of the dry creek bed (Figure 7). A tree located in this area had a mark on it about 5 m above the ground and there was a large branch located near the base. The ATSB determined that the contact mark and branch were not related to the event.

The accident trail and wreckage distribution was in a northerly direction over a distance of about 100 m and was consistent with an in-flight break-up.

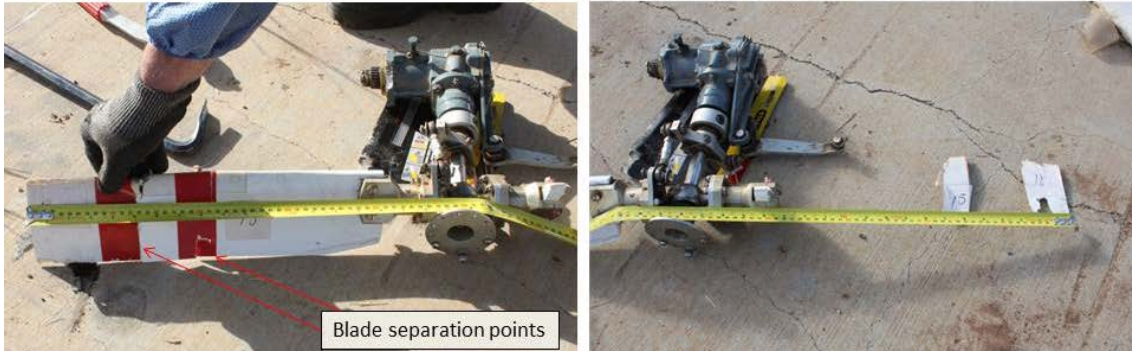
Figure 8: Tail rotor components retained for further examination

Several components from the helicopter were retained by the ATSB for further examination. This included the stabiliser assembly, tail rotor gearbox, tail rotor blade fragments and rear section of the tail boom (Figure 8 and Figure 9).

Detailed examination of the retained tail components was conducted at the ATSB’s technical facilities in Canberra. The examination found that the TGB had separated from the rear of the tail boom. The fracture surfaces of the TGB exhibited features associated with gross overstress.

The recovered sections of blade from the tail rotor presented damage signatures that were consistent with having struck the aerofoil sections of the stabiliser. Matching contact marks were identified on the lower vertical and horizontal fin surfaces.

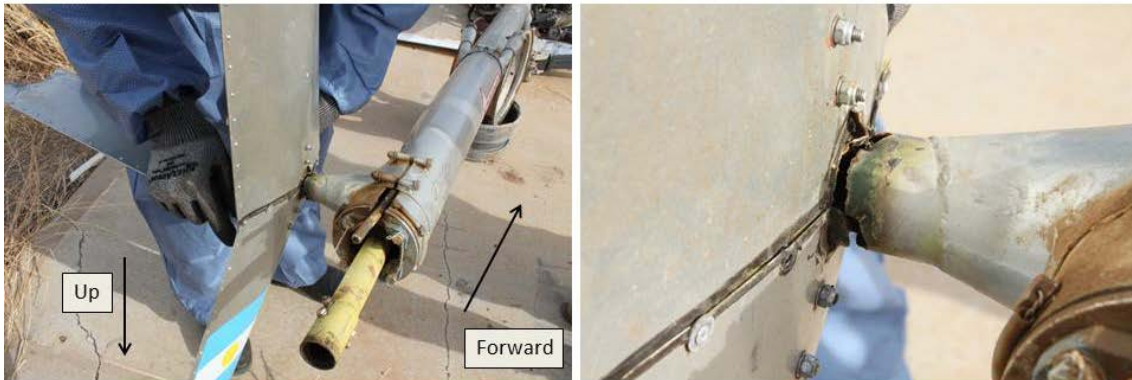
Figure 9: Stabiliser point of fracture

The ATSB's technical examination found that the stabiliser assembly failed due to cracking associated with metal fatigue.

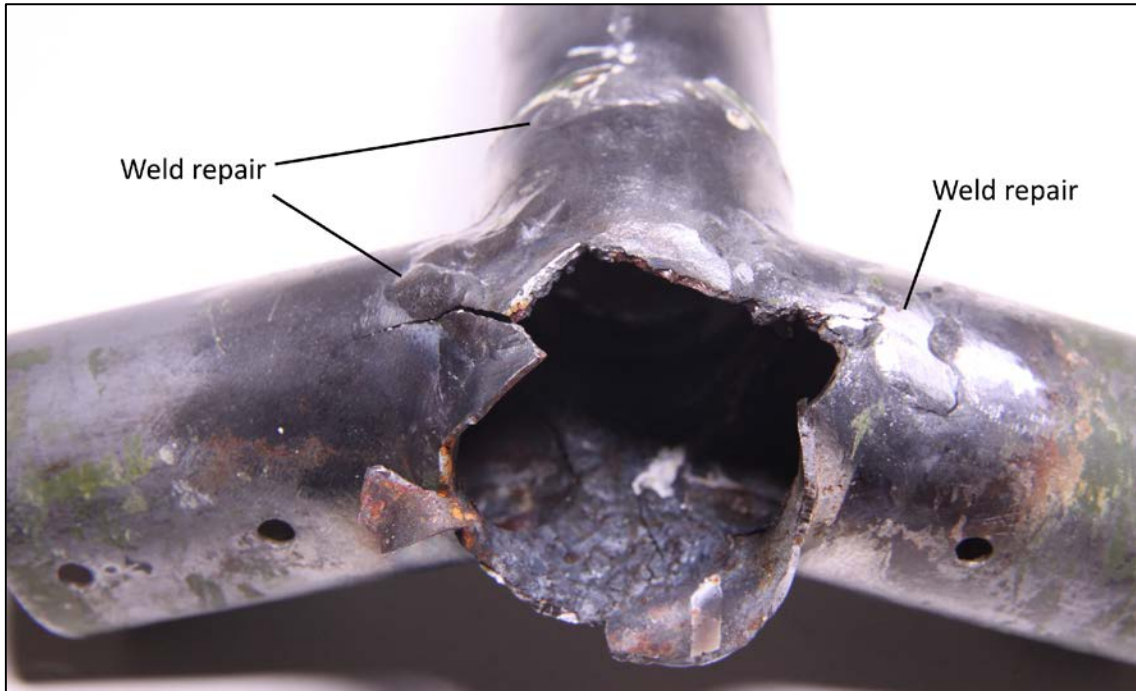
Figure 10: Fracture surface detail of the stabiliser mount (view looking outboard) with the locations of previous weld repairs identified

Examination of the fractured stabiliser mount showed evidence that it had been welded on at least two occasions post manufacture (Figure 10). Detailed microscopic examination of the stabiliser mount fracture revealed metal fatigue cracking that primarily followed the welded portions of the tube junction. The fatigue crack had progressed around 40 to 50 per cent of the tube circumference.

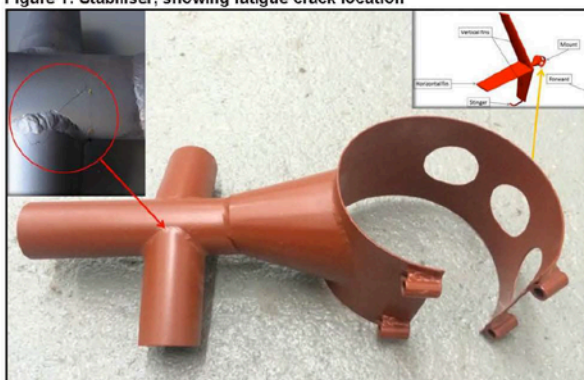
Figure 1: Stabiliser, showing fatigue crack location

Technical examination at the ATSB's facilities in Canberra, Australian Capital Territory indicates that the stabiliser failed due to cracking associated with metal fatigue (Figure 1). While the ATSB cannot determine the origin of the crack, its initiation and propagation may have been associated with on-going operation of the helicopter with vibration that was reported as being above defined limitations.

The initial crack occurred within the stabiliser and thus was unlikely to be visible during inspection. However, it was reported that the fatigued area was identified earlier by unanticipated movement of the stabiliser and evidence of loose or working fasteners. An example of evidence of working fasteners (rivets) is shown at Figure 2.

Owners are reminded of the importance to operate and maintain their helicopter in accordance with the Cicaré publications, including the flight and maintenance manuals. The maintenance manual provides the maintenance schedule, inspection criteria and vibration level limits for continued safe operation and includes the following:

During inspection, check the general condition of the components and observe if there is evidence of damage, colour change due to high temperatures, dents, scratches, notches, corrosion and specially cracks. Also check for any sign of friction in the parts that are near one another. Usually, friction on aluminium parts produces a fine black powder, whereas in the steel parts rust red or black residues are evident.

Check the whole surface of the stabilizers. Verify there are no scratches or cracks.

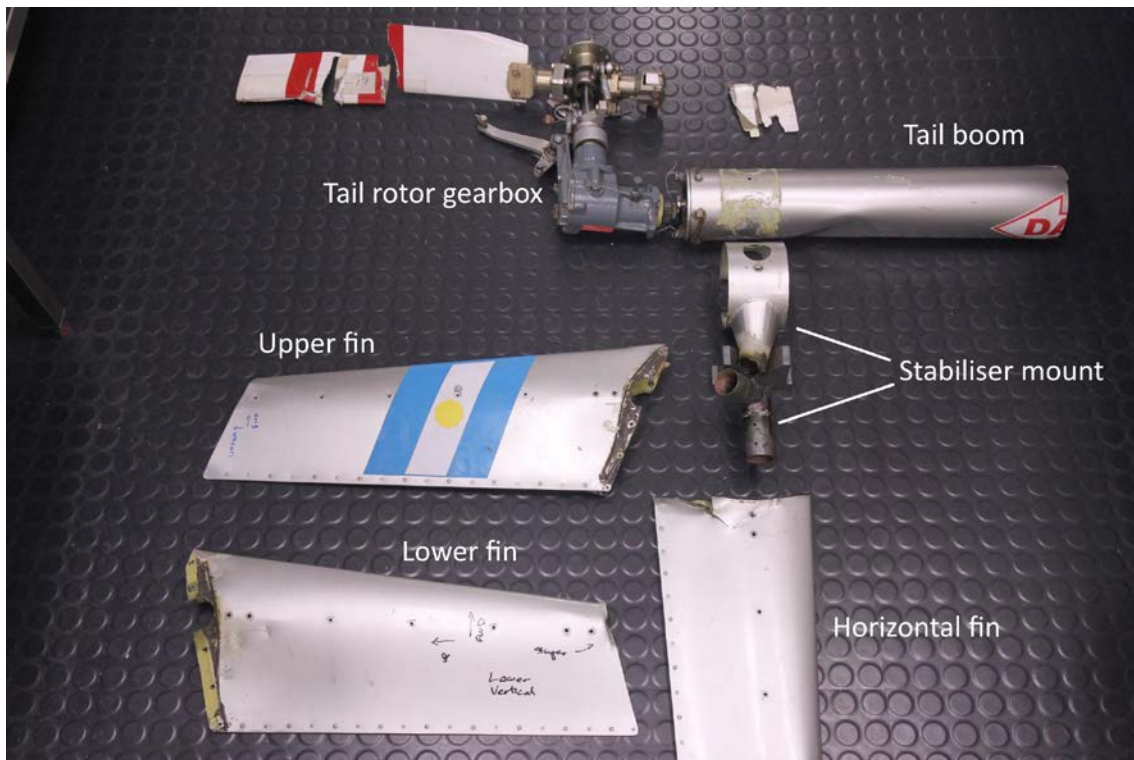
Figure A1: Dismantled tail rotor assembly components

A detailed examination of the fins, tail rotor, aft tail boom section, and tail rotor gearbox (TGB) was conducted at the ATSB’s technical facilities in Canberra (Figure A1). The examination indicated that the TGB had separated from its installed position at the rear of the tail boom. The fracture surfaces of the TGB only exhibited features associated with gross overstress. The recovered sections of blade from the tail rotor presented damage signatures that were consistent with having struck the aerofoil sections of the stabiliser. Matching contact marks were identified on the lower vertical and horizontal fin surfaces (Figure A2).

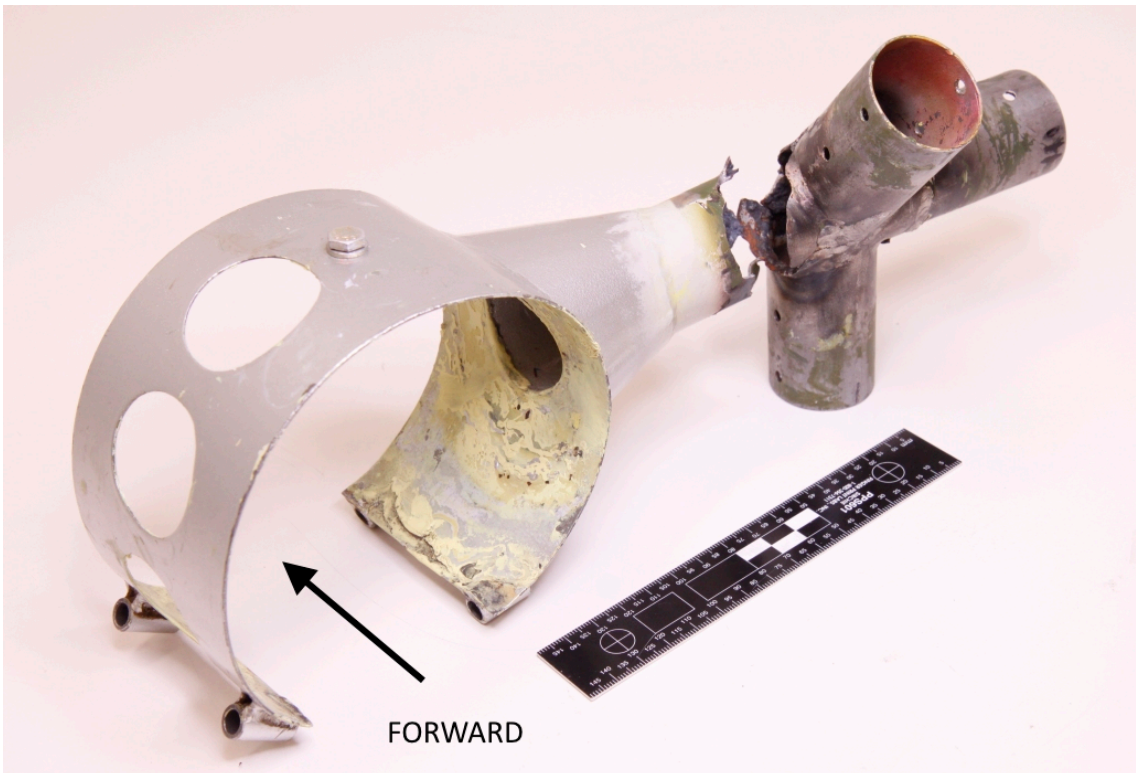
Figure A3: Fractured stabiliser mount with fins removed

The fins were removed from the stabiliser assembly in order to completely expose both portions of the fractured stabiliser mount (Figure A3).

The stabiliser mount was comprised of three main sections; a clamp for attaching to the tail boom, a conical support and three oval-shaped, thin-walled metal tubes that were used to locate and secure the fins into position. During manufacture at the factory the three tubes had been cut to fit and then welded together at the apex of the support cone. The appearance of the weld beads indicated that a tungsten inert gas welding method had been used to join the tubes during fabrication. Some surfaces surrounding the welded tube junction displayed evidence of having been bead blasted.

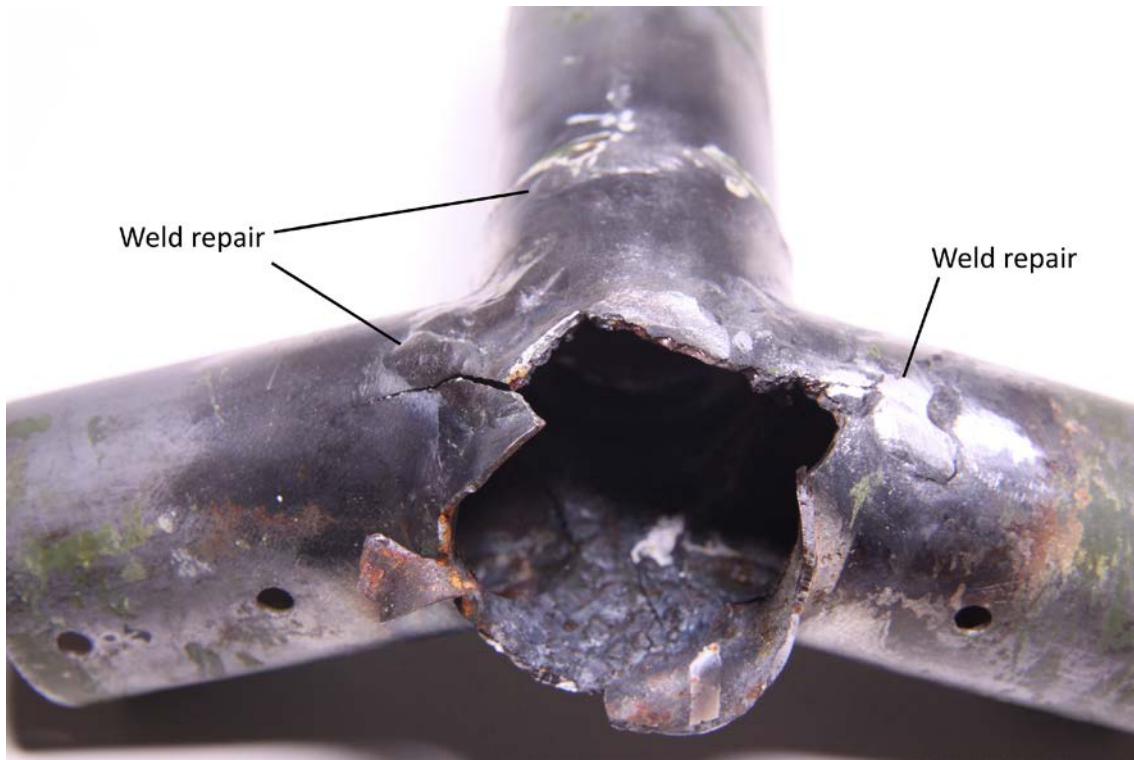
Figure A4: Fracture surface detail of the stabiliser mount (view looking outboard) with locations of previous weld repair identified

It was noted that the tube junction contained four areas that had been weld repaired. The surface of three of the weld repairs had been bead blasted, while one of the repairs had been ground flat. This was indicative that the welding was conducted subsequent to the other repair. The presence of the weld repairs was consistent with the reported service history of the helicopter, where the owner discovered that the stabiliser mount was cracked at a number of locations surrounding the tube junction. The owner had those cracks welded on two separate occasions (Figure A4).

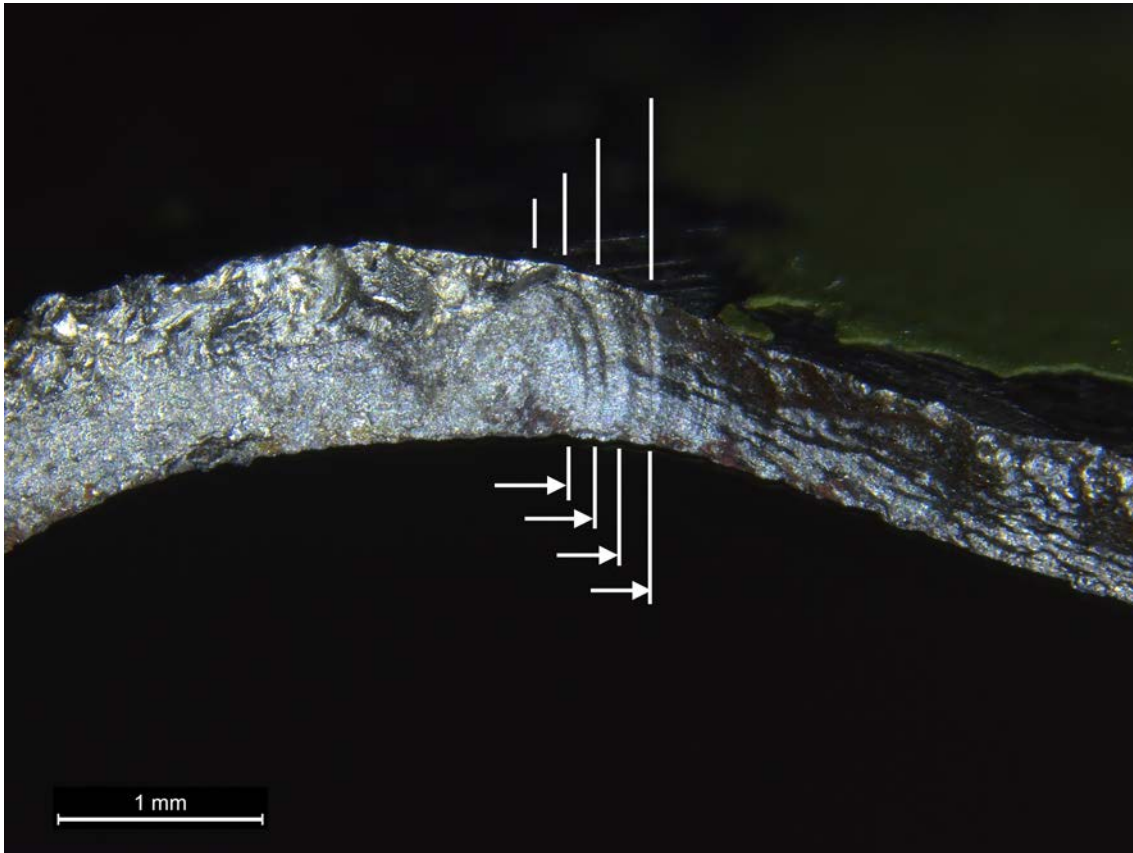
Figure A5: High magnification view of a portion of the stabiliser mount fracture surface with clearly defined fatigue progression bands (arrowed)

Detailed microscopic examination of the stabiliser mount fracture surfaces was accomplished using a binocular microscope. The examination revealed that the fracture path primarily followed the welded portions of the tube junction. One half of the fractured component revealed the presence of a finely spaced series of continuous progression marks (Figure A5). Such features are entirely consistent with a fatigue crack growth mechanism that was propagated due to cyclic loading of the tail rotor components. Fatigue cracking was identified to have progressed around 40 to 50 per cent of the tube circumference. The origin of the fatigue cracking could not be clearly identified due to post-accident damage from metal-to-metal contact that had smeared some of the finer fracture surface details. No obvious defects or anomalies were observed in the welded regions that might have otherwise contributed to the growth of the fatigue cracking.
