Aviation Short Investigations Bulletin

Issue 28

ATSB Transport Safety Report
Aviation Short Investigations
AB-2014-037
Final – 27 March 2014

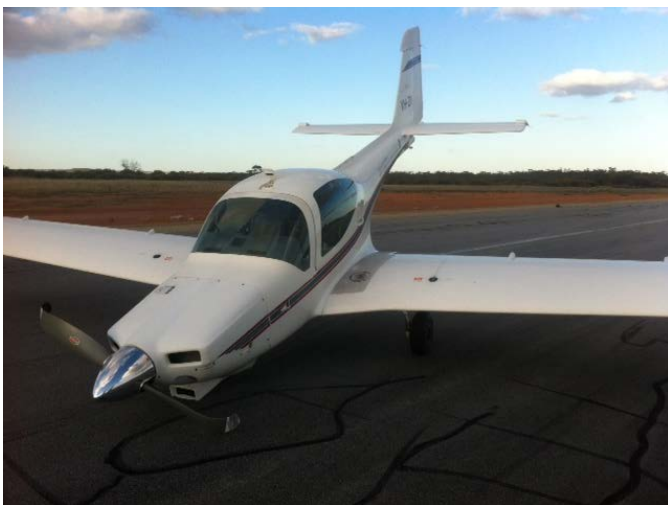
Figure 1: Accident site

The student located Merredin and joined the circuit for runway 28. When turning onto the base leg of the circuit, the student reported that the aircraft's airspeed was low so he adjusted the engine power and aircraft attitude. When on short final he determined that he was too high and initiated a go-around. The student commenced a second circuit to runway 28. When on short final, the student reported there was a crosswind with slight windshear, and the glare from the sun was making it increasingly difficult to see the runway. The student indicated that, at the height of the windsock, he reduced the engine power to idle and the aircraft sank quickly. At about 1700 Western Standard Time (WST),² the aircraft touched down heavily and bounced. The student reported that the sun glare made it very difficult to judge the height of the aircraft and he believed that the aircraft had not bounced very high. The aircraft touched down again on the nose landing gear, which subsequently collapsed. The aircraft slid along the runway and came to a stop. The student pilot was uninjured and the aircraft sustained substantial damage (Figure 1).

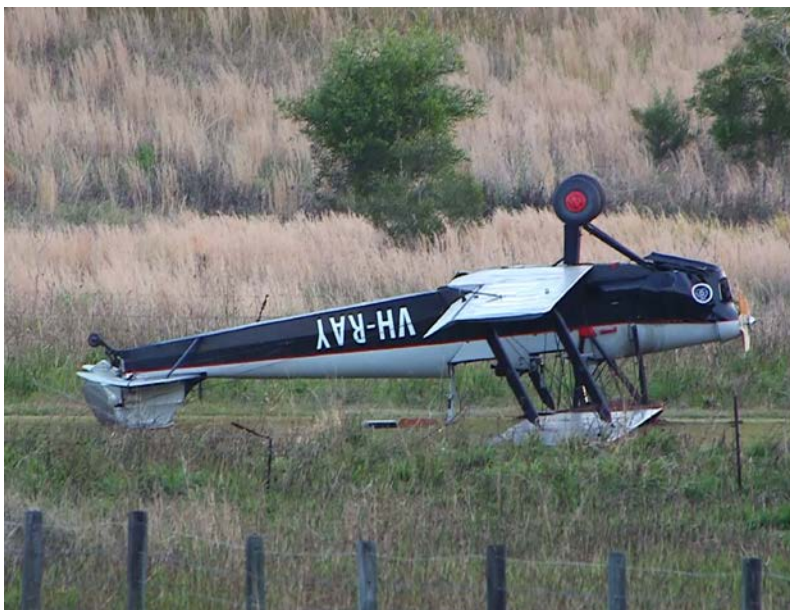
Figure 1: VH-RAY

The aircraft was modified in 1997, installing main wheel brakes in accordance with an engineering order. Following the accident, the aircraft was inspected by the maintenance organisation and it was determined that the left main landing gear brake drum had evidence of corrosion and the brake operating rod was found stiff to operate. When the brakes were applied and released the left brake did not release fully. After the brake was cleaned and lubricated the brake operated normally. The maintenance organisation suspects that the left brake was partially engaged on take-off. They also determined that the aircraft was last flown on 12 February 2013 and the aircraft was normally stored in a high corrosion environment.

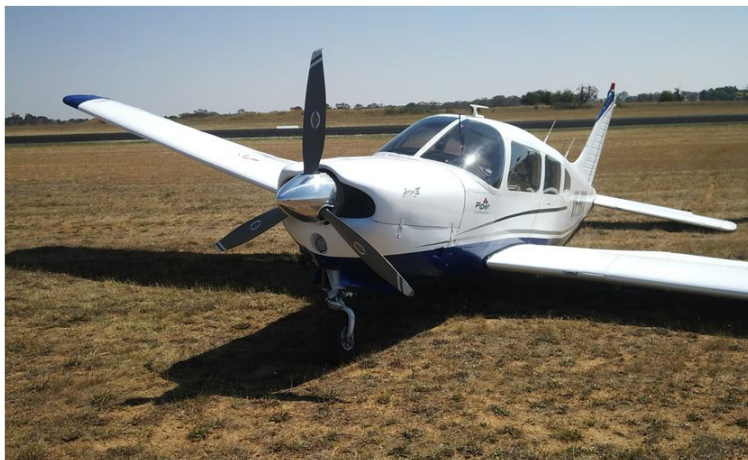
Figure 1: Damage to VH-HVX

When at about 50 ft above ground level (AGL) and about 65-70 kt IAS, the testing officer reduced the engine power to idle and stated “simulated engine failure”. The pilot immediately lowered the nose of the aircraft in an attempt to increase the airspeed and selected the third stage of flaps. At about 10 ft AGL, the pilot reported the aircraft was sinking and flared³ the aircraft for landing. However, the aircraft continued to sink and landed heavily. The left main undercarriage collapsed and the aircraft slid along the runway and then veered off to the left, coming to rest outside the airstrip gable markers. The aircraft was substantially damaged and both pilots were uninjured.

The pilots reported that the stall warning did not sound during the descent and that a shift in the wind direction was the most likely cause of the accident.

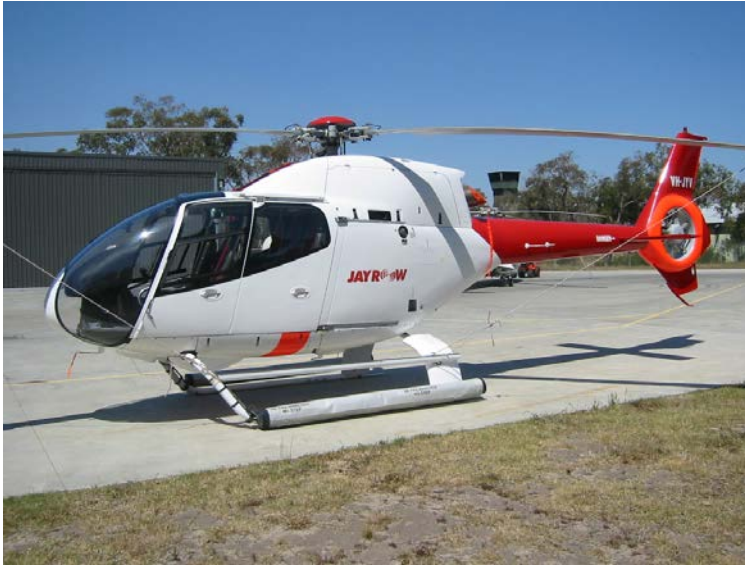
Figure 1: VH-JYV

No defects were found in the chip monitor, fuel control unit or fuel injector and no fuel contamination was found. No faults were recorded on the VEMD.

A boroscopic inspection of the engine revealed burnt dilution tubes however these were deemed to be within normal limits by the engine manufacturer.

The engine manufacturer subsequently tested the engine and found no discrepancies that would explain the flameout.

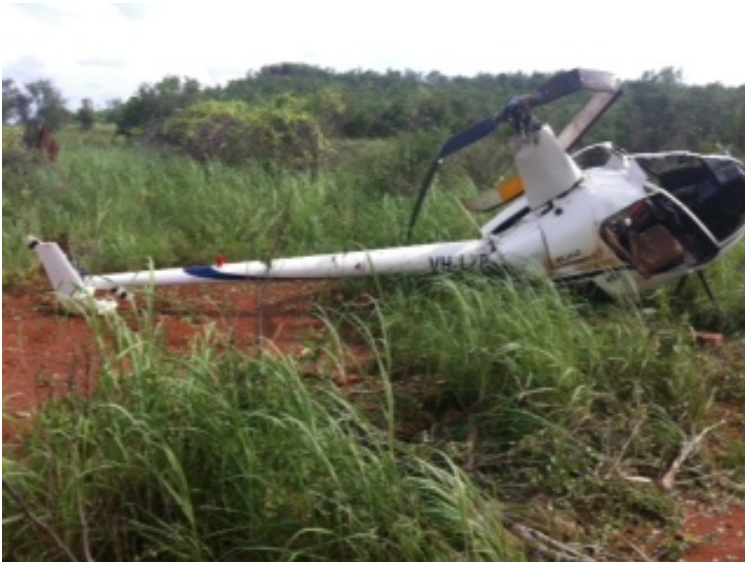
Figure 1: Damage to VH-LZR

As the helicopter became airborne heading to the south-east, the pilot sighted an object moving to his right. At about 10 ft above ground level, the pilot was distracted looking outside the door at the object and the helicopter collided with a tree. The object was not identified. The helicopter sustained substantial damage and the pilot was uninjured (Figure 1).
