Derailment of Sydney Trains Passenger Train 602M

near Edgecliff station, Sydney, NSW | 15 January 2014

ATSB Transport Safety Report
Rail Occurrence Investigation
RO-2014-001
Final – 3 December 2015

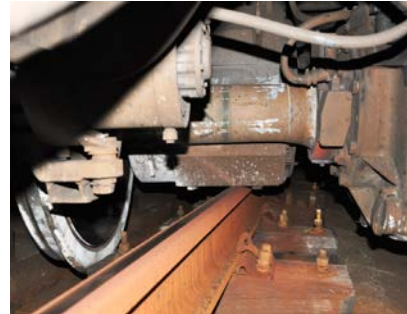
Motor resting on rail head

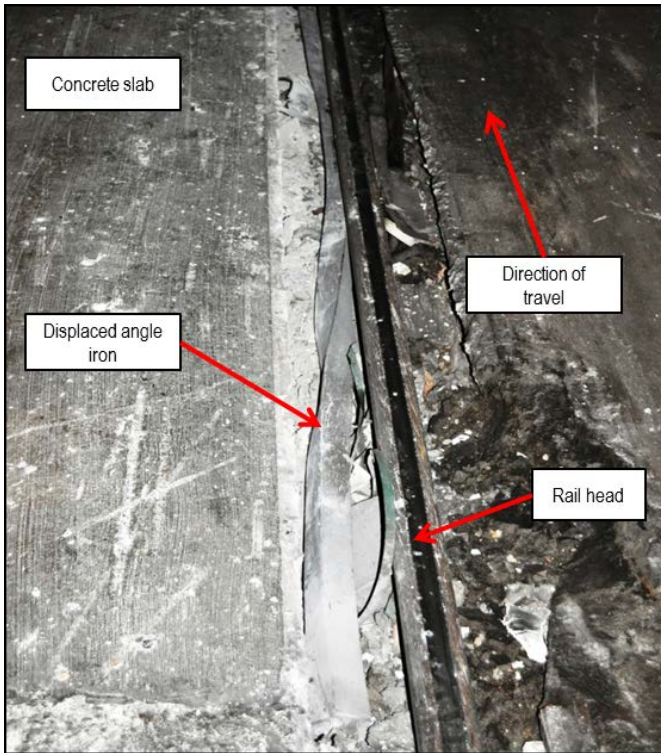
Figure 2: Concrete Slab with displaced angle iron

As Run 602M departed from platform 1 of Edgecliff Station one wheel of the leading axle of the third carriage, N5222, derailed just beyond the end of the platform. The right hand wheel (in the direction of travel) of the leading axle of the first bogie had slipped into the space between the two rails at 4.668 km. The wheel continued in a derailed state for 17 m where it collided with a concrete slab used to allow road / rail maintenance vehicles to be put on or taken off track. This is evidenced by the damage apparent to the concrete. Lengths of 'angle iron', pieces of steel formed into a right angle section, were fitted to protect the edge of the slab. The first one began a short distance after the start of the slab. This piece was dislodged by the wheel and remained in the flange way between the slab and the rail (Figure 2).

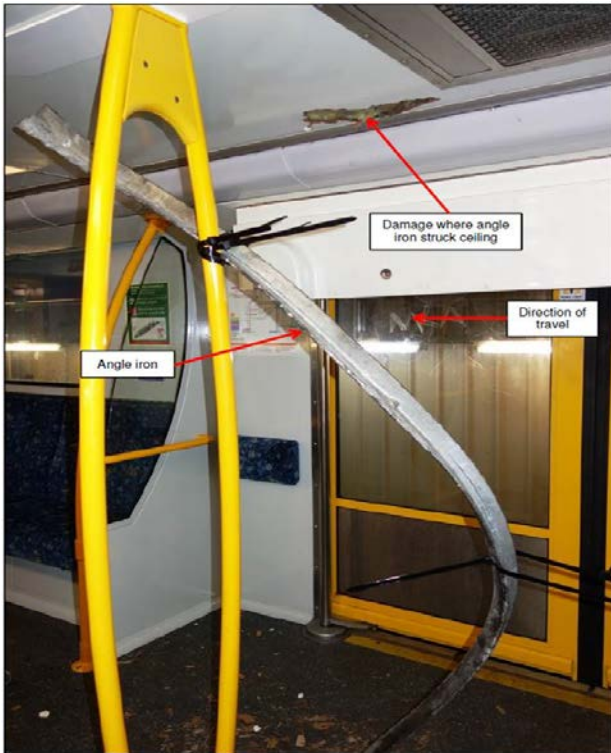
Figure 3: Angle Iron secured inside carriage N5222

The second piece of angle iron was also dislodged and was picked up by the derailed train. Approximately 25 m beyond the slab there was a set of points which allowed trains that had terminated on the other platform to return towards Central and join the track that 602M was travelling on. The derailed wheel interacted with this set of points such that the other wheel on the axle and both wheels on the bogie's other axle also derailed towards the outside of the rail corridor (that is, towards the left in direction of travel).

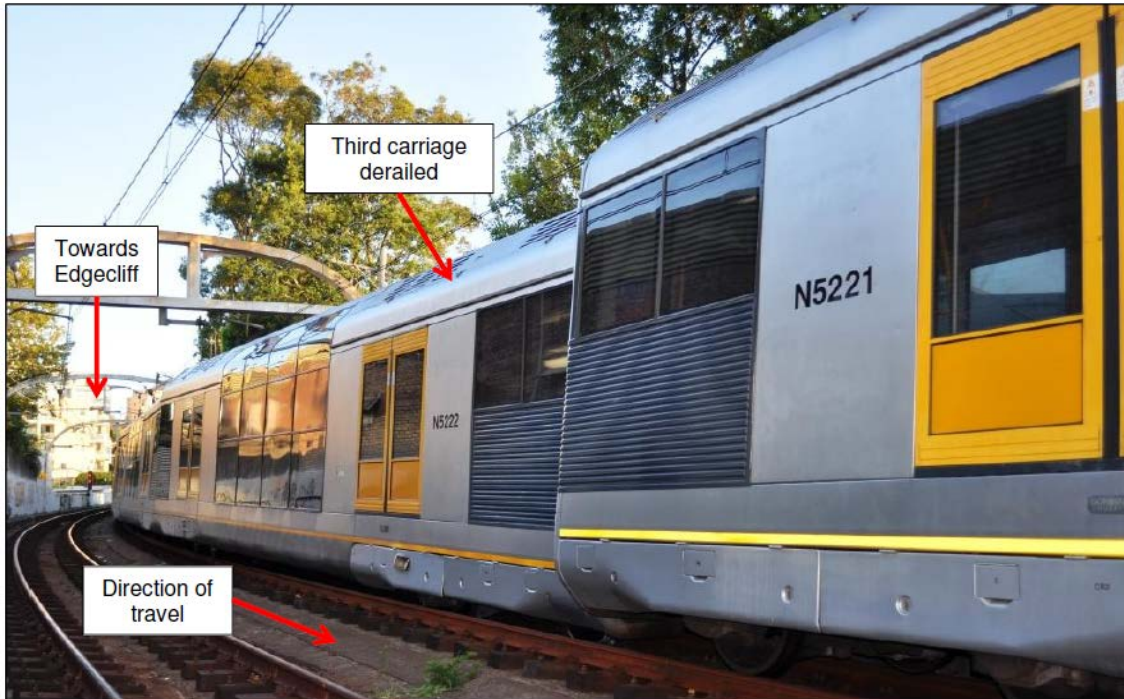
Figure 4: Run 602M after derailing

The driver of the other train, stationary on the down track, noticed that 602M was derailed as the derailed carriage moved towards and past his location.

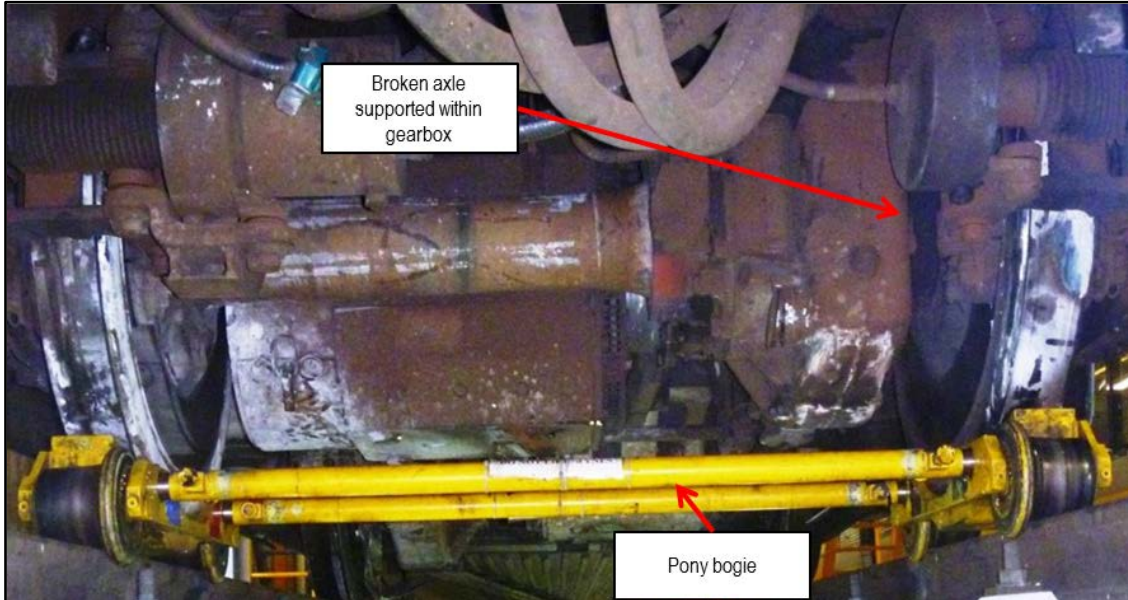
Figure 5: Axle supported by pony bogie after recovery

The pantographs on 602M were lowered to allow the derailed bogie to be railed by Sydney Trains' Emergency Train Rescue Unit and the broken axle was placed on a pony bogie (Figure 5) to support it on the journey to Mortdale Maintenance Centre (MMC). Once railing was complete, the pantographs were raised again to allow the train to move under its own power to MMC. The transfer was at a reduced speed, as dictated by the use of a pony bogie.

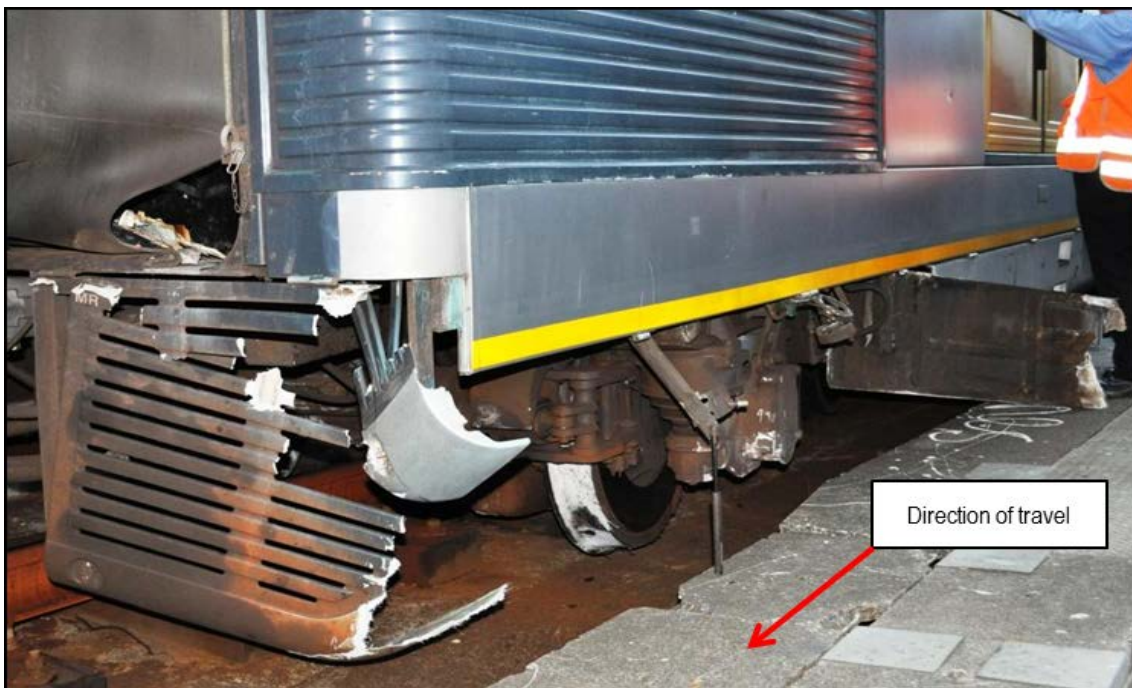
Figure 10: Coachwork damage

There was some damage to the bodywork of the third carriage (Figure 10) and line-side infrastructure consistent with the leading end of the third carriage travelling in a derailed state. The wheels of the derailed bogie were suspended above the rail infrastructure with the weight of the carriage being borne by the traction motor resting on the Up rail.

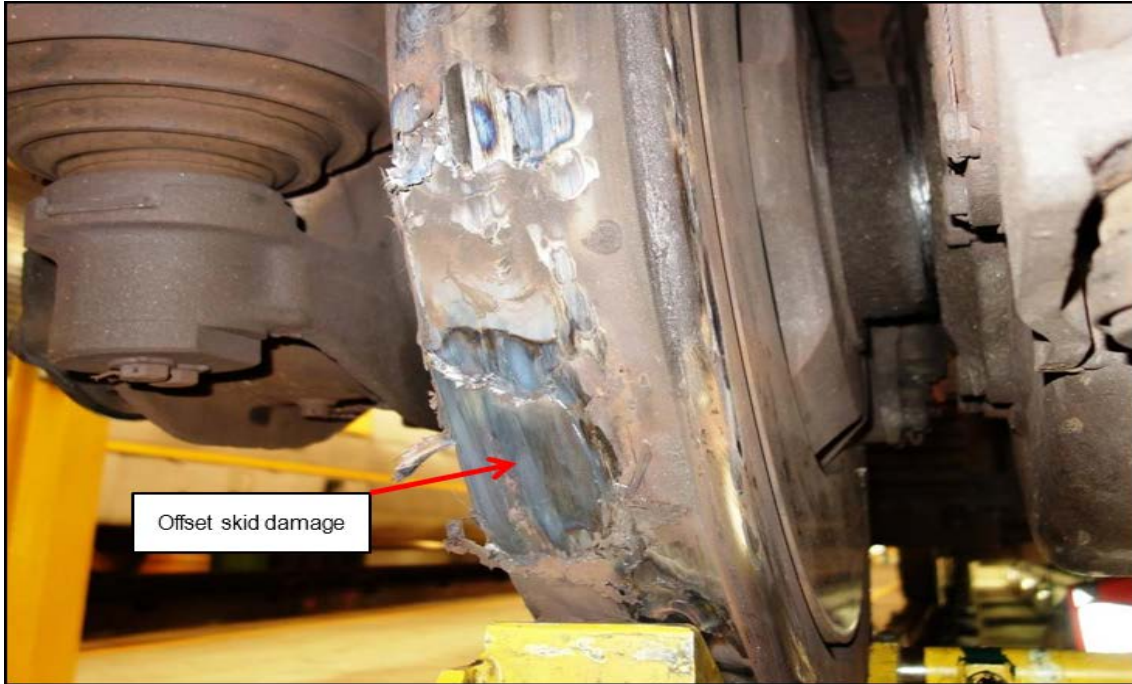
Figure 11: Damage to No. 8 wheel

There were numerous and extensive areas of damage on No. 8 wheel consistent with skidding of the wheel (Figure 11). Also, some skidding on No. 8 wheel was offset, indicating that it had not been tracking normally on the rail head when the damage occurred. While the No. 7 wheel displayed some damage, including damage consistent with a derailment, the damage did not correspond in location or severity with damage evident on the other wheel.

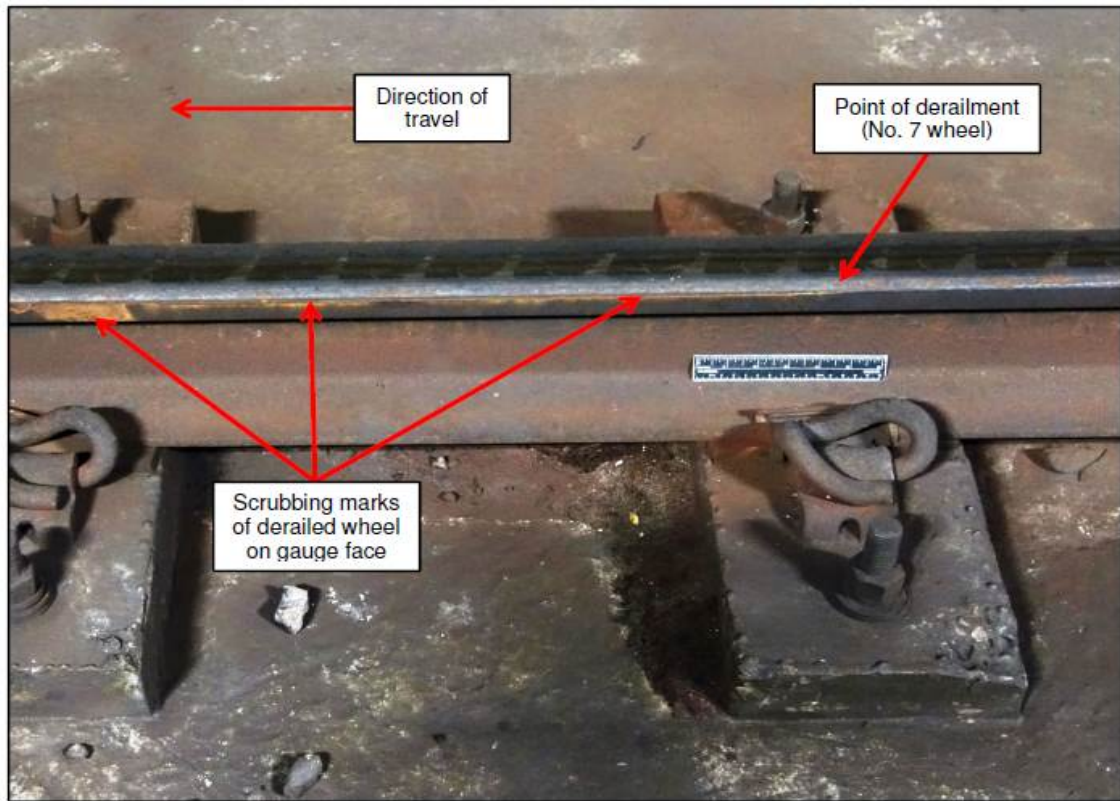
Figure 12: Point of derailment

The first evidence of derailment was found at 4.668 km, 17 m after the end of the platform corresponding with a 27.5 mm wide track gauge. Marking on the gauge face of the rail indicated that No. 7 wheel had slipped off the Down (right hand) rail and into the four foot between the rails (Figure 12).

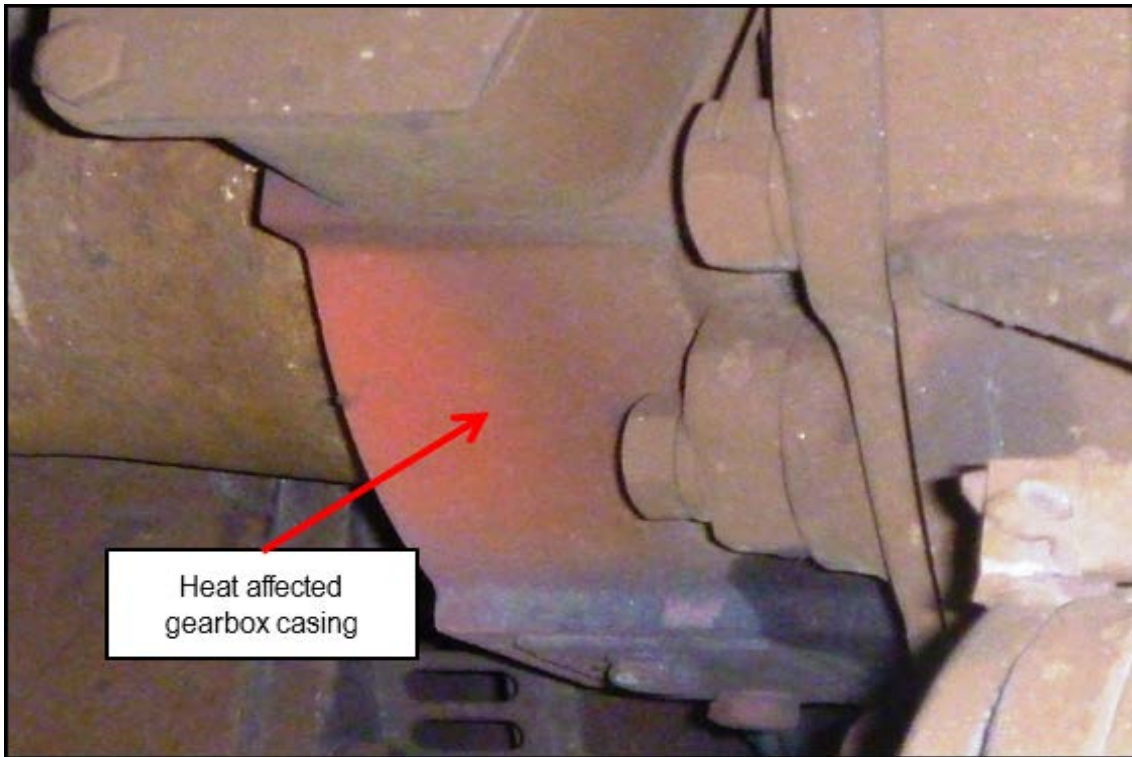
Figure 15: Gearbox casing showing evidence of overheating

Following the accident, bogie MKA0379 was removed from N5222 and was transported to UGL Unipart’s maintenance facility at Maintrain, Auburn. There the bogie was examined and it was noted that the gearbox casing attached to axle 881228 exhibited evidence of overheating (Figure 15).

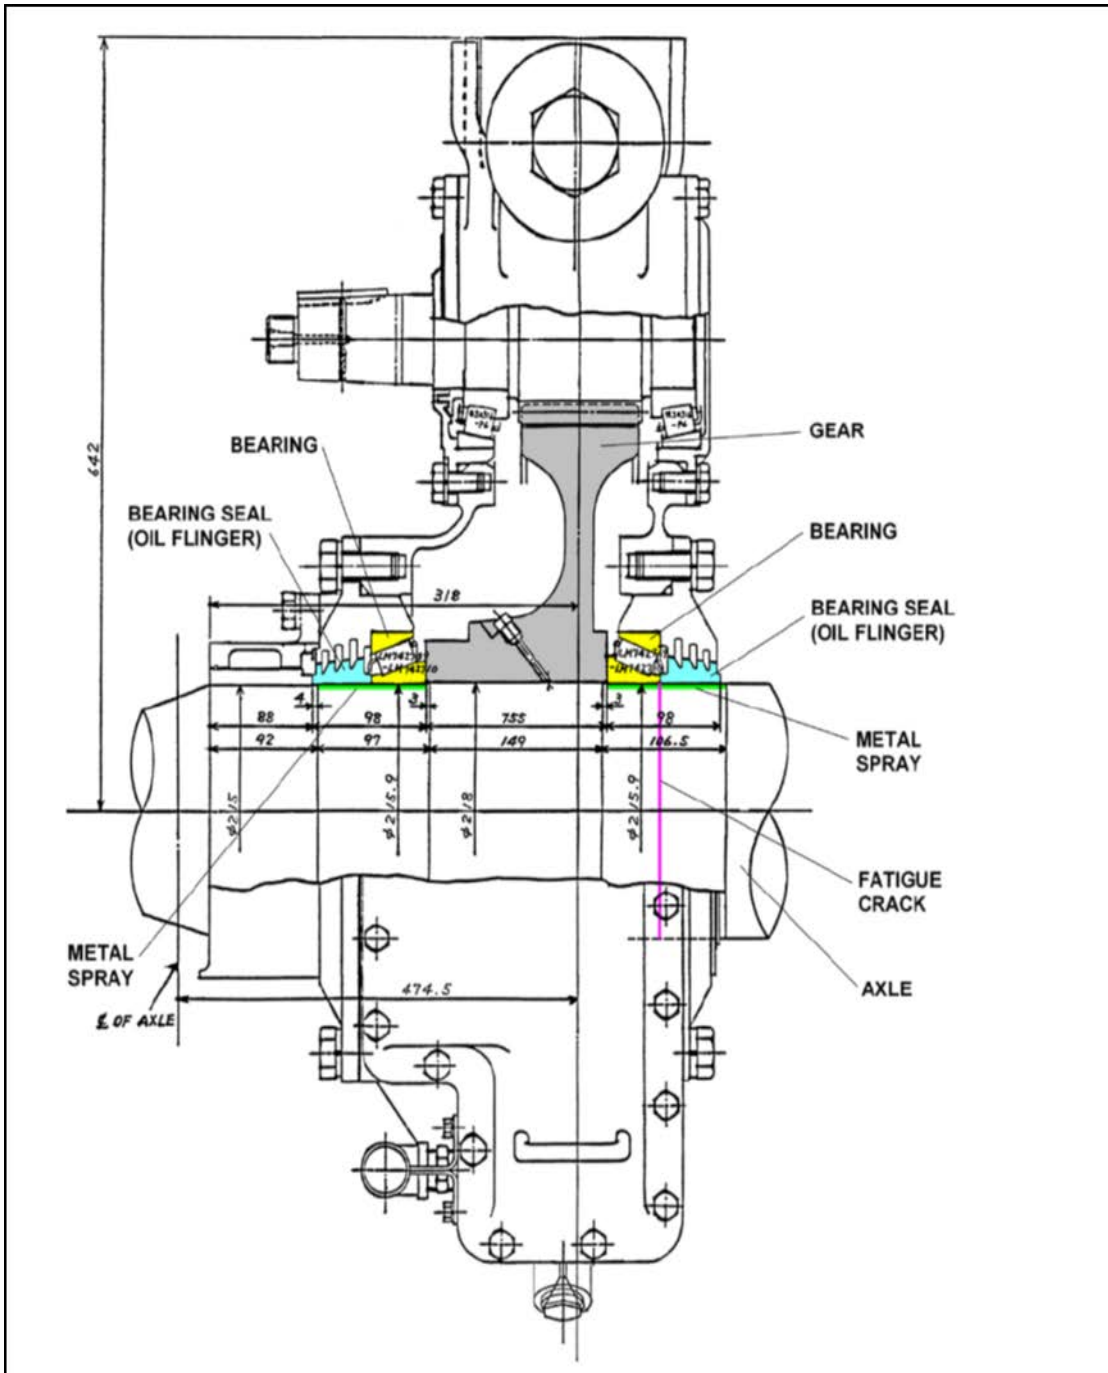
Figure 16 Section of gearbox area on axle 881228

The axle, with gearbox, was removed and stripped down under the supervision of OTSI investigators. The axle was found to have broken within the gearbox between an oil flinger and a bearing (Figure 16).

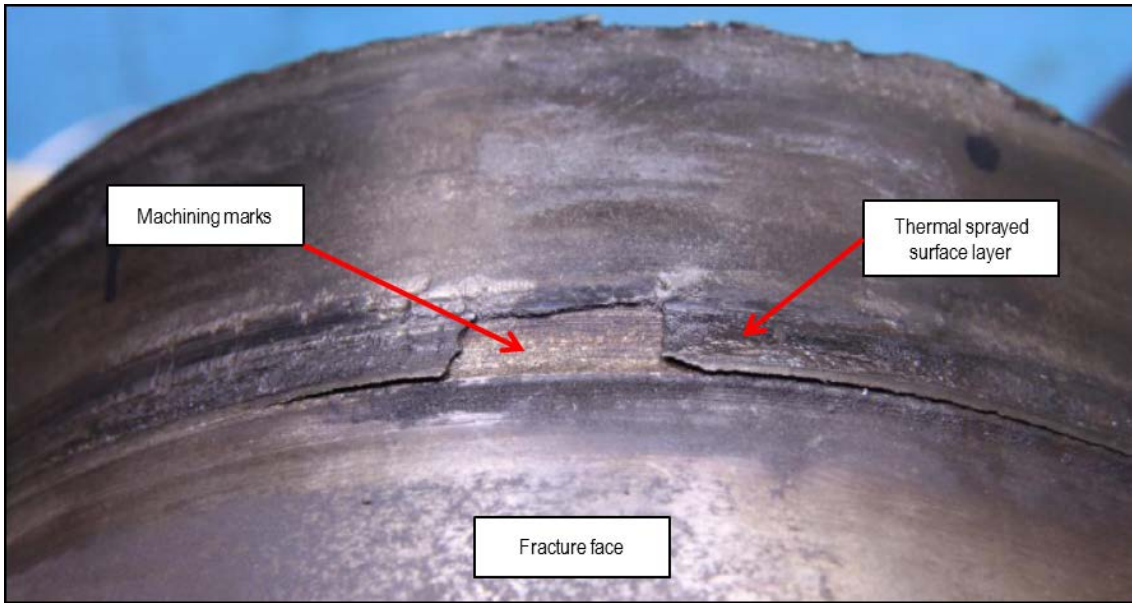
Figure 17: View of axle segment showing metallic surface deposit

Sections from either side of the defect were cut out of the axle and transported to the ATSB's laboratories in Canberra for detailed analysis. Due to their relative differential rotational speeds as they rotated against each other after the axle broke, much of the evidence of the defect initiation on the axle fracture surfaces had been destroyed. However, it was determined that a stress fracture had developed over time (see Appendix A: Technical examination of a fractured rail axle from passenger train 602M). Of particular note was the discovery of a laminated layer on the axle's surface with machining marks visible beneath (Figure 17).

It was determined that a metal spraying process had been used to repair the axle and that this rendered the axle susceptible to the initiation of fatigue cracking.

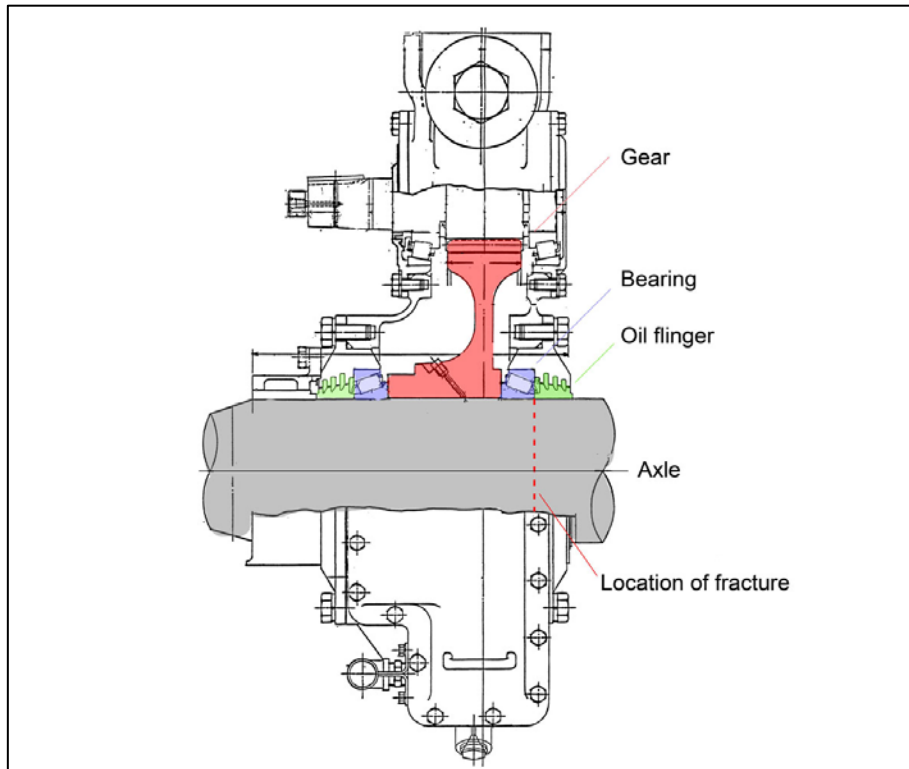
Figure 1: General arrangement of the axle and gearbox, showing the location of fracture relative to the assembly

Disassembly of the bogie from the carriage at the operator’s maintenance provider’s depot revealed that the drive axle had fractured through its cross-section within the axle-mounted gearbox. The location of fracture was between the oil flinger and low speed bearing (**Figure 1**). Sections of the fractured axle were transported to the Australian Transport Safety Bureau for metallurgical examination and further analysis.

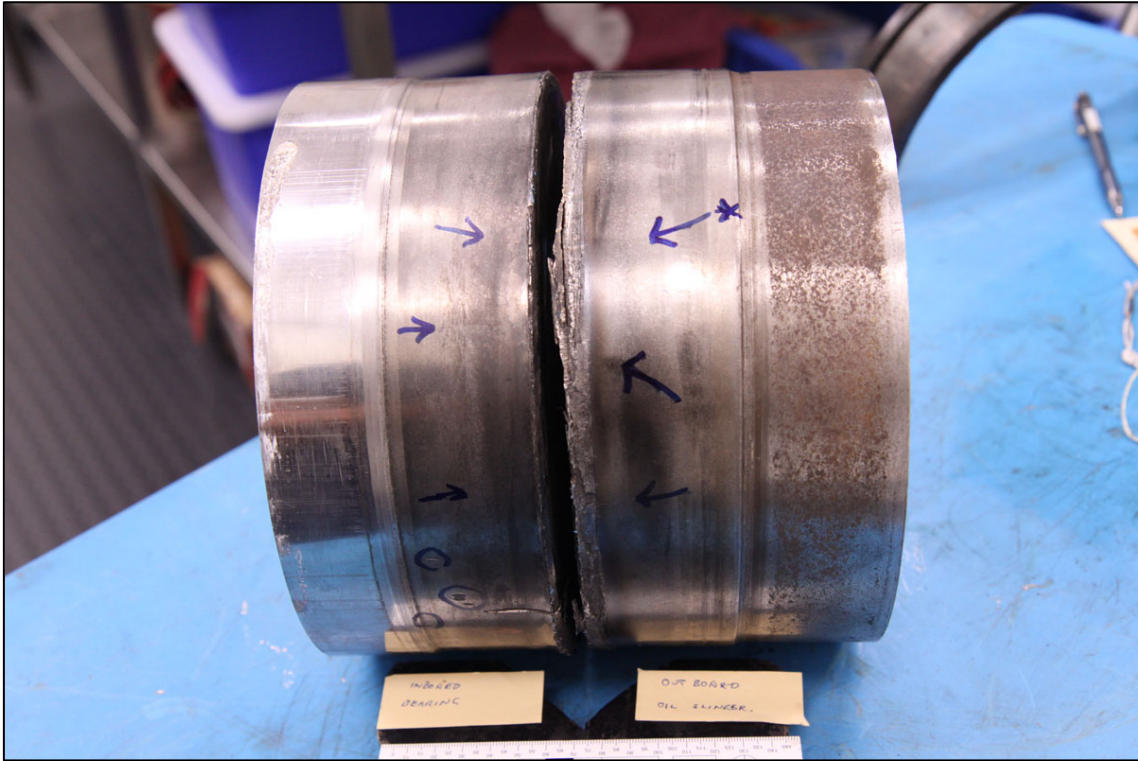
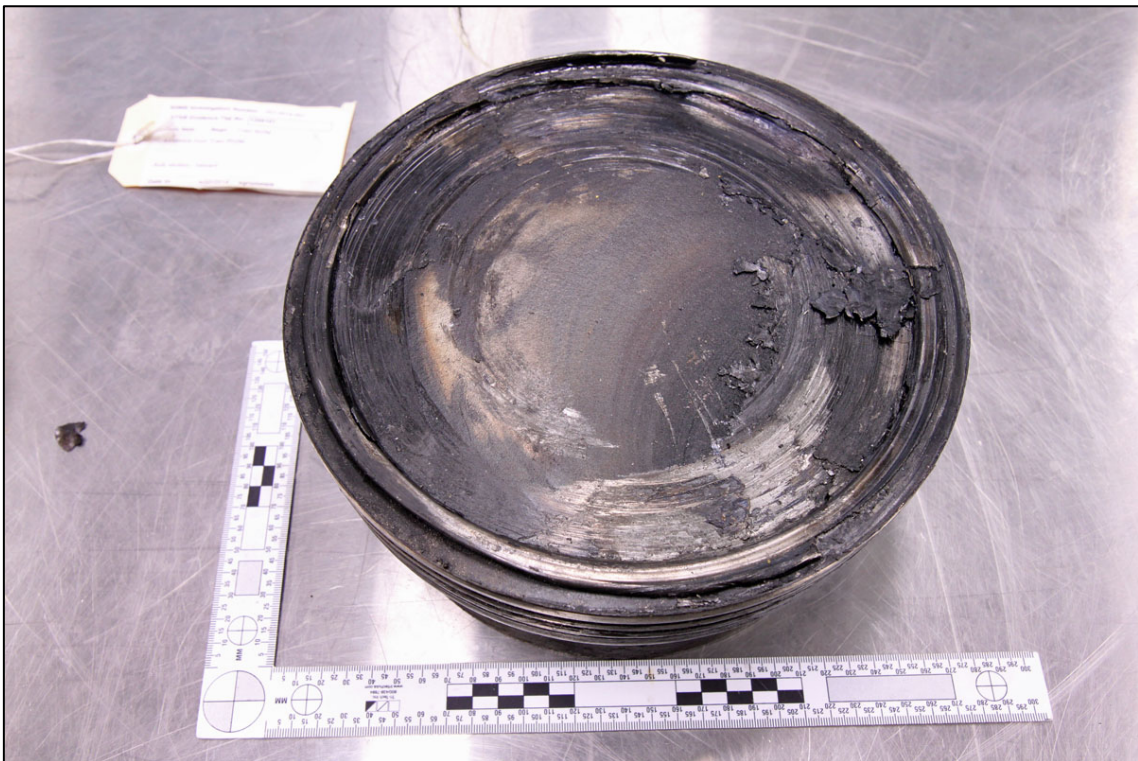
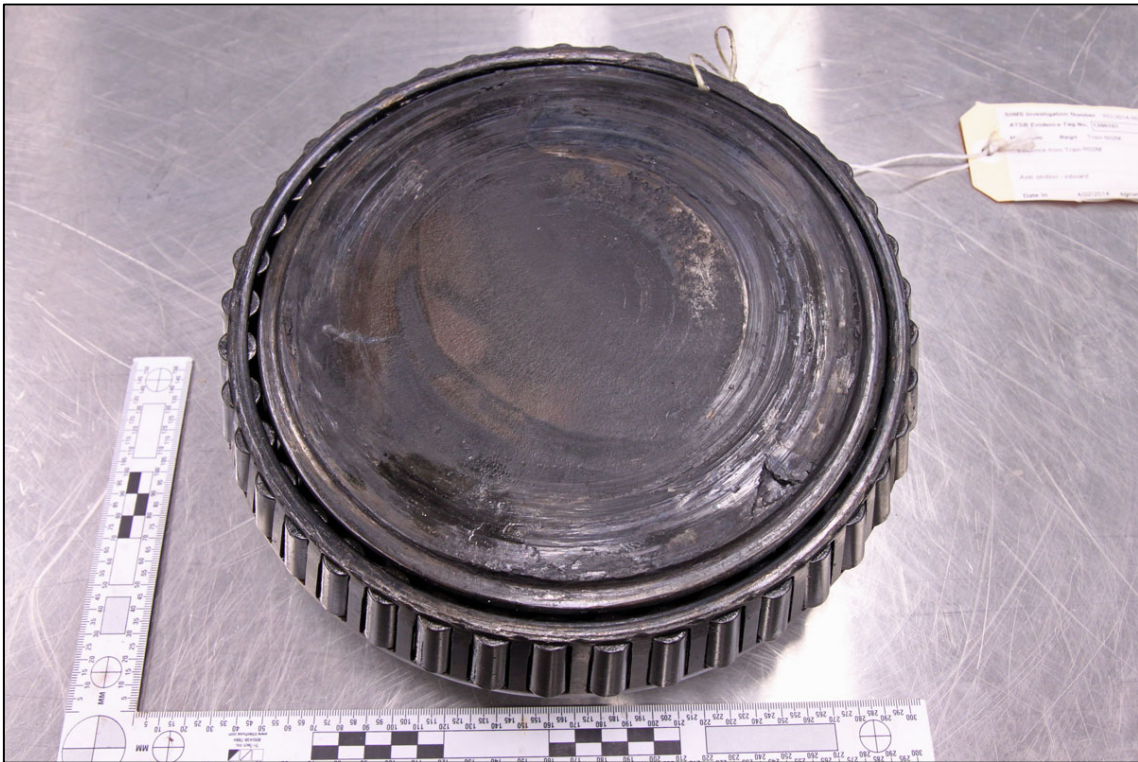
The fatigue crack had propagated almost entirely through the axle cross-section, indicating that both the crack growth rate and stresses that were driving the cracking were relatively low. See **Figure 4** to **Figure 6** for photographic detail of the axle failure.

Figure 4: The fractured axle S/N 881228: low speed bearing (left axle segment) and oil flinger (right axle segment)

Figure 5: View of the fractured axle adjacent the oil flinger

Figure 6: View of the fractured axle adjacent the low speed bearing

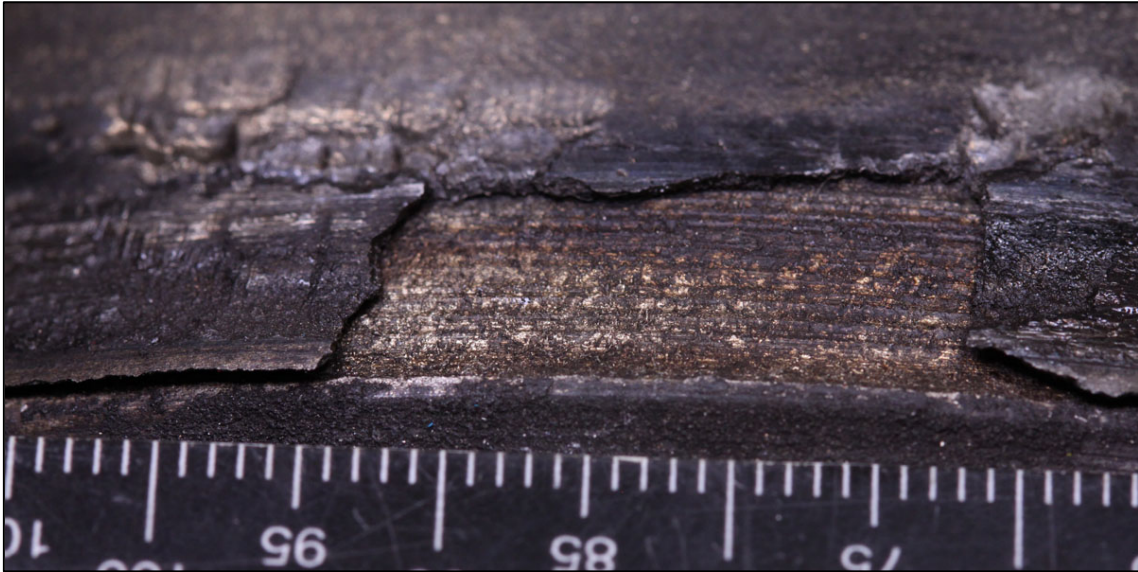
It was noted during the examination that a metallic layer had been deposited onto the external axle surface which extended across the location of the fatigue fracture (**Figure 7**). The layer extended around the full circumference of the axle for a length of 100 mm and had been applied over the seating area for the bearing and oil flinger. It was also observed that small sections of the metallic layer had separated from the axle which showed underlying machining marks. Such machining is typically applied during metal spray repair processes for enhancing the mechanical bond strength of the applied alloy.

Figure 7: Close view of a metallic surface deposit that has flaked from the underlying steel axle

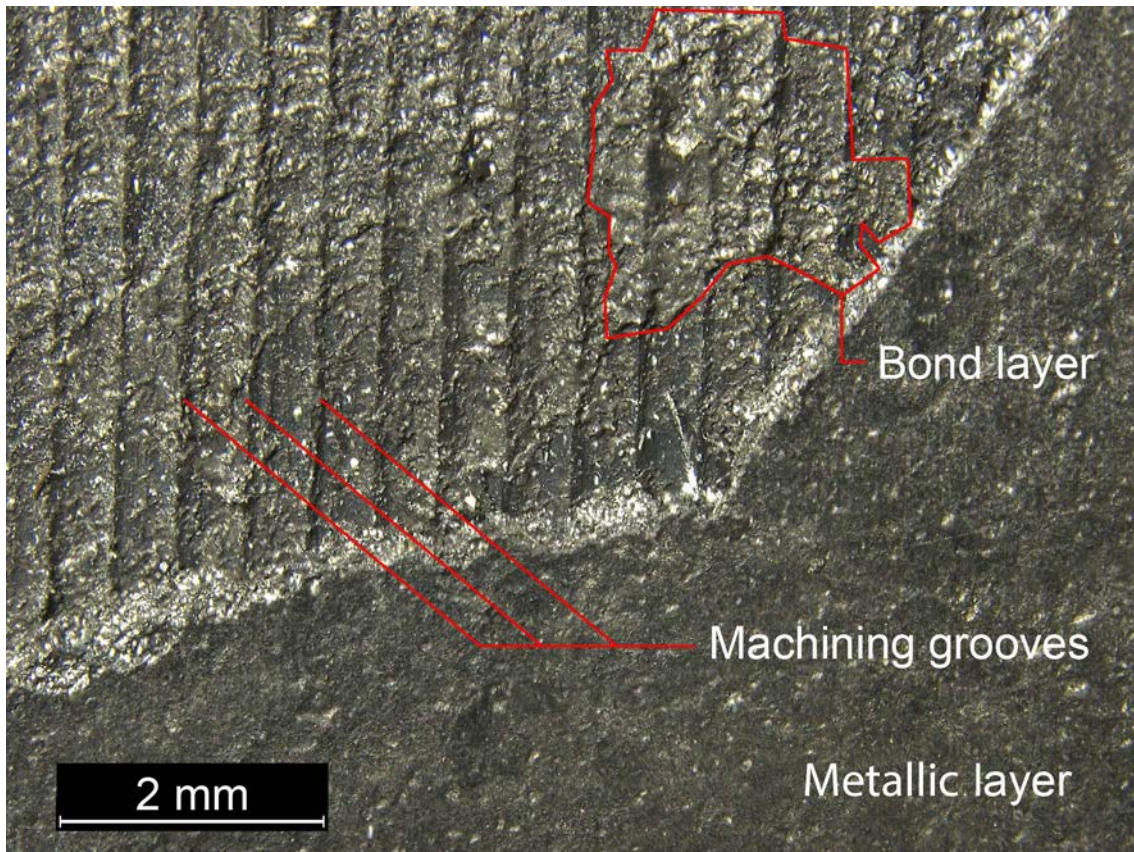
A very thin bonding layer of a secondary alloy had been applied between the steel substrate of the axle and the thick metallic outer layer (**Figure 8**). Such intermediate bond layers are typically applied during thermal spray processes to enhance the adherence of the applied alloy to the substrate. The presence of the interlayer was further confirmed by a metallurgical cross-section of a segment of the axle (**Figure 9**). Measurements indicated that the metal sprayed region was around 0.70 mm to 0.80 mm in thickness. The machining marks were approximately 0.10 mm in total depth, measured peak-to-trough.

Figure 8: Close up of the metallic surface layer with key elements highlighted
