Tail rotor strike of slung load involving a Eurocopter AS 350, VH-NPS

Glenbrook, New South Wales, on 19 December 2015

ATSB Transport Safety Report
Aviation Occurrence Investigation
AO-2015-147
Final – 13 April 2016

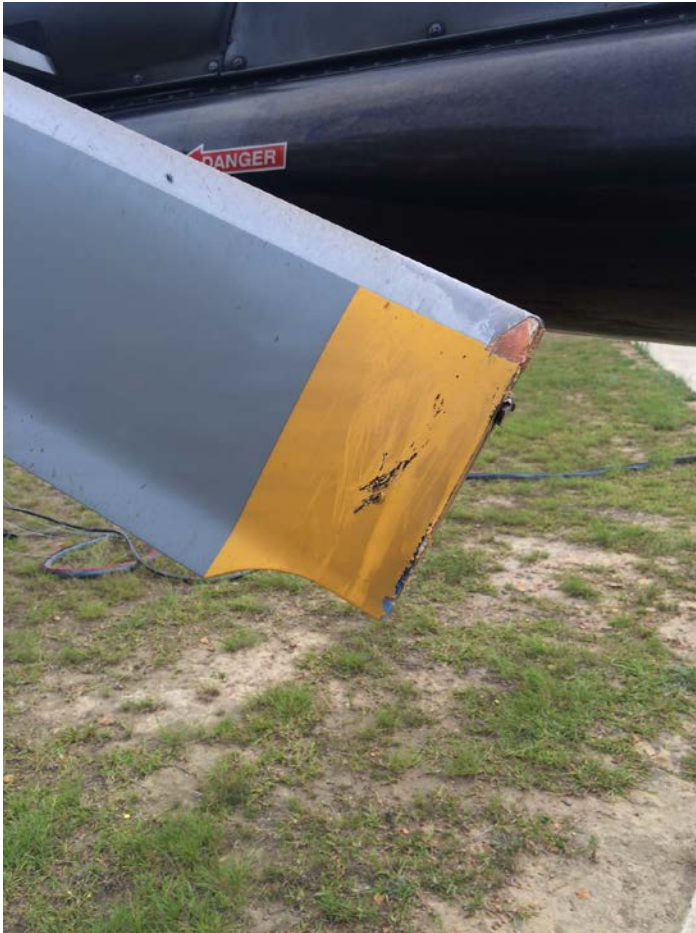
Figure 2: Damage to VH-NPS tail rotor

The tail rotor was damaged (Figure 2); the pilot and crewperson were uninjured.

- The pilot lost situational awareness of the bucket.
- Fatigue may have played a small role in reducing the pilot's situational awareness of the bucket, and the pilot may not have been aware of this fatigue level.

Where possible, pilots who are more experienced with a particular type of operation, such as fire control work, will be rostered with less experienced crewpersons and vice versa.

The operator will monitor fatigue levels in a more robust manner, including crew self-reporting and managers monitoring their staff.

The operator's training strategy and practices will be overhauled, with a training package released by 30 March 2016. Pilots and crewpersons will be assessed on their understanding of the operations manual.
