Derailment of freight train 9T92

Near Julia Creek, Queensland, 27 December 2015

ATSB Transport Safety Report
Rail Occurrence Investigation
RO-2015-028
Preliminary –21 April 2016

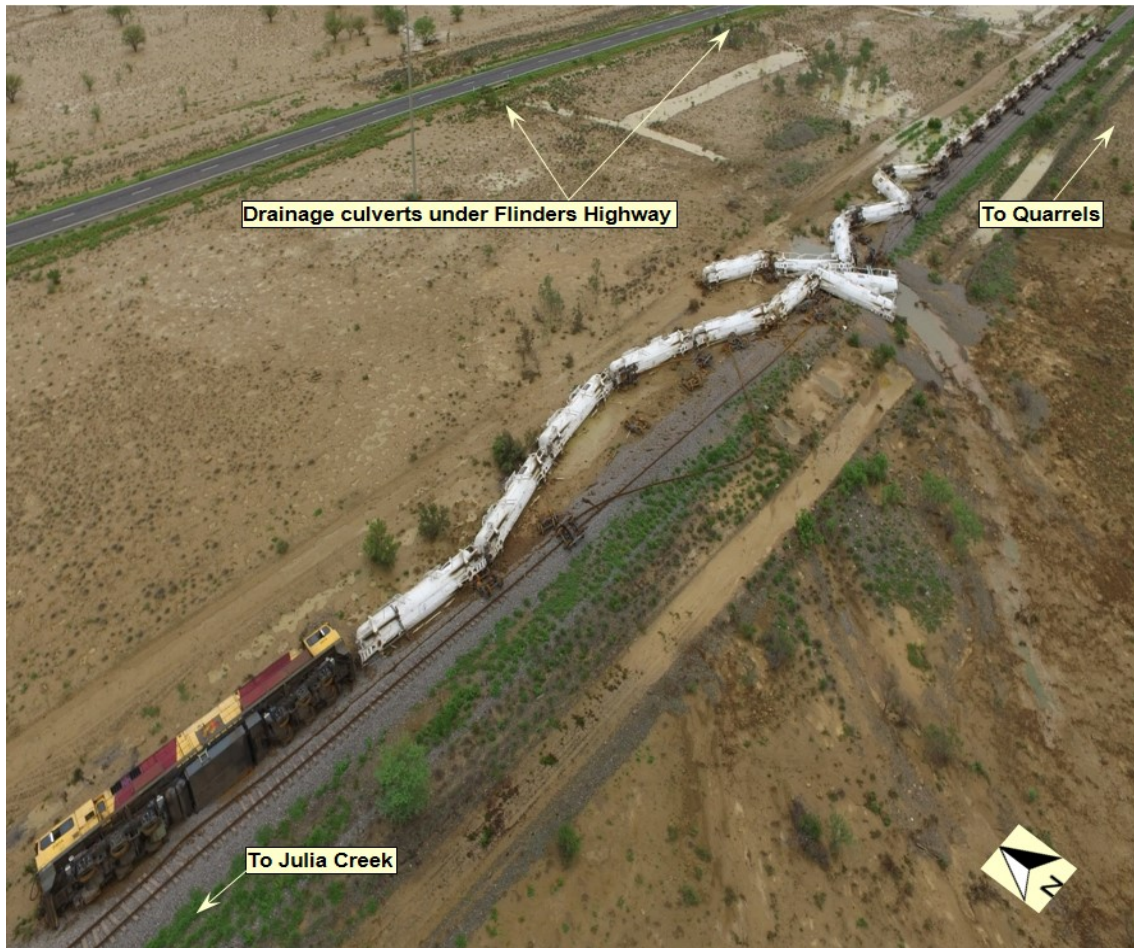
Figure 2: Derailed train 9T92

Train 9T92 had travelled about 2.6 km from Quarrels before encountering the washout. The locomotive came to rest on its side to the north of the track, about 68 m past the washout (Figure 2). The locomotive was laying in about 600 mm of pooled floodwater. All of the 26 trailing tanker wagons had also derailed to the north of the track and were laying in the pooled floodwaters.

The derailed locomotive 2814 and 26 trailing tanker wagons of 9T92 laying to the north of the railway about 20 km east of Julia Creek. The floodwaters present at the time of derailment had receded, however pooled water is visible in the drainage channels from culverts under the Flinders Highway leading toward the washout of the track formation. Source: Queensland Police Service

- Scouring of the ballast and formation adjacent to the 617.190 km point by floodwater meant that the track could not support the weight of train 9T92 as it passed over the affected area. The resulting deformation in alignment of the track initiated the derailment.

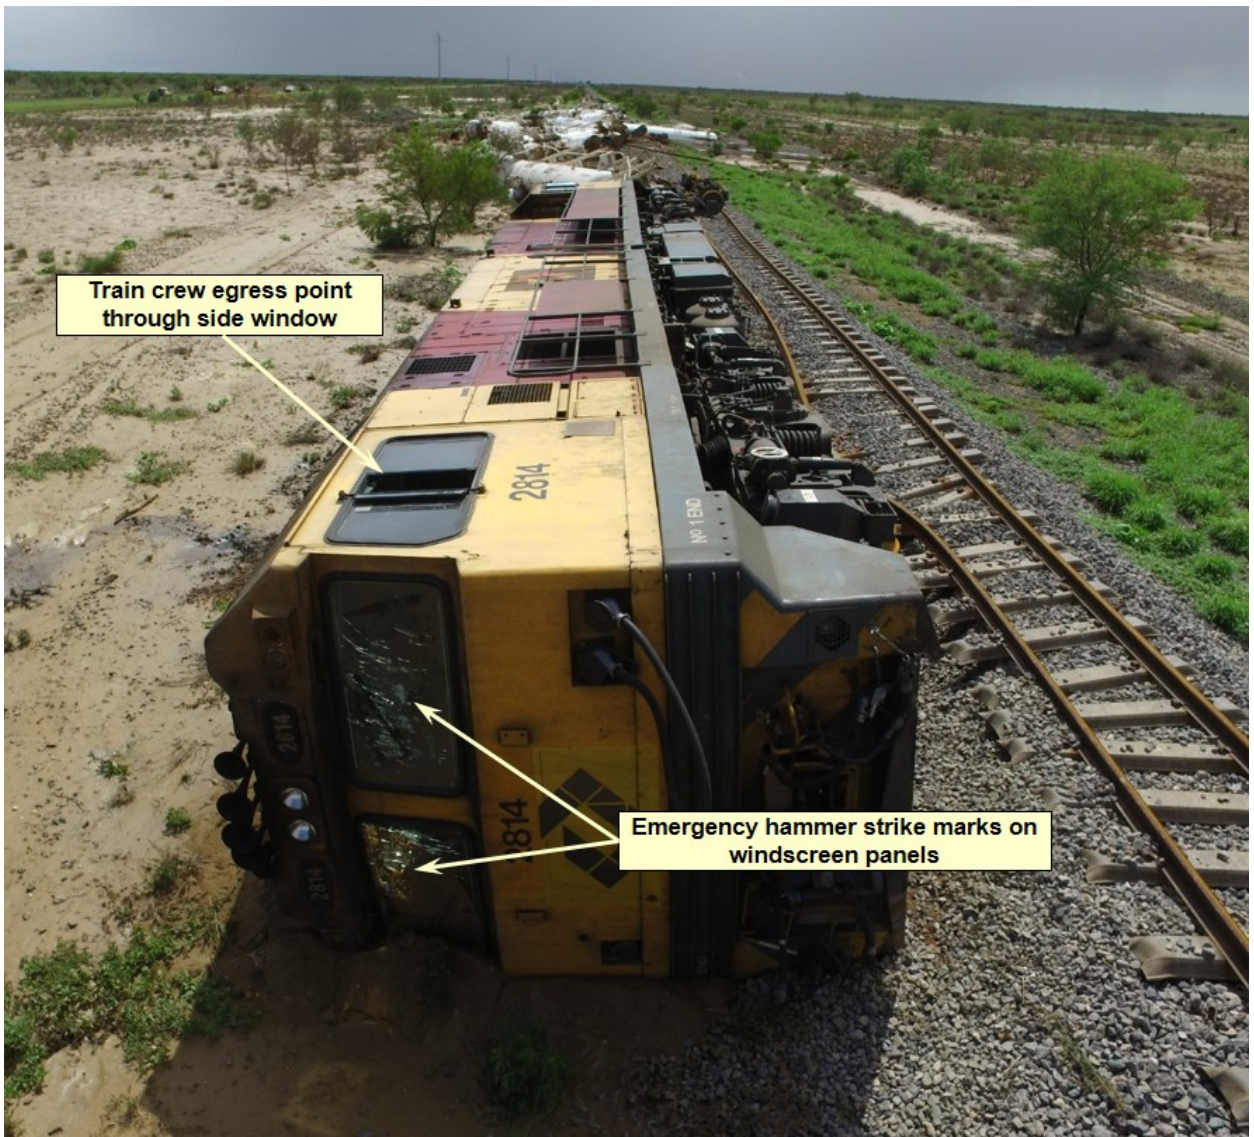
Figure 3: Derailed locomotive 2814

Immediately after the derailment, floodwater entered the cabin, before receding to a depth of about 600 mm. To escape the cab, the train crew attempted to break the front windcreens using

the emergency hammer (Figure 3). After repeated strikes, they were unable to open an escape route through the windscreens, so the crew decided to climb up and out of the locomotive's side window.

Derailed locomotive 2814 situated on the northern side of the track. The damage to the inside surface of both windscreens was from numerous strikes using the supplied emergency hammer. The train crew were unable to break out the windscreens. The train crew escaped from the locomotive through climbing up and out the sliding side window. Source: Queensland Police Service

Aurizon have advised that respiratory protection masks have been introduced on trains transporting acid. Additionally, Aurizon have commenced a review of emergency evacuation procedures, locomotive windscreens, and secondary communication opportunities/options.

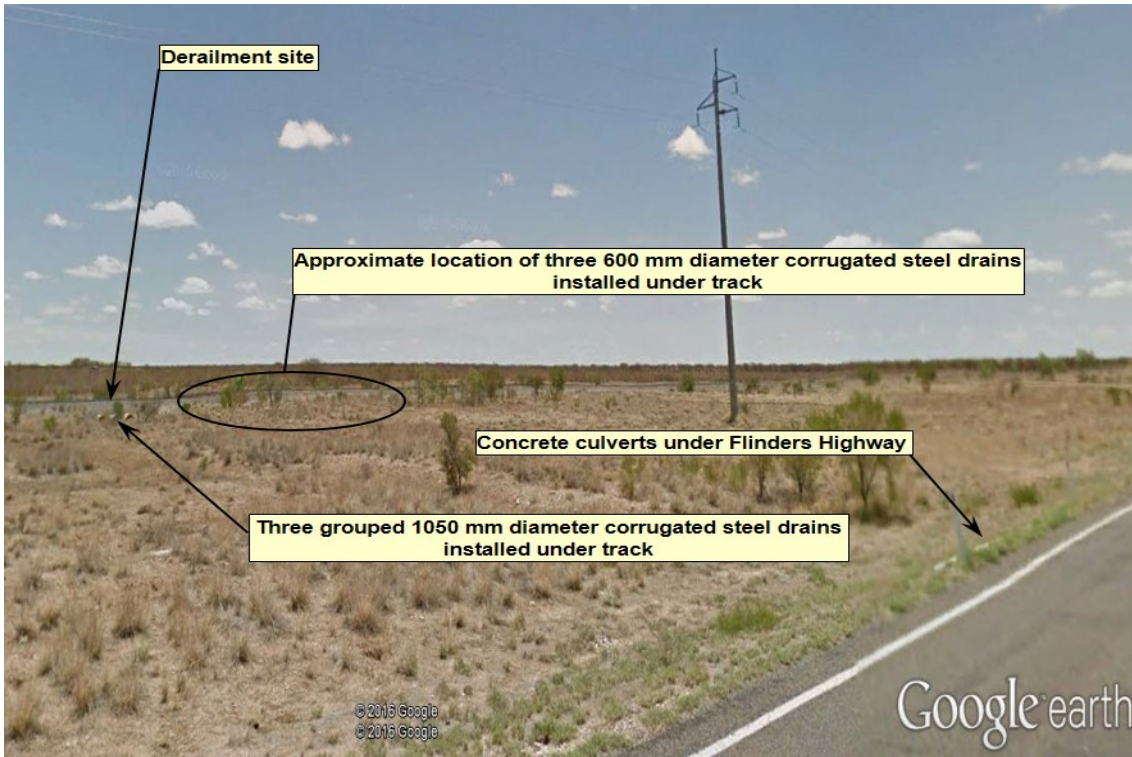
Figure 4: Under-track drainage at the derailment site

At the derailment site (617.190 km), there was a grouping of three 1050 mm diameter corrugated steel pipes installed under the track formation (Figure 4). Immediately west of the site three additional 600 mm diameter corrugated steel pipes were installed at about 10 m intervals (617.200, 617.210, 617.220 km).

Location of the derailment as it appeared before the event - viewed in a south-westerly direction from the Flinders Highway. Rainwater runoff flows from the catchment to the north, passes through a series of concrete culverts under the highway and toward the railway formation. A series of circular corrugated steel pipes installed under the track formation allows water to then flow into the watercourses located to the south of the railway. Source: Google Earth, annotated by ATSB
