# Signals Passed at Danger by passenger train TD3050

Upwey and Upper Ferntree Gully | Victoria, 12 April 2015

**ATSB Transport Safety Report**  
Rail Occurrence Investigation  
RO-2015-008  
Final – 21 April 2016

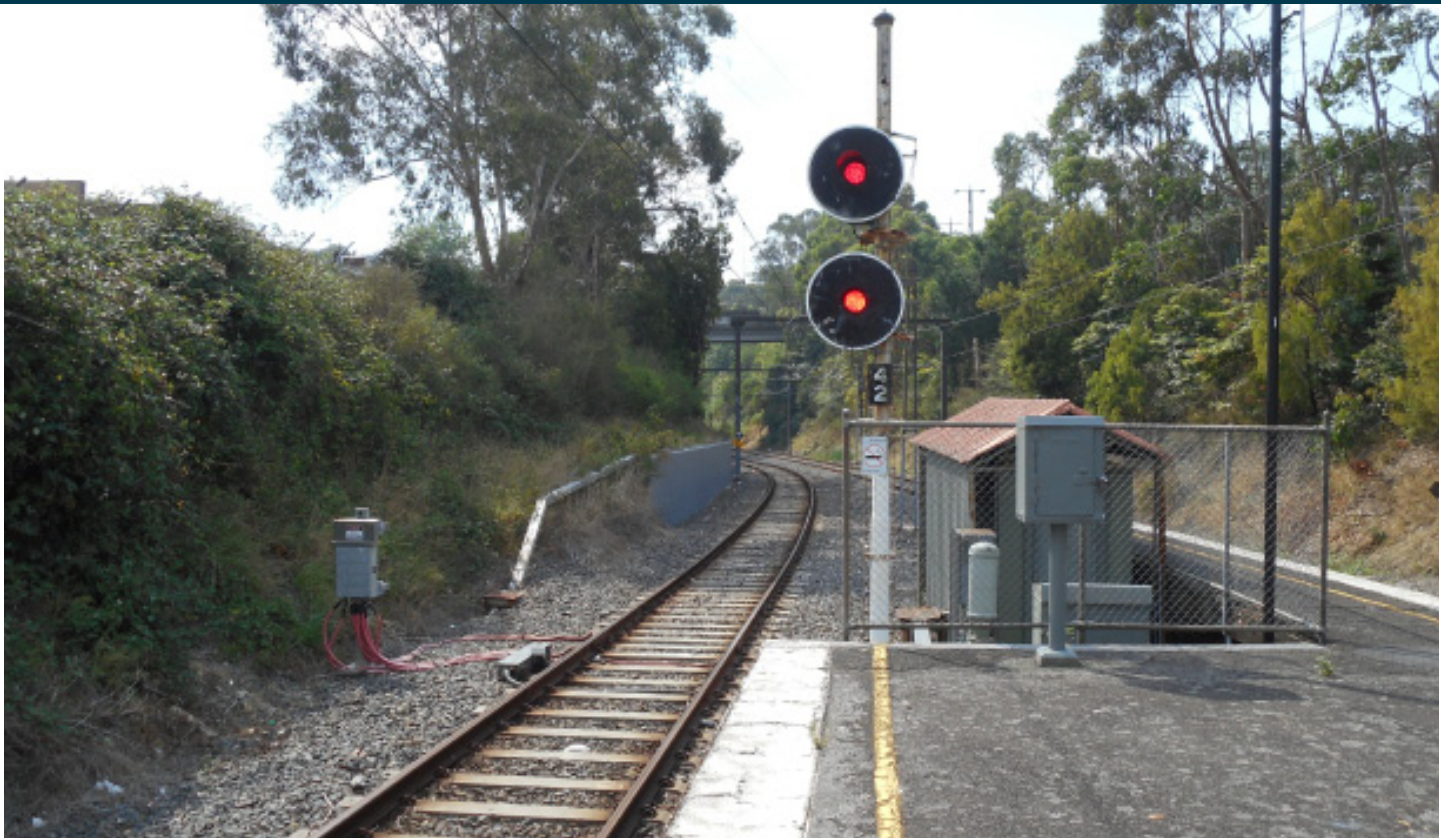
**Cover photo:** Home Departure signal № 42 at Upwey (Source: Chief Investigator, Transport Safety (Vic))

The ATSB found that the train passed both the Upwey Home Departure and the Upper Ferntree Gully Home Arrival signals at Stop without authority. The departure from Upwey was possibly influenced by the driver's anxiety at having to operate the points machine a short distance beyond Upwey.

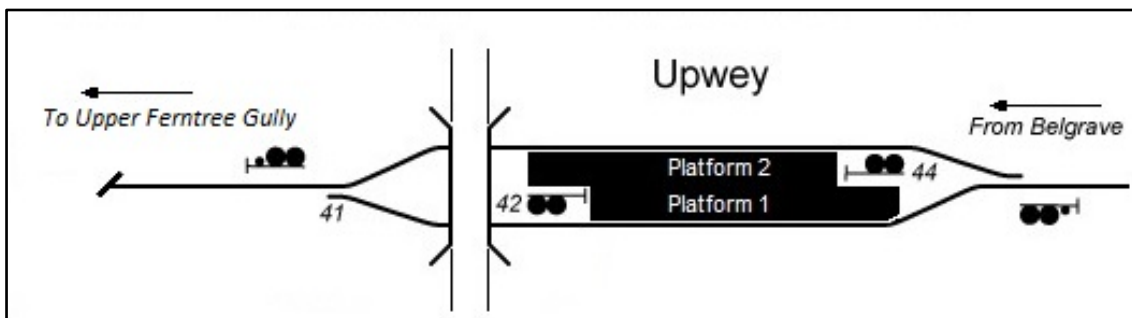
**Figure 2: Upwey track layout with key signals and points marked**

Train TD3050 arrived at platform 1 at Upwey Railway station (Figure 2) to cross the Belgrave-bound service that had arrived at about the same time and was at platform 2. Just prior to the arrival of TD3050, the signal control panel at Upper Ferntree Gully failed. As a result the signaller based at Upper Ferntree Gully (UFG) no longer had control of signals and points at Upwey and could not determine the location of trains in the vicinity of Upwey.

Unable to see the status of № 41 points from the Upwey platform, the driver boarded his train and ran forward towards the points. By this action, he passed the Home Departure signal at Upwey at Stop. This was the first Signal Passed at Danger (SPAD<sup>1</sup>) event of this incident. Passing this Home signal at Stop, led to activation of the trip lever and a resulting enforced brake application which brought the train to a stand (see p5).

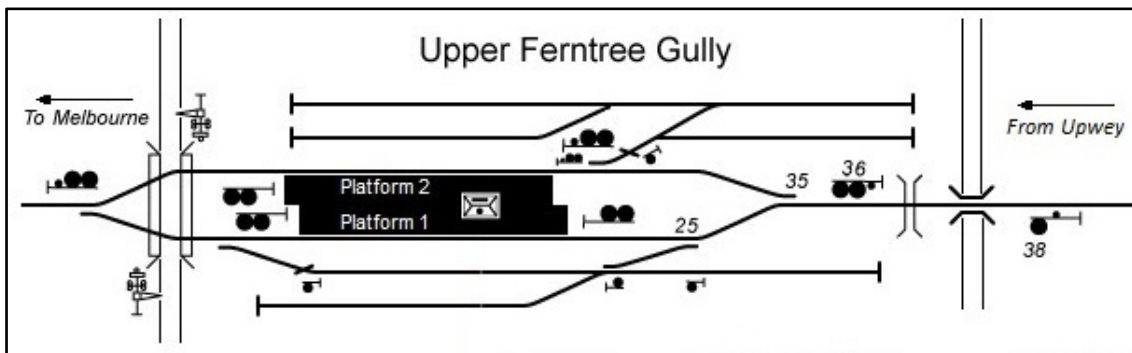
**Figure 3: Upper Ferntree Gully track layout with key signals and points marked**

Train 3050 subsequently arrived at Home Arrival signal № 36 at Upper Ferntree Gully (Figure 3). Observing that the points appeared correctly set, the driver proceeded past this Home signal that was also at Stop, again experiencing a mandatory stop initiated by the mechanical trip system. This was the second SPAD event of this incident.

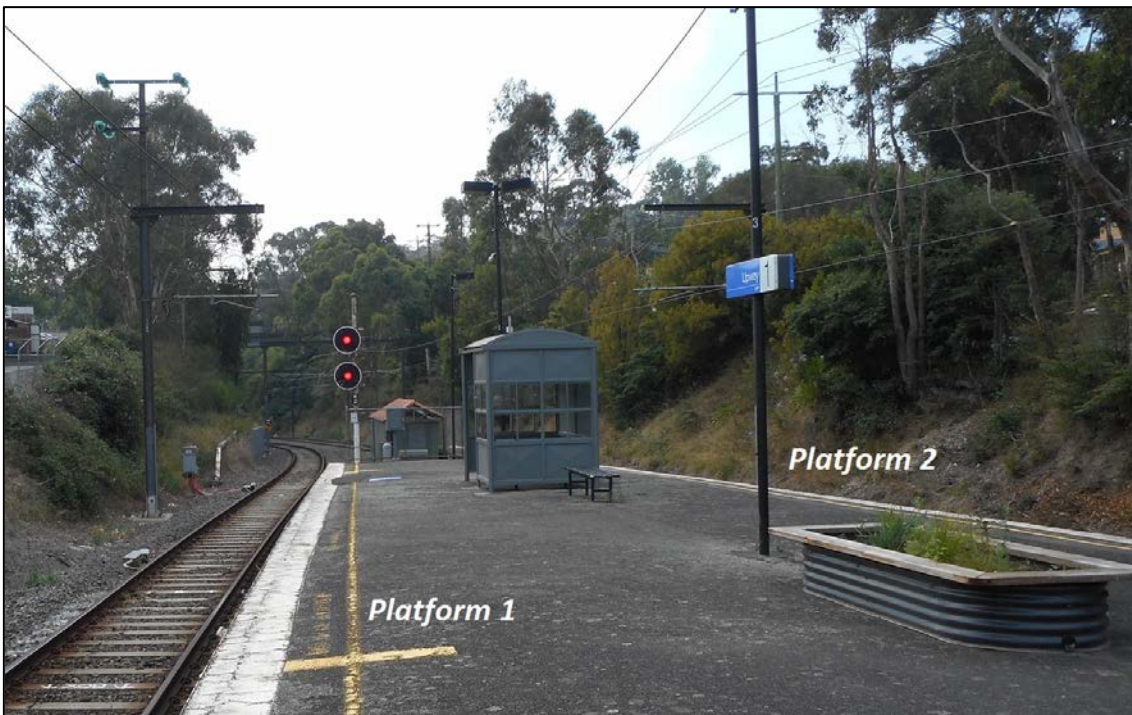
**Figure 4: Upwey railway station looking towards Upper Ferntree Gully and signal No 42**

Upwey is an unattended crossing station, about 40 km from Flinders Street Station. Home Departure Signal No 42 is at the Melbourne end of Platform 1 (Figure 4).

The procedures for passing Home signals following signalling system failure are well established formal processes. At Upwey, the correct authority to proceed past the Home Departure signal that was at Stop was a dictated ATC System Caution Order. The train proceeded without this process being followed and therefore without authority. In addition, the train then proceeded over points № 41 without them first being secured by hand and the signaller being advised.

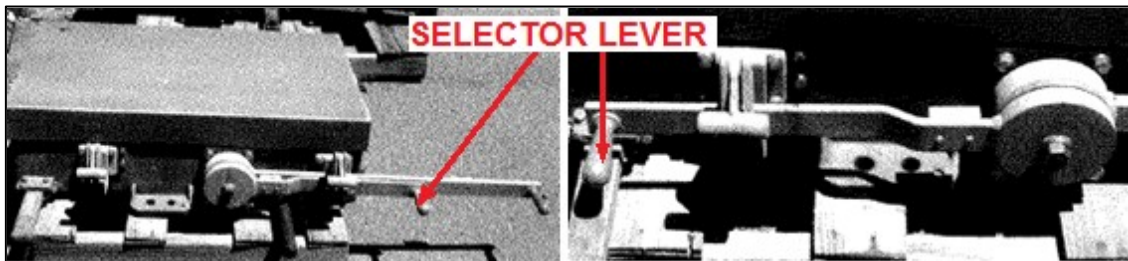
**Figure 5: Dual Control Point Machine. The Selector lever is shown in the ‘Motor’ position (right-hand photo) and ‘Hand’ position (left-hand photo)**

The Dual Control Point Machine has two levers – the Selector lever and the Hand Throw lever. The Selector lever is the shorter of the two. The normal position for the Selector lever is in the ‘Motor’ position (Figure 5 right-hand photo). To place the machine into ‘Hand’ mode the lever is rotated clockwise by 180 degrees (Figure 5 left-hand photo). With the Selector lever in this position, the Hand Throw lever can then be used to manually move the points to their required position. Figure 5 does not depict the actual point machine at the № 41 points at Upwey.

Despite the ease of the task, it is apparent that the driver was apprehensive about operating the points. It is possible that this apprehension led to the driver forgetting the requirements to first check the points and then obtain a Caution Order before departing the train from Upwey.

MTM has reviewed training provided to drivers in the operation of Dual Control Points Machines. MTM is also considering [1] the incorporation of SPAD alarms at this location, and [2] modifying the communications network to capture all safeworking communications at Upper Ferntree Gully.

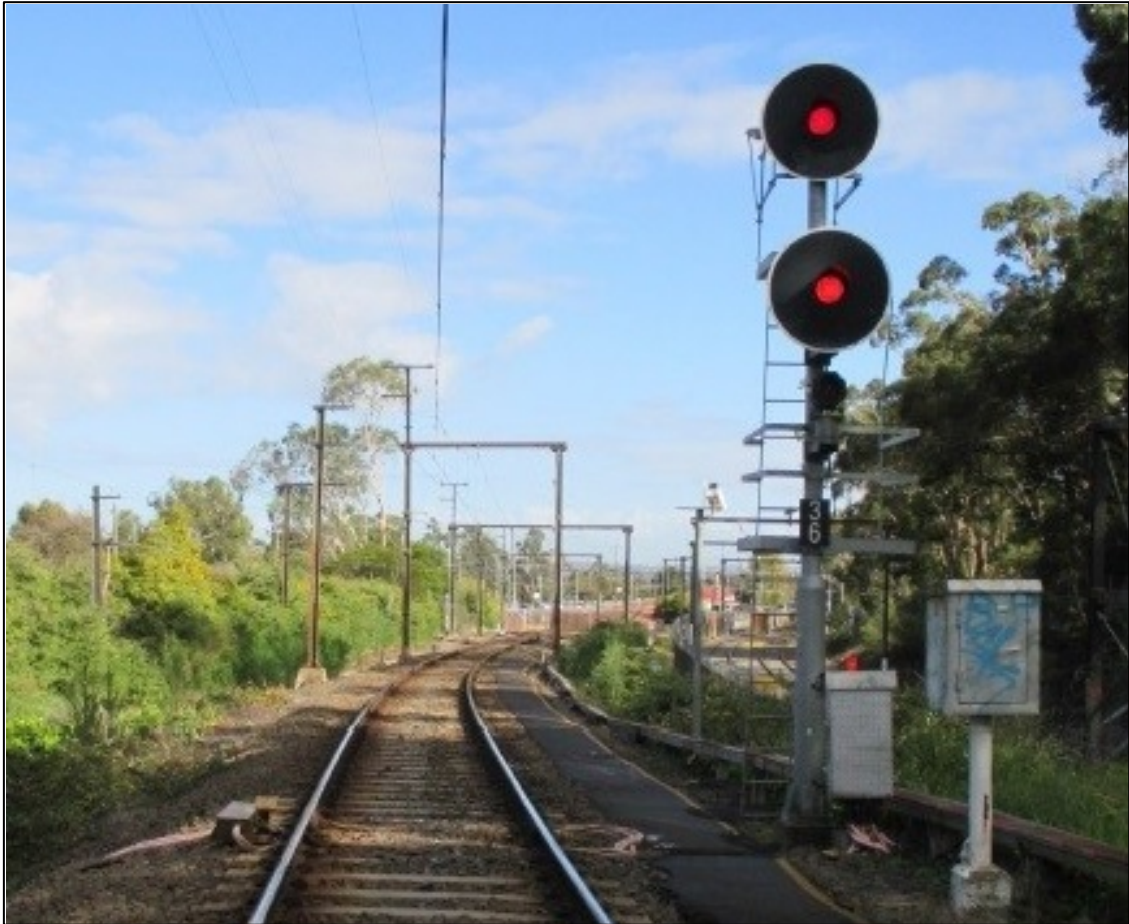
**Figure 6: Home arrival signal № 36 at Upper Ferntree Gully**

Upper Ferntree Gully is an attended crossing station about 36 km from Flinders Street. Home Arrival Signal № 36 (Figure 6) is located about 220 metres prior to the platform.

Therefore at Upper Ferntree Gully station, in the case that the signaller was to issue a Caution Order, Nos 35 and 25 points would be secured by the signaller, before a train was given the written authority to pass signal No 36 and proceed to Platform 1.

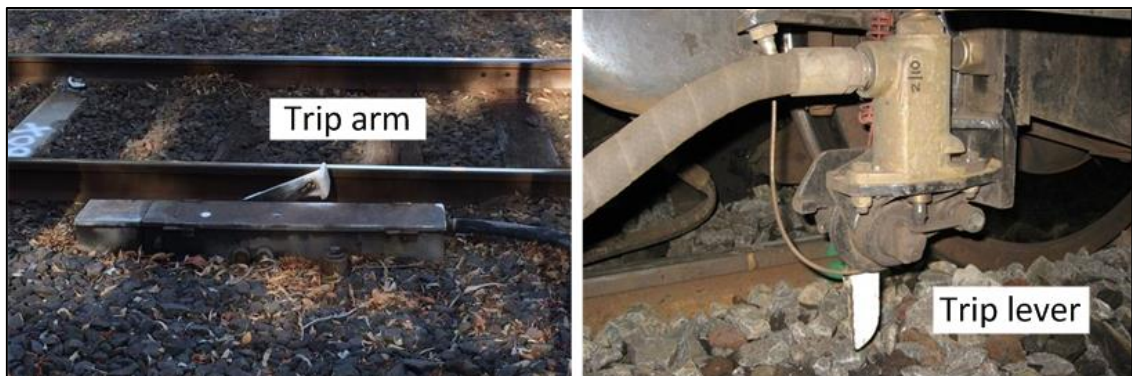
**Figure 7: Automatic train stop (left) and trip lever on suburban trains (right)**

In this incident, the train brake was 'tripped' when passing signals Nos 42, 38 and 36. This stopped the train in each case, and the driver manually reset the trip, enabling the train to recommence its journey.

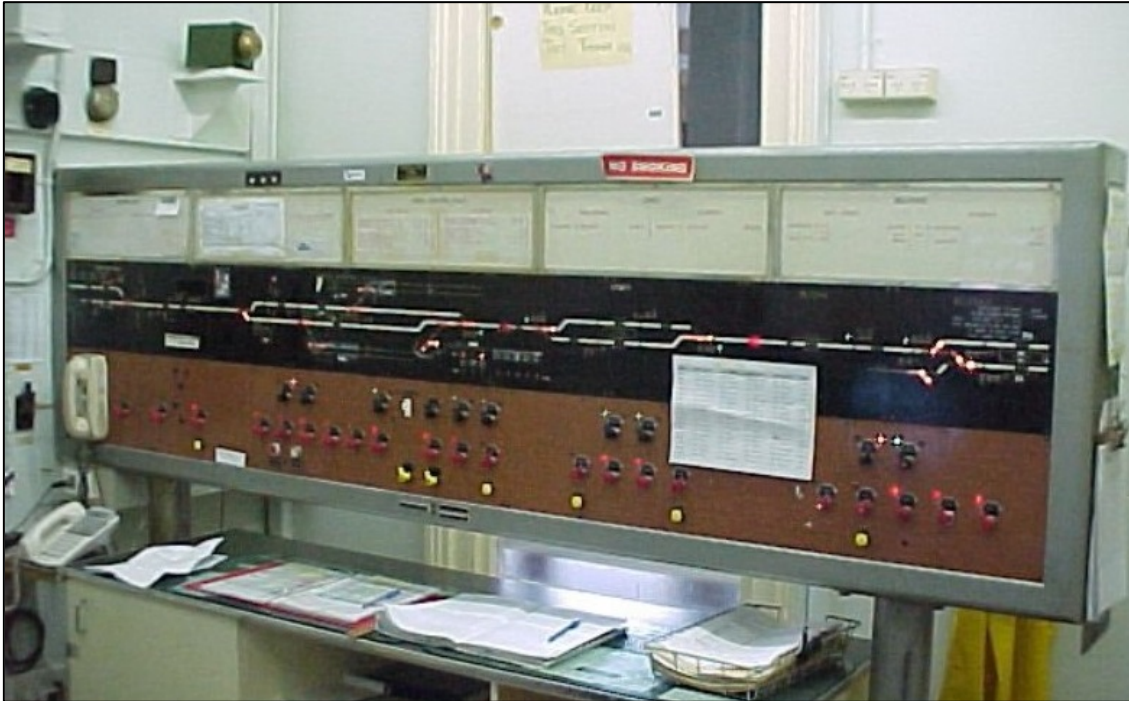
**Figure 8: Signal control panel, Upper Ferntree Gully**

MTM maintenance attended to the loss of panel functionality. The inspection identified that the panel fault was the result of a processing failure within the Railmaster compact telemetry unit. This is an interface component between the signal control panel and field equipment. The Railmaster unit had failed and required a hardware reboot. The equipment that had caused the signal control panel outage was reset after about an hour. However, a secondary and separate fault with a set of points resulted in a delay in re-establishing the signalling system.

The signal control panel at Upper Ferntree Gully lost functionality as a result of a processing failure within the Railmaster compact telemetry unit.

Due to this failure, the signaller lost control over and information on the signals and points at Upwey. As a result, safeworking reverted to a back-up procedural system. This required the use of Caution Orders as the authority for trains to pass Home signals at Stop. This substitute process introduced a greater procedural burden on operational staff and an increased exposure to human error.
