Australian Government
Australian Transport Safety Bureau

Collision between V/Line train 8280 and MTM train 6502

Altona, Victoria | 22 August 2014

ATSB Transport Safety Report
Rail Occurrence Investigation
RO-2014-016
Final – 6 July 2016

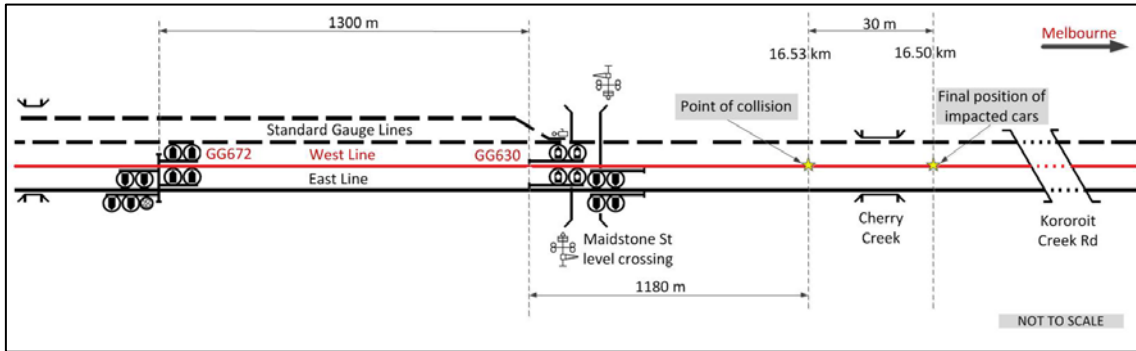
Figure 2: Collision location and signals

The track infrastructure in this section consisted of a Broad Gauge East Line, a West Line and an independent parallel Standard Gauge line (Figure 2). Both trains were operating on the West Line. From the Maidstone Street level crossing, the track has a slight uphill gradient towards Cherry Creek. Clear sighting is available up to Cherry Creek from the Maidstone Street level crossing. The weather conditions were fine and it was a clear night with light winds.

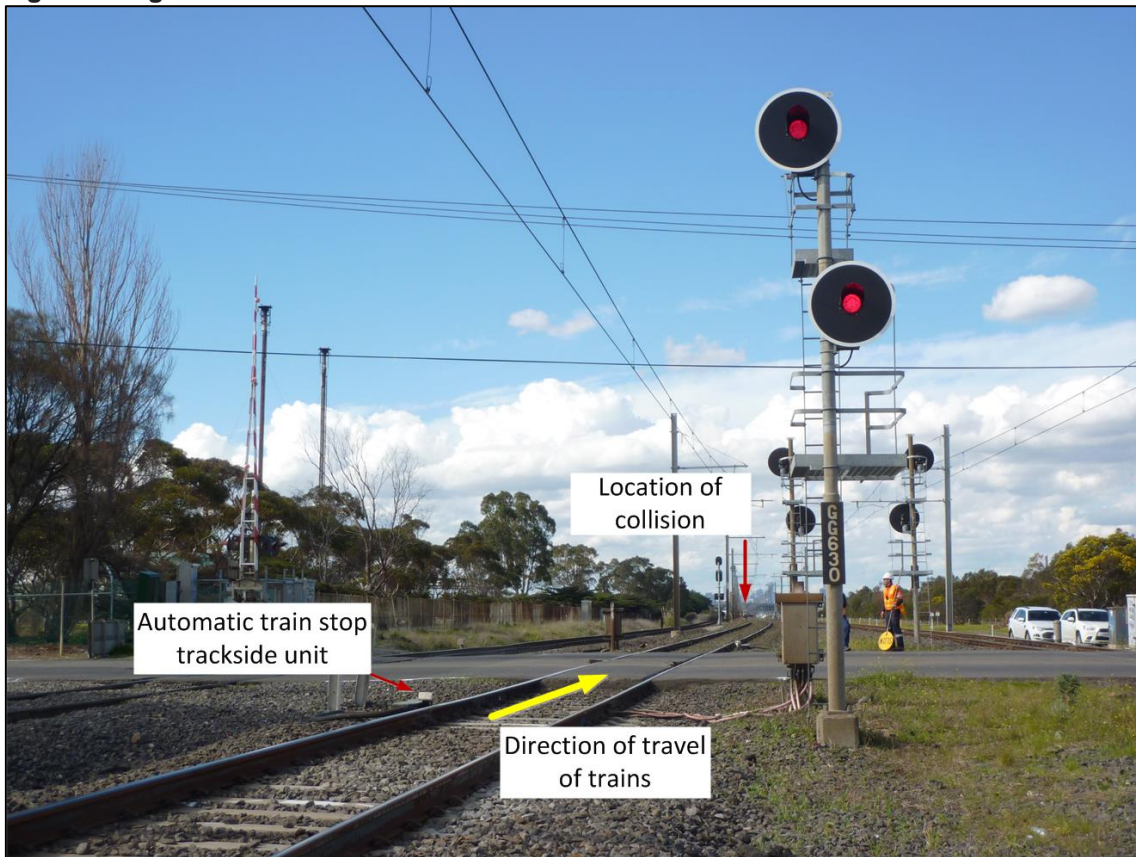
Figure 3: Signal GG630 and indication of collision site

After passing signal GG630, the V/Line train reached a speed of 43 km/h and collided at this speed with the rear of the stationary MTM service 6502 at about 1901. The MTM train had been stopped for about 6 minutes, before the collision. The data logger of the V/Line train indicated that emergency braking was applied by the driver 1.4 seconds before the collision.

The MTM train was shunted about 30 m due to the impact and the impacted cars stopped at about the 16.5 rail km mark, approximately 1210 m from signal GG630. The driver of the MTM train was thrown onto the cab floor by the impact. The V/Line driver was trapped between the train control console and the seat but managed to extricate himself by lowering the seat. He got out of his cab, walked towards the MTM train and spoke to passengers on the train to inquire as to their wellbeing and then spoke to the MTM driver who was still in the cab of his train.

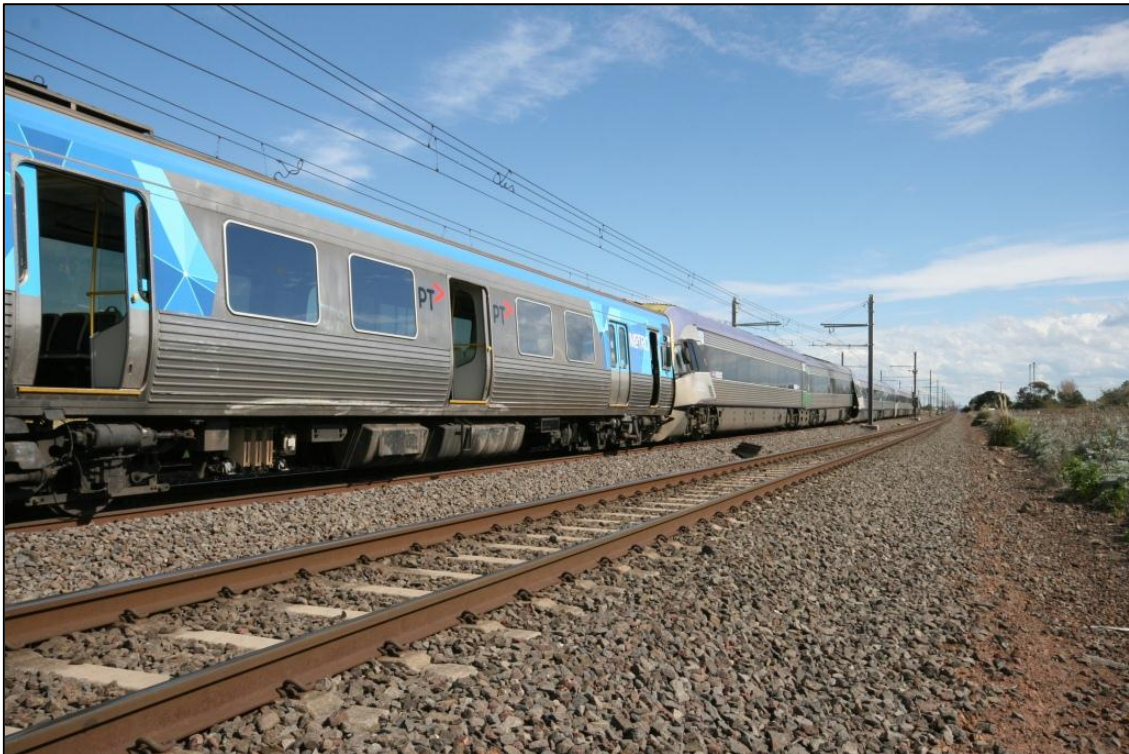
Figure 4: Impacted trains

MTM staff detrained the 51 passengers and escorted them to service replacement buses. The driver and conductor on the V/Line train, the driver of the MTM train and eight passengers from the MTM train sustained minor injuries in the incident. Both trains were significantly damaged (Figure 5).

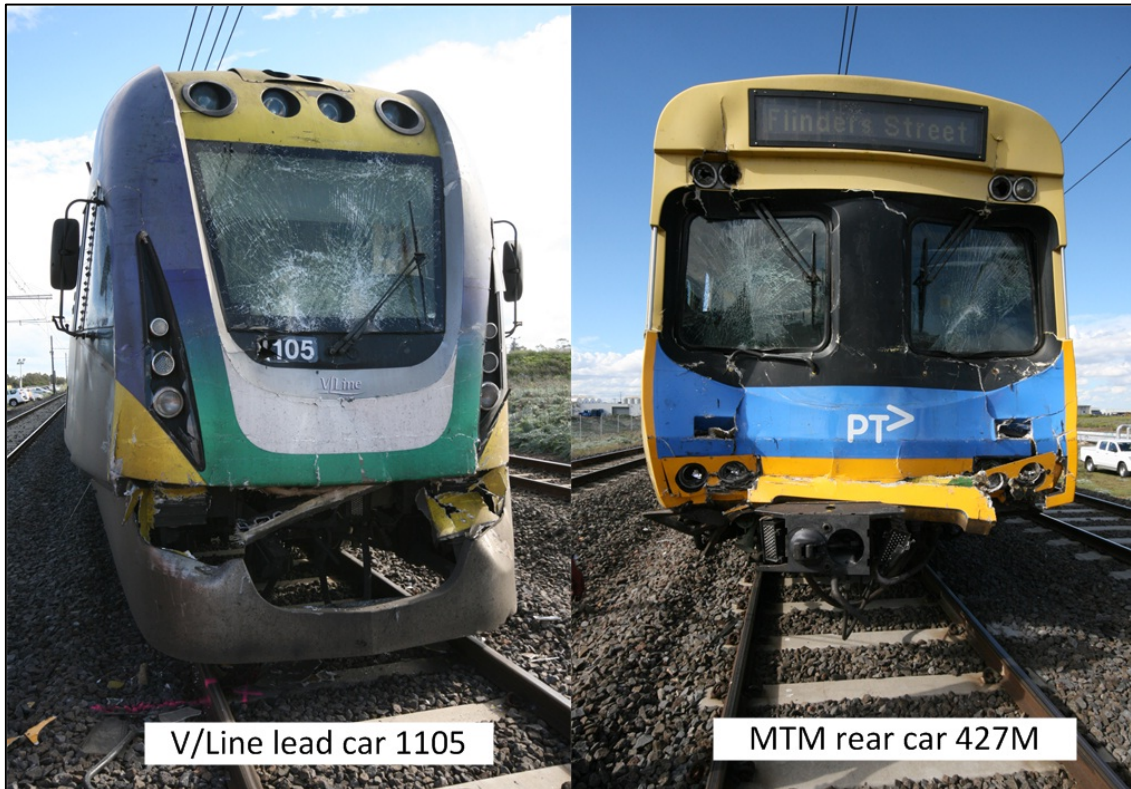
Figure 5: Train damage

- The shear off plates on the leading coupler functioned in advance of any significant absorption within the coupler itself.
- The leading coupler of the second car set (car 1112) did not absorb energy as might have been expected in an end-to-end collision.
- Anti-climbers between the lead and second car sets (between cars 1205 and 1112) have engaged but then distorted leading to some override by car 1205. Probably as a result of this climb, some members and connections within the structure protecting the cab have failed in advance of full absorption of collision energy. In turn, there was significant encroachment of the cab of car 1112.

The car body structures of both trains generally withstood the collision loading with some minor structural incursions at car ends. As a result, the level of damage within the passenger envelopes was not significant. In addition, on both trains there was only a small amount of equipment dislodgement within the passenger compartments.

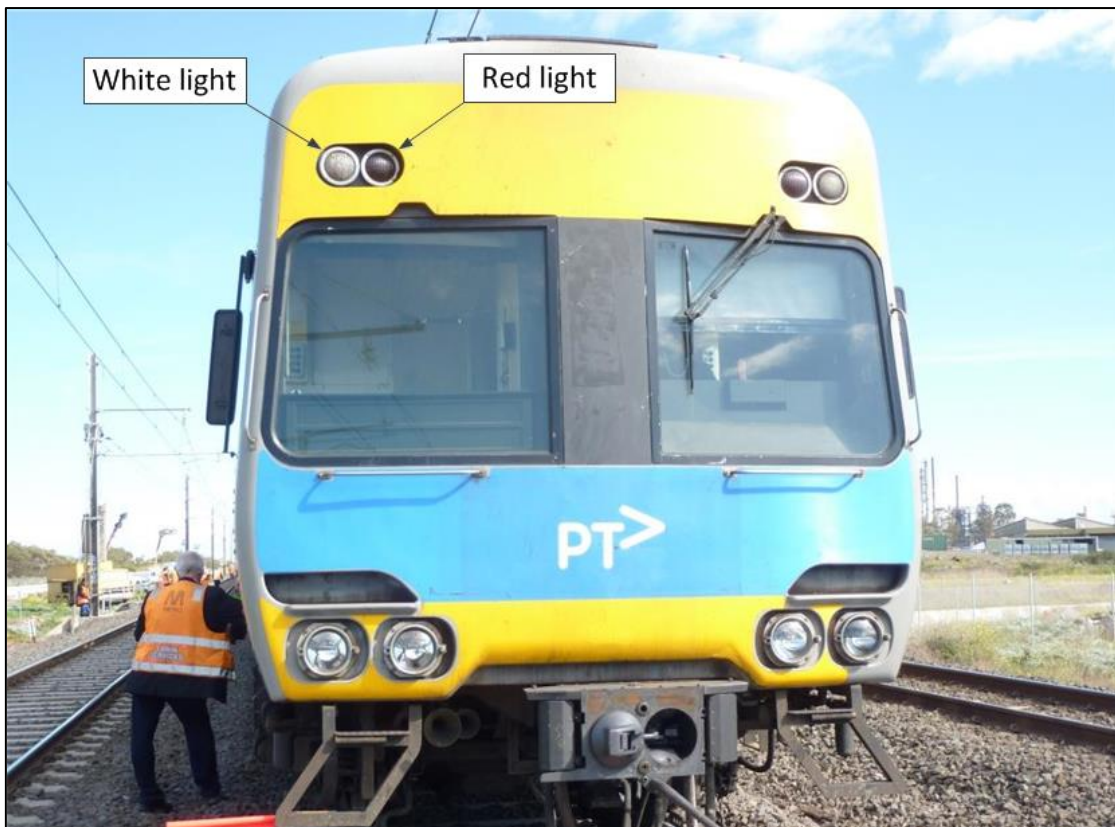
Figure 8 - Comeng train lights

Comeng train marker lights are located above the drivers cab windcreens and consist of an outer white light and an inner red light. The white light when illuminated indicates the front of the train, while the red light when illuminated indicates the rear of the train.

Tests carried out on the type of marker lights used on the Comeng and Siemens trains indicated a luminosity of 33 Lux at one metre and a luminosity of 30 Lux at one metre, both below the value recommended by the Standard. After the incident, Comeng train tail light sighting tests were conducted at night, in the incident site. An observer noted that the marker lights tended to disappear at night due to the refinery lighting and the LED signals. Low luminosity marker lights may not be discernible in areas of other illuminations. Although MTM had adopted the *AS/R/SSB Standard*, they have not implemented it on their rail fleet.

- **The marker lights on the Comeng train did not meet the requirements of the standard for *Railway Rolling Stock Lighting and Rolling Stock Visibility, AS/RISSB 7531.3:2007*. [Safety issue]**

MTM advised the ATSB that ‘after consideration and testing of other options including flashing marker lights, MTM is developing a modification for inclusion in the Comeng Life Extension Program to increase the intensity of the marker lights to a level compliant with the standard for *Railway Rolling Stock Lighting and Rolling Stock Visibility, AS/RISSB 7531.3:2007*, including provision of a system to enable the automatic operation of the emergency battery back up in the event of loss of overhead power’.
