# Runway excursion involving Cessna 550, VH-FGK

Lismore Airport, New South Wales | 25 September 2015

**ATSB Transport Safety Report**  
Aviation Occurrence Investigation  
AO-2015-114  
Final – 25 July 2016

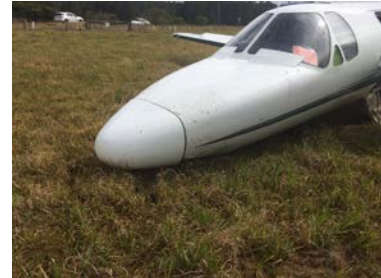
## Accident site

The captain rejected the take-off, applied full braking and reverse thrust, but the aircraft overran the runway. The nose landing gear detached from the aircraft about 50 m beyond the end of the sealed runway, and the aircraft came to rest in long grass and mud. The aircraft sustained substantial damage, and the captain and copilot were uninjured.

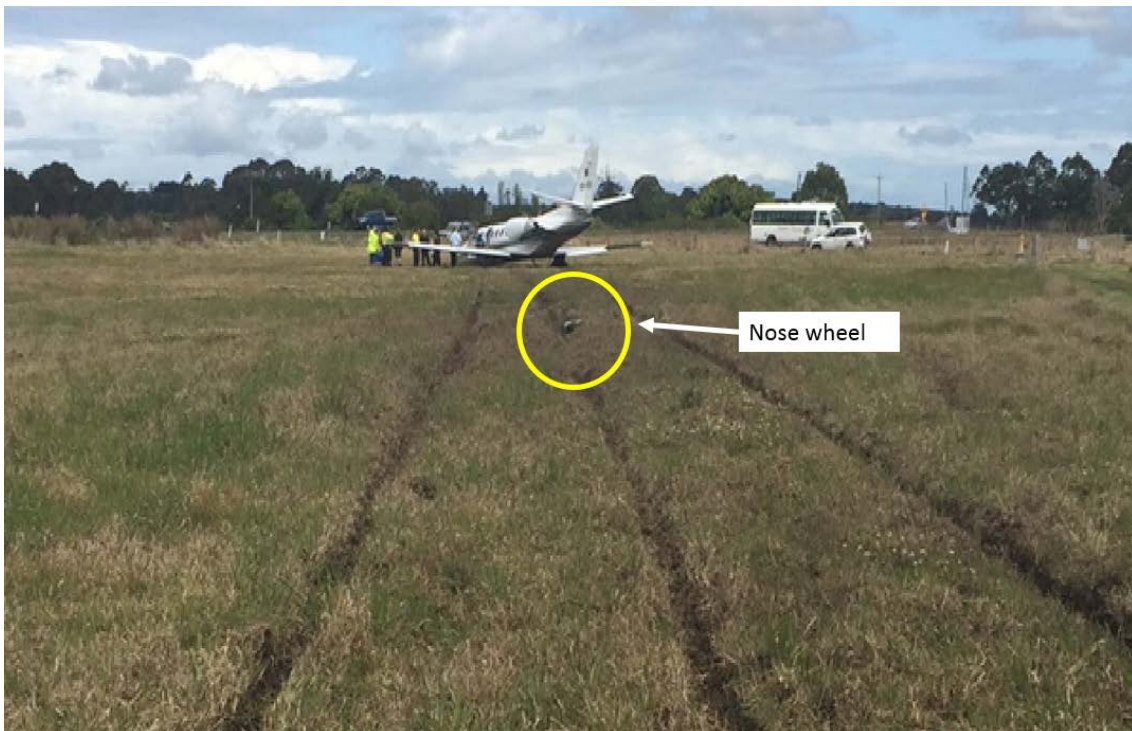
**Figure 2: Accident site**

The aircraft continued to the end of the sealed runway and onto the grass in the runway end safety area (RESA), coming to rest slightly left of the extended centreline, about 100 m beyond the end of the runway (Figure 2).

Similarly, using measurements from Google Earth based on photos of the accident site, the aircraft came to rest about 150 m beyond the sealed runway and before the airport boundary fence. The RESA at Lismore may have assisted in decelerating the aircraft after the rejected take-off and reduced risk of injury and damage to the aircraft.

The grass overrun area beyond the sealed end of runway 15 at Lismore was about 180 m to the airport boundary fence, longer than the required 150 m (90 m runway end safety area extending beyond the 60 m runway strip), and contained the aircraft which came to rest about 150 m beyond the end of the runway. The suitable overrun area restricted the aircraft damage and resulted in no injuries resulted from the accident.

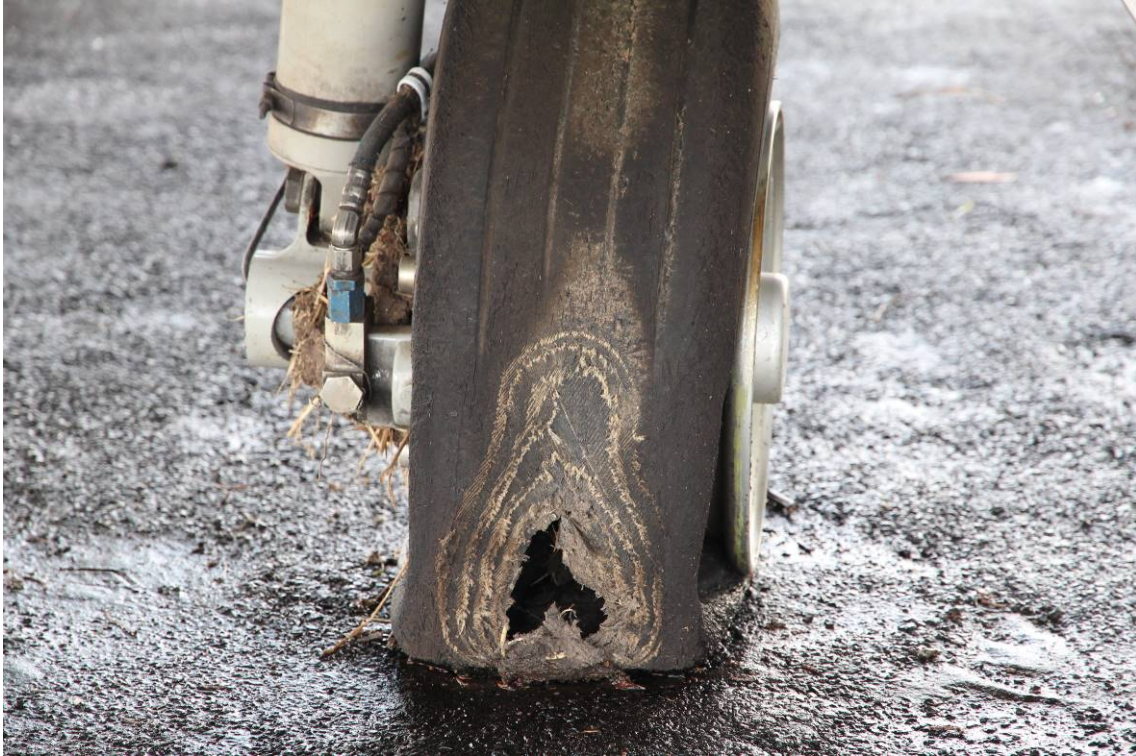
**Figure 3: Right tyre**

The aircraft sustained substantial damage and the flight crew, who were the only occupants of the aircraft, were uninjured. The nose landing gear separated from the aircraft during the overrun (Figure 2), and there was significant structural damage to the fuselage and wings. The right wheel tyre had deflated due to an apparent wheel lockup and flat spot, which had progressed to a point that a large hole had been worn in the tyre (Figure 3).

Given that only one tyre was damaged (and that witness marks indicate it was damaged after the rejected take-off), it is therefore probable that the rolling resistance experienced by the aircraft was a result of partial brake pressure in both wheels. This affected both the slow acceleration rate and inability to rotate the aircraft at  $V_R$ .

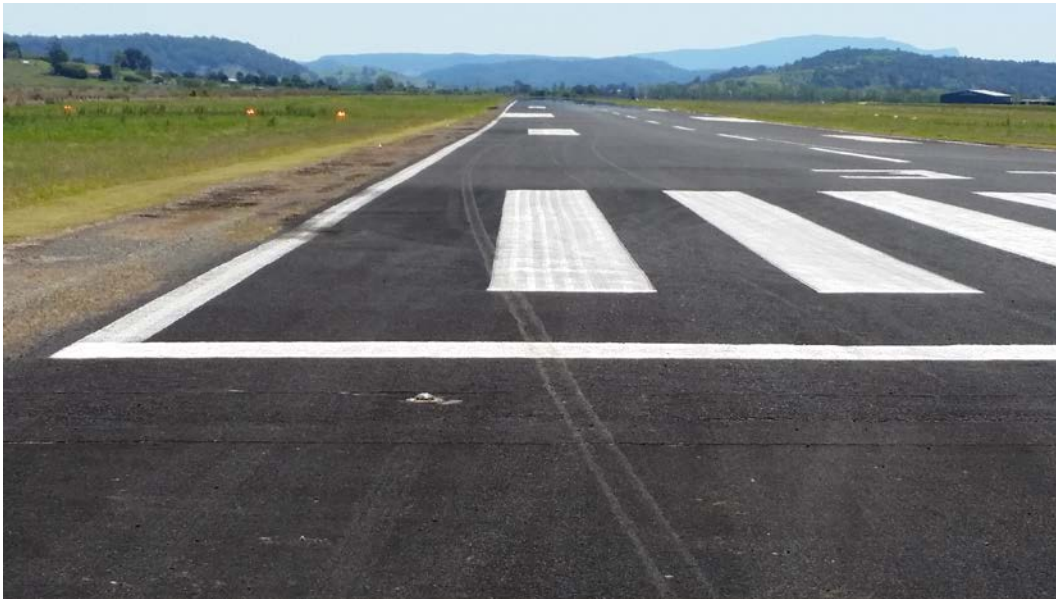
**Figure 5: Southeast end of the runway showing right wheel contact marks on the runway and their position in relation to the runway centre line**

Distinctive marks on the end of runway 15 indicated that the right wheel tyre had deflated after the captain rejected the take-off and the wheel's rim was making contact with the runway. The position of the tyre witness marks on the runway showed that the aircraft remained just to the right of the centreline but moving towards the left as it exited the runway (Figure 5).

Neither crew member detected any tendency for the aircraft to yaw. Additionally, the position of the tyre witness marks on the runway showed that the aircraft remained on the runway centreline until after the captain rejected the take-off. This is indicative of equal resistance from both main wheels and not a failure of one wheel, brake or tyre.

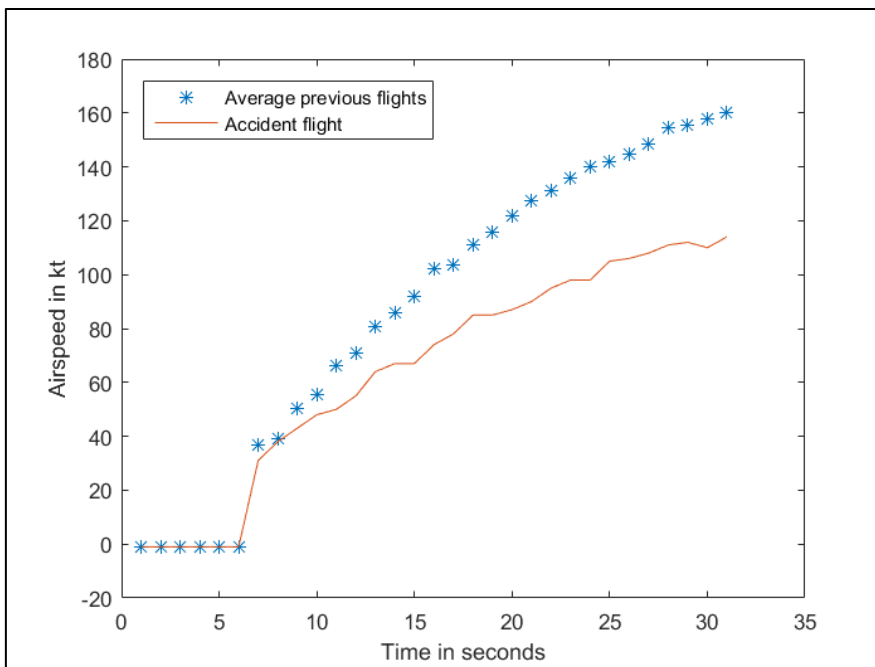
**Figure A-1: Airspeed of accident flight compared to the average of four previous flights**

The accident flight take-off data shows a reduced acceleration compared with the previous four flights, but a similar engine RPM. Figure A-1 shows the airspeed of the accident flight and the average of the four previous flights, which were not significantly different from each other.

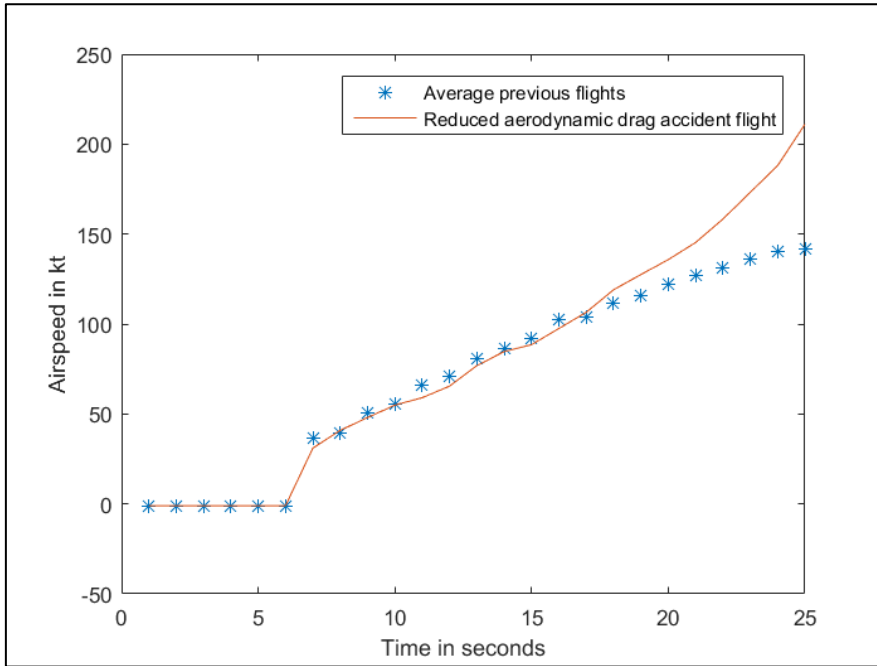
**Figure A-2: Airspeed of accident flight without an aerodynamic drag component, compared to the average of four previous flights**

The aerodynamic drag increases with the *square* of speed. If the increased drag was primarily aerodynamic, the effect on the airspeed curve would be an increase in the curvature (downwards) as speed increased, after being similar at lower airspeeds. Figure A-2 shows the airspeed from the accident flight with a component of aerodynamic drag removed, and compared to the average previous flights. As can be seen from the graph, this does not reflect a similar acceleration profile to the previous flights. The graph depicts the airspeed showing the commencement of the take-off run, to when the captain rejected the take-off in the accident flight.

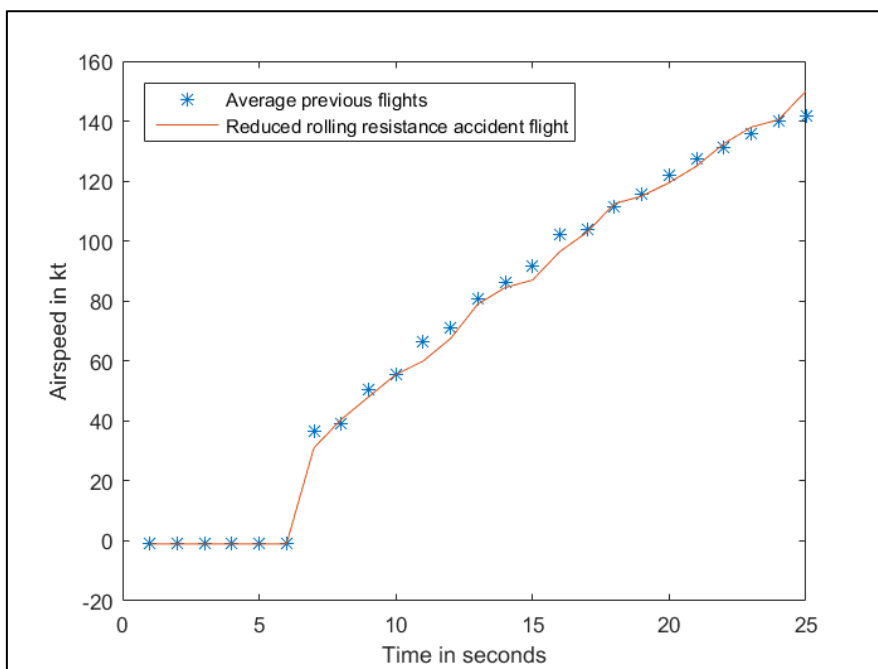
**Figure A-3: Airspeed of accident flight with a reduced rolling resistance component, compared to the average of four previous flights**

A correction of an acceleration of 2.5 kt/second as a constant applied to the accident flight is depicted in Figure A-3. As can be seen, the corrected line correlates closely with the average take-off acceleration from the previous four flights. Adding an acceleration component equates to a deceleration (or rolling resistance) component present in the accident flight data. A deceleration component of 2.5 kt/second is 0.13 g.

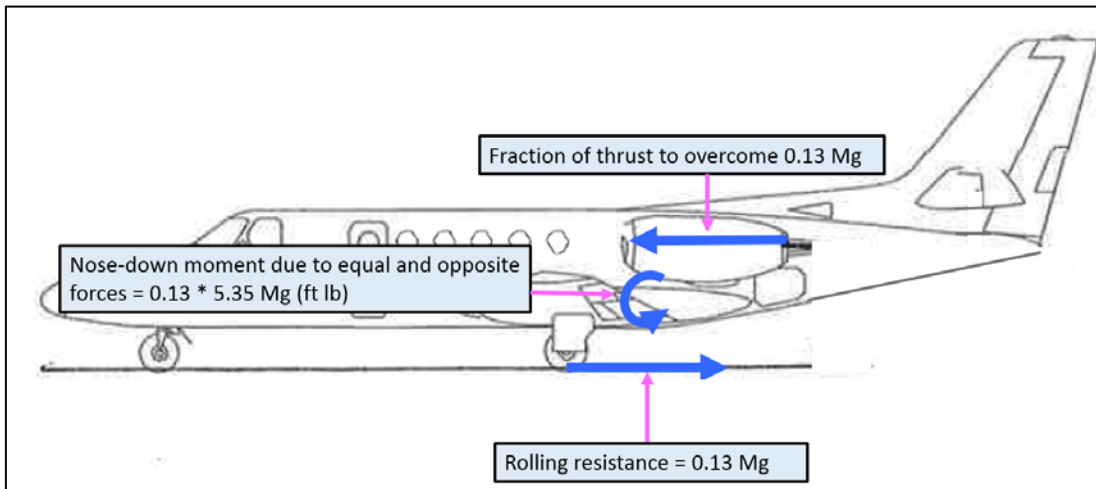
**Figure A-4: Representation of thrust, rolling resistance and nose-down moment**

The nose-down moment of the thrust force required to counteract the additional rolling resistance of 0.13 g, is  $0.13 \text{ Mg} \times 5.35 \text{ (ft lb)}$ .<sup>8</sup>

The nose-down moment due to the additional rolling resistance, depicted in Figure A-4, is equivalent to the nose-down moment due to the vertical force ( $Mg$ ) through a more forward centre of gravity position (Figure A-6). So that  $0.13 Mg * 5.35 \text{ (ft)} * 12 \text{ (inches per foot)} = Mg * x$ , where  $x$  is the effective forward movement of the CG. Therefore,  $x$  is 8.35 inches, which is 10.3% MAC.

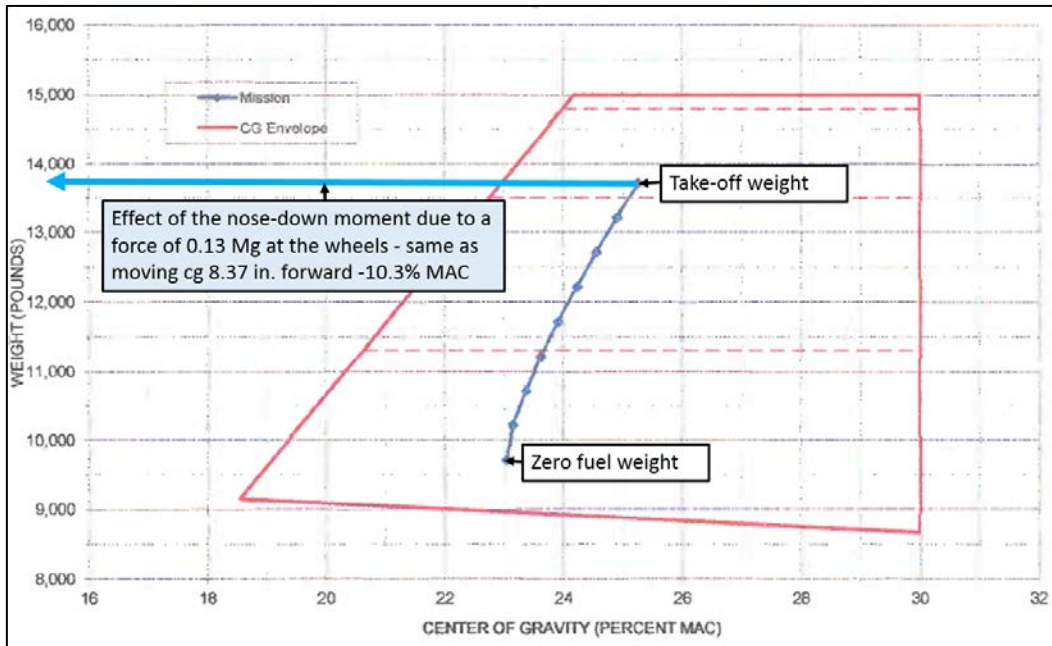
**Figure A-7: Load sheet for VH-FGK showing the accident flight computation of weight and balance from take-off to landing, and the effect of moving the centre of gravity 8.35 inches forward**

The aircraft's load sheet the flight crew prepared for the flight is depicted in Figure A-7. The computed CG was 25.1% MAC at take-off. The most forward allowable at that weight was 22% MAC. Moving the centre of gravity forwards 8.35 inches, or 10.3% MAC, would place the effective centre of gravity over 5 inches forward of the allowable range (and off the chart). In that condition it should be impossible to raise the nose of the aircraft – to rotate on take-off.

Despite achieving full elevator deflection, at the thrust setting and the airspeed when the captain attempted to rotate the aircraft, it was insufficient to overcome the nose-down moment caused by the additional rolling resistance.
