Derailment of freight train 735

Near Colebrook, Tasmania, | 9 November 2014

ATSB Transport Safety Report
Rail Occurrence Investigation
RO-2014-020
Final – 26 July 2016

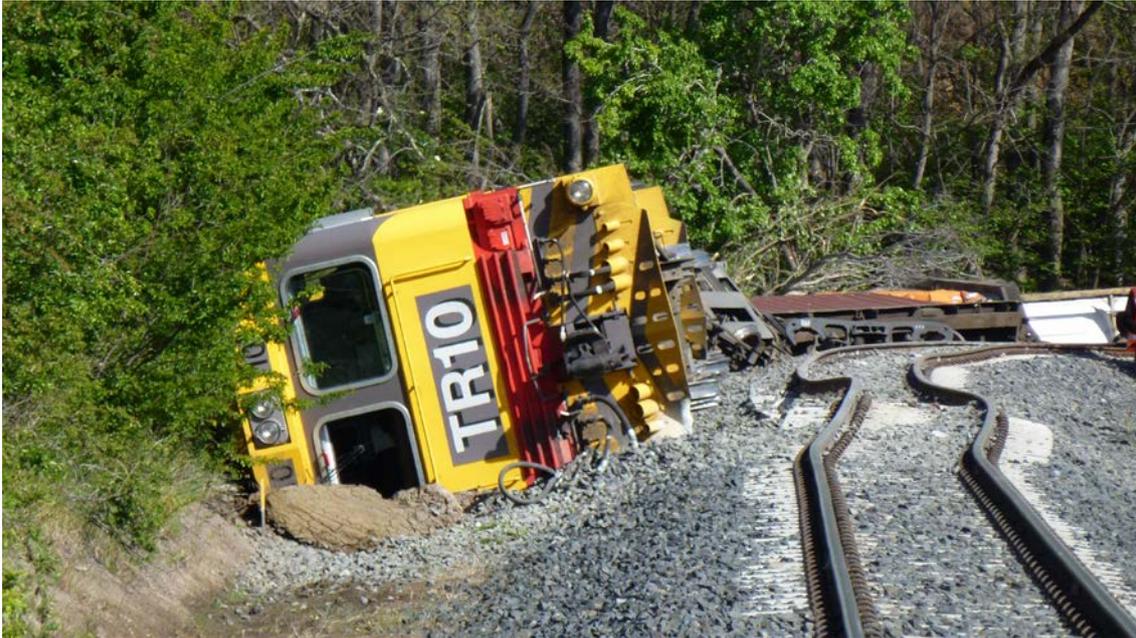
Figure 1: Locomotives TR10 and TR07 with wagons of train 735 at the derailment site

The derailment caused extensive damage to both locomotives, the nine wagons and the track.

As train 735 traversed the curve at speed, it was unable to maintain normal contact with the rail. Consequently, both locomotives and the following four wagons rolled onto their sides and came to a rest in the cess drain on the right hand side of the track. The force generated during the derailment sheared the draft gear of locomotive TR07, which detached it from TR10. That same force also caused locomotive TR07 to uncouple from the rest of the train. At some stage, during the derailment, the train brake pipe was severed which initiated an emergency brake application.

A further five wagons also derailed, but remained within the ballast area of the track formation. Many of the containers from the derailed wagons sustained damage and some were cast down the railway embankment. The remaining seven wagons at the end of the train did not derail and were undamaged.

Image shows the lead locomotive (TR10) and trailing wagons having tipped onto their side after attempting to traverse a left-hand curve. The driver (who sustained minor injuries) was able to exit the locomotive via the front windscreen, which is designed as an emergency exit. Source: ATSB

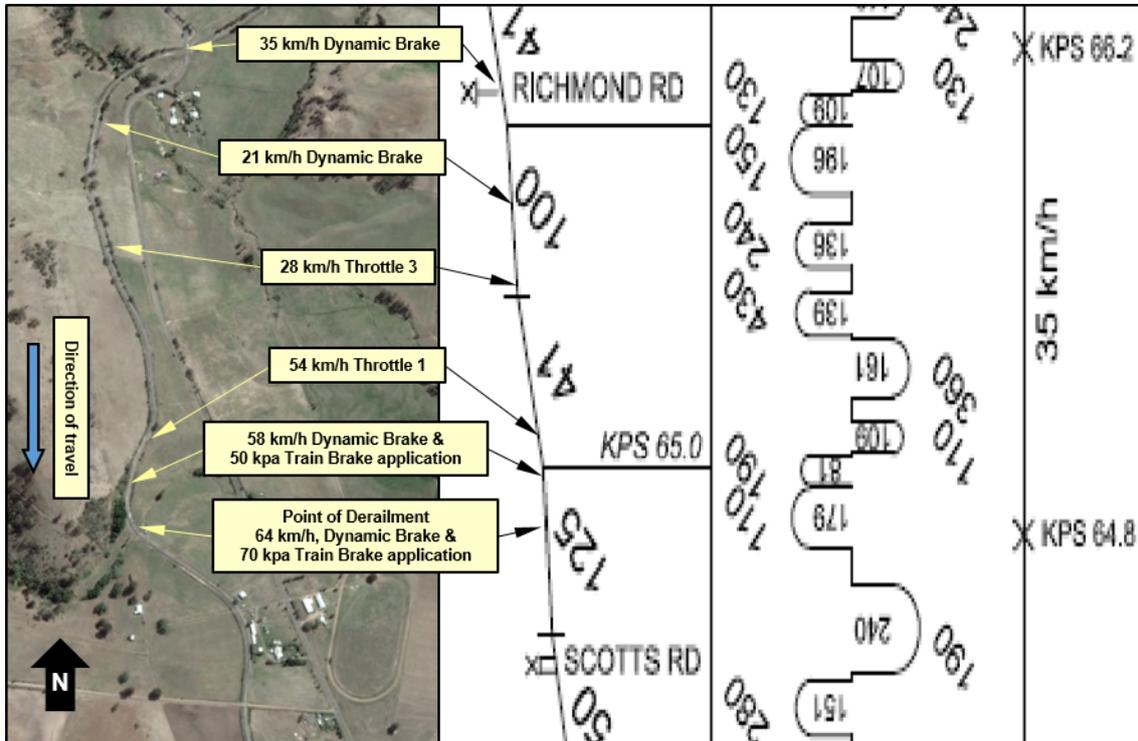
Figure 2: Sequence of events for the derailment of train 735

The image shows an aerial view of the track from Richmond Road (top) and a track geometry graph showing gradient, curvature and posted track speeds. The annotations show driver actions and track speed (obtained from locomotive data loggers) at the key points during the train's descent and subsequent derailment (bottom). Source: Google Earth and TasRail

About 500 m later in its descent, the train travelled through a short section of flat terrain and slowed to 21 km/h. The driver chose to move out of dynamic braking and into throttle position 3 and, in doing so, caused the train to accelerate (Figure 2).

Train 735 accelerated from 21 km/h to 54 km/h over a distance of about 700m, before the driver moved the throttle from position 3 to 1. At 54 km/h, train 735 was travelling at 19 km/h over the maximum allowed track speed and in the midst of a track curve with a 179 m radius. The high train speed combined with the track curve radius significantly increased the risk of derailment.

The train reached a maximum speed of 65 km/h as it exited the compound track curve located at the 64.7 km mark. It was at this location that the wagon immediately behind the locomotives derailed by rolling off the track. The rolling of this wagon transferred forces through the couplers to the locomotives ahead and the wagons immediately following it. This rolling force, in conjunction with the outward centrifugal forces acting on the vehicles themselves allowed both the locomotives and the three wagons following to roll onto their sides and derail to the right hand side of the track on the outside of the curve.
