# Near collision between Fairchild SA227, VH-MYI, and Cessna 150, VH- RZP

31 km N of King Island Airport, Tasmania, 26 February 2016

**ATSB Transport Safety Report**  
Aviation Occurrence Investigation  
AO-2016-017  
Final – 27 July 2016

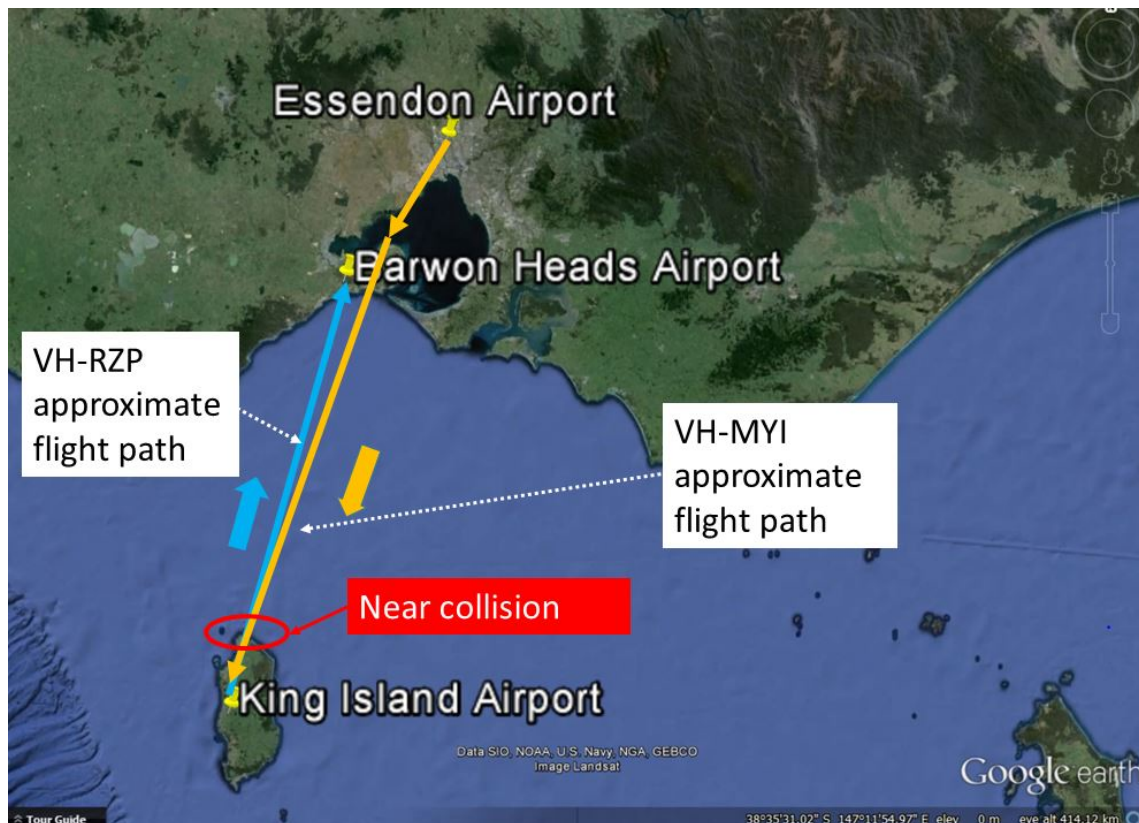
**Figure 1: Approximate flight paths of Cessna 150 VH-RZP and SA227 VH-MYI**

On 28 February 2016 at about 1642 Eastern Daylight-saving Time (EDT), a Cessna 150 aircraft, registered VH-RZP (RZP), departed from King Island Airport, Tasmania, for a flight to Barwon Heads Airport, Victoria (Figure 1). On board were a pilot and passenger.

descent through FL 115.<sup>3</sup> The pilot of RZP responded to this broadcast, and reported RZP's position and their intentions. After a brief radio discussion, the pilot of RZP agreed to advise the crew of Aircraft 2 when RZP was close to the northern coast of the island (Figure 1). The crew of Aircraft 2 had temporarily stopped their descent at 6,500 ft until they could confirm that they had safely passed RZP.
