Flight below minimum permitted altitude involving Cessna 441, VH-EQU

Near Wollongong Airport, New South Wales, 3 August 2015

ATSB Transport Safety Report
Aviation Occurrence Investigation
AO-2015-093
Final

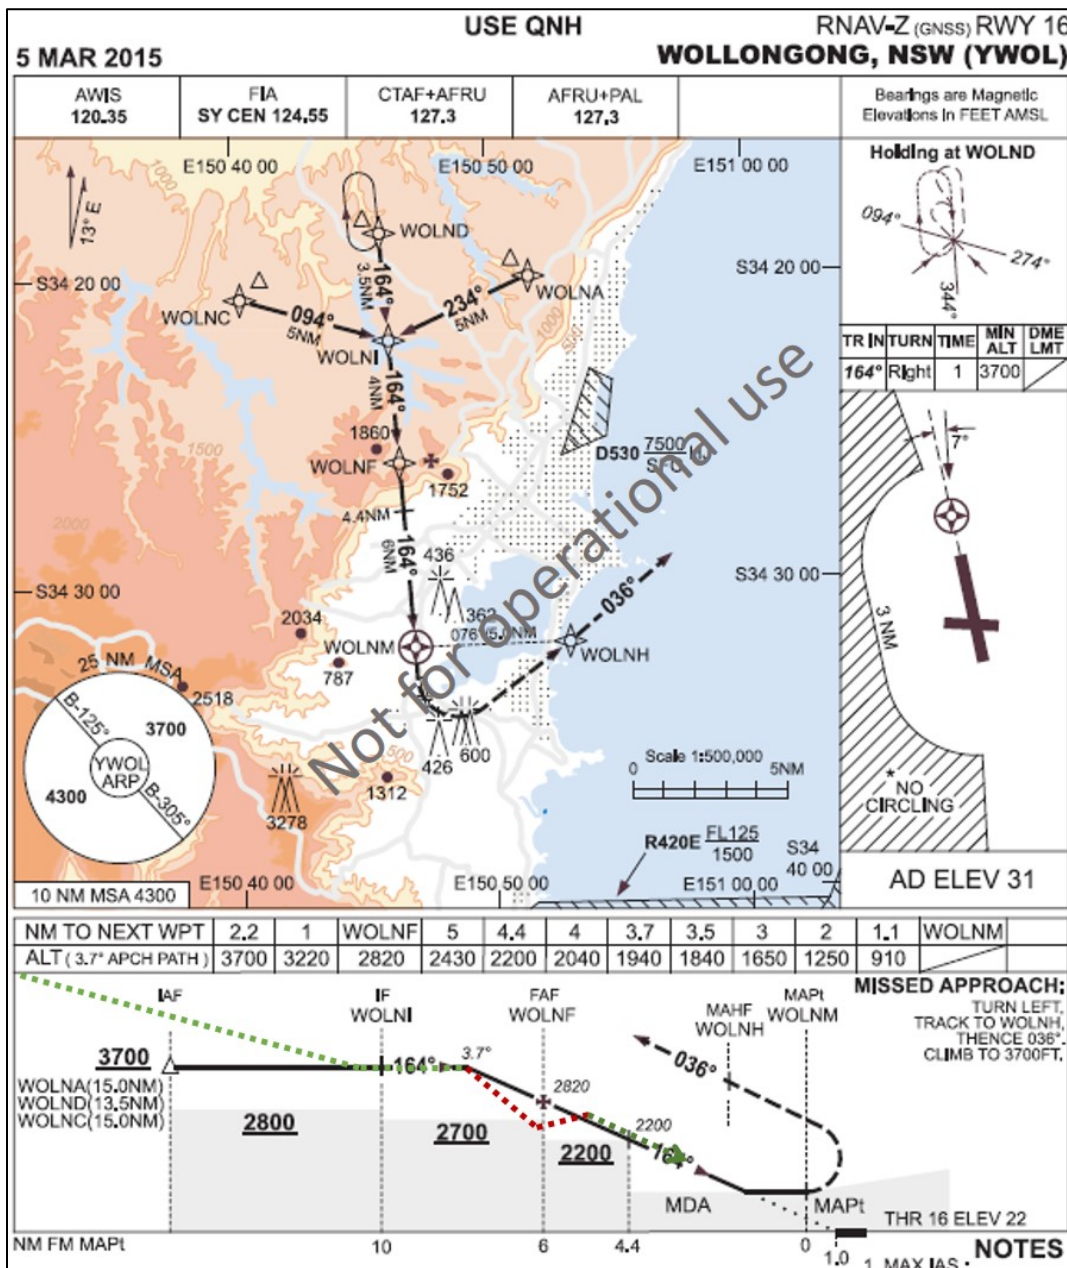
Shortly before WOLNF and as the aircraft approached 2,700 ft, the PM called ‘two thousand seven hundred’ with the expectation that the PF would maintain that altitude until passing WOLNF. However, the descent continued and a few seconds later, the terrain alerting and warning system (TAWS)¹ generated visual and aural ‘CAUTION-TERRAIN’ alerts. These alerts were generated as the system detected that the flight path was projected to come within 300 ft of an obstacle or terrain.

Figure 2: Wollongong RNAV(GNSS) approach to RWY 16 showing approximate flight path profile (green/red dotted line) based on air traffic control surveillance data

The PM believed that when the TAWS alert activated, the aircraft was at an altitude somewhere between 2,600 ft and 2,500 ft and about 0.5 NM before WOLNF. The time between being below 2,700 ft, having the TAWS alert and an appropriate response was less than 10 seconds.

As a result of this occurrence, the aircraft operator has advised the ATSB that all pilots now receive TAWS training.
