Loading irregularity on train 6MC2

near Bowser, Victoria | 24 July 2015

ATSB Transport Safety Report
Rail Occurrence Investigation
RO-2015-013
Final – 19 August 2016

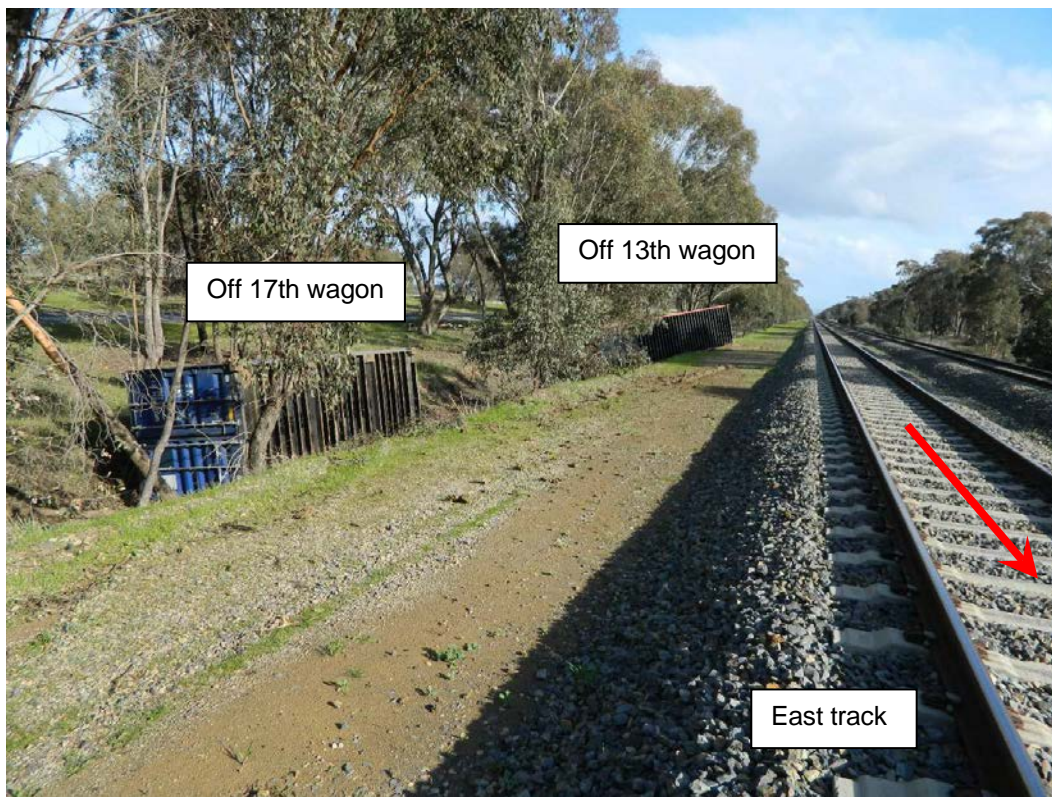
Figure 1: Containers laying adjacent the track

On 24 July 2015, container freight train 6MC2 lost two containers from the train as it passed through Bowser, north of Wangaratta. The two containers lost from the train landed clear of the track on the eastern side. The train continued its journey with the crew unaware of the incident.

At about 0430 on 25 July 2015, the driver of freight train 3PW4 (travelling on the west track) sighted a shipping container lying next to, but clear of, the east track between Wangaratta and Springhurst at the 244.500 track km point. The driver reported the container to the Australian Rail Track Corporation (ARTC) Network Control Centre South located at Junee, New South Wales. The ARTC network control centre warned another following train, XPT passenger train ST21 travelling from Sydney to Melbourne on the east track, to proceed at caution. At 0447, the driver of ST21 confirmed the details and location of the container with the ARTC network control centre.

Note: The blue container in the foreground was located on the 17th wagon. The red container in the background was located on the 13th wagon. The direction of travel shown with a red arrow.
Source: Pacific National

The ARTC arranged to have the track inspected. At about 0634, the inspector arrived on site and discovered a second shipping container near the track. Both containers were clear of the track and normal train running resumed.

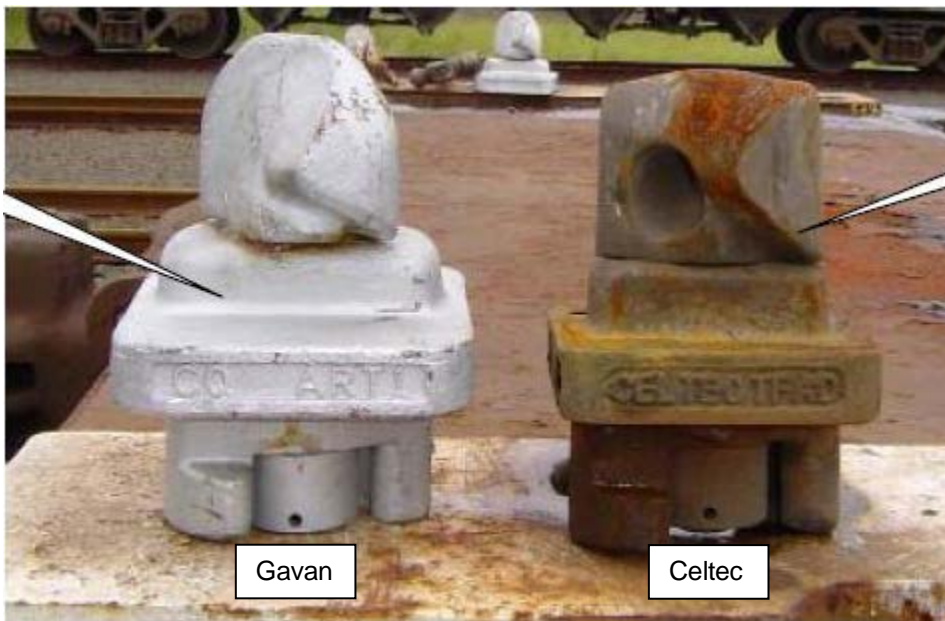
Figure 2: Twist lock types

Patrick Port Logistics (PPL) loaded the two containers that subsequently fell from train 6MC2. PPL also had requirements² for securing containers to rail wagons. These requirements largely reflected the Pacific National (PN) specific requirements. On the day of the incident, PPL used eight automatic twist locks, one on each corner, securing both containers to the rail wagons. PPL used a combination of two Gavan, one Celtec Cel-Lock TFA, and five Celtec Cel-Lock TFAD twist locks, Figure 2 and Figure 4.

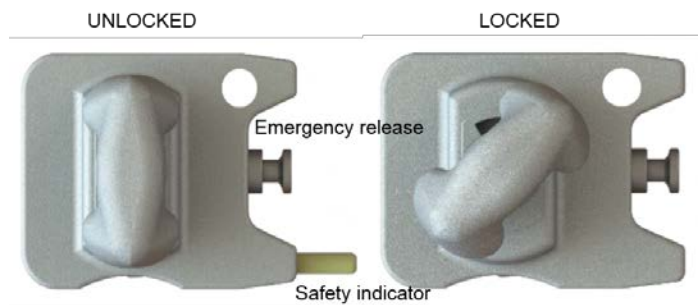
Figure 3: Twist lock engagement

The normal position of an automatic twist lock is in the locked position, Figure 3. When a container is loaded onto a rail wagon the container pocket unlocks the twist lock head. When the container is fully seated, the twist lock head returns to the locked position, securing the container. When a container is unloaded, the lifting action applies sufficient force to unlock the twist lock head and releases the container.

Note: Celtec TFAD type twist lock showing unlocked and locked positions. Source: Celtec.

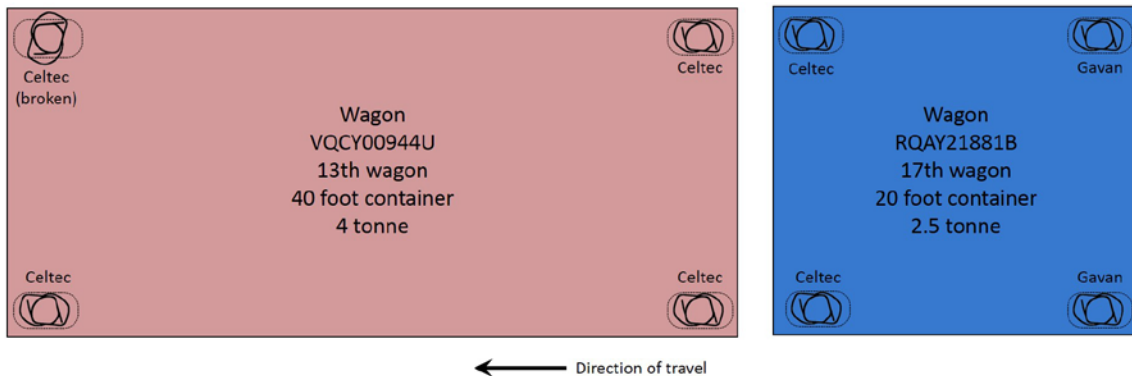
Figure 4: Twist lock layout as found

Following the incident, PN found the twist locks still fastened to the rail wagon. One lock was broken and all others were in the unlocked position, as shown in Figure 4.

Note: Based on 'as found' condition by PN.

All but one twist lock was in open position when collected. 2 X Gavan + 1 X first generation Celtec TFA had broken Emergency Release (See new design Celtec TFAD and TFAE how the house is designed so that ER is not exposed to impact as much as the old TFA). 2 X Celtec TFAD could be returned to activated position. 1 X Celtec TFAD had a broken shaft. The twist locks should not have been in use as they were not activated or could not be activated...

It is concluded that containers MAGU5655514 and MRKU8741873 were able to break free from their respective wagons due to twist locks being in poor condition rendering them completely ineffective.

Based on the condition of the twist locks, and supported by the specialist report, it is very likely that the twist locks were not working prior to the incident. This condition allowed the containers to fall from the train. Given the distance behind the locomotives, dark light condition, and that no other train operational systems were affected, the train crew were not aware of the incident.

- initiate a process to include checks for twist lock operation as part of wagon maintenance and inspection
- develop a twist lock inspection manual
- update freight loading manuals to include methodology for identifying defective twist locks
- update wagon maintenance manual to include methodology for identifying defective twist locks
- update twist lock training materials to include identification of defective twist locks
- initiate a review of twist lock integrity history
- initiate a review of twist locks currently in service – supply and type
- calculate the failure rate of twist locks across the Intermodal fleet for probability and risk mitigation considerations.

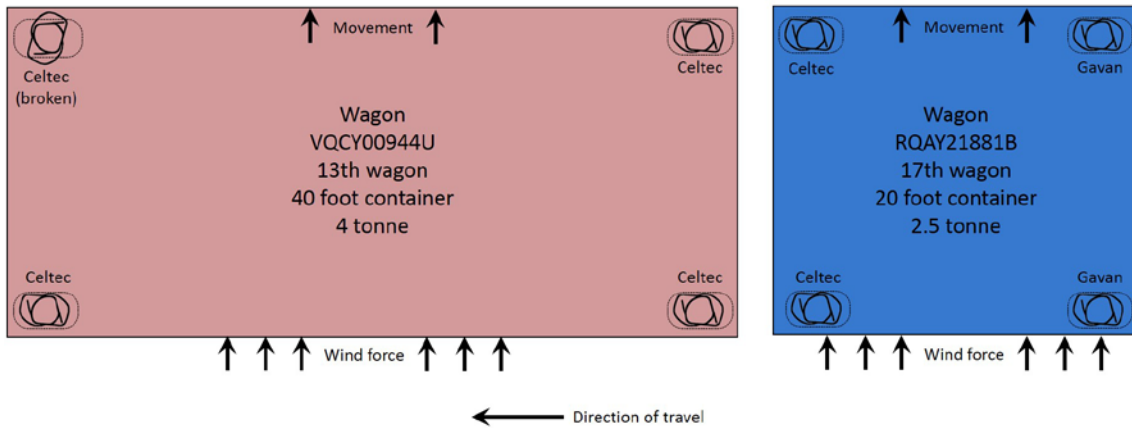
Figure 5: Wind affect

Based on the characteristics of the wagons, a perpendicular wind speed in excess of 160 km/h would be needed to apply sufficient lifting force to unlock the twist locks and tip the containers off. There is no evidence of a weather event in that location generating wind speeds in excess of 160 km/h.

There was no evidence that environmental conditions existed that were severe enough to tip containers, if secured by effective twist locks.

However, considering the post incident condition of the twist locks in this case, it is probable that the weather witnessed by the train crew contributed to the movement of the unsecured containers (Figure 5). Other external forces, such as train and track dynamics, may have also contributed to the movement however, there was no evidence of such contribution.
