# Runway incursion involving Hawker Beechcraft Corporation B200, VH-FDG, and vehicle

Blackall Airport, Queensland, 28 February 2016

**ATSB Transport Safety Report**  
Aviation Occurrence Investigation  
AO-2016-021  
Final – 25 August 2016

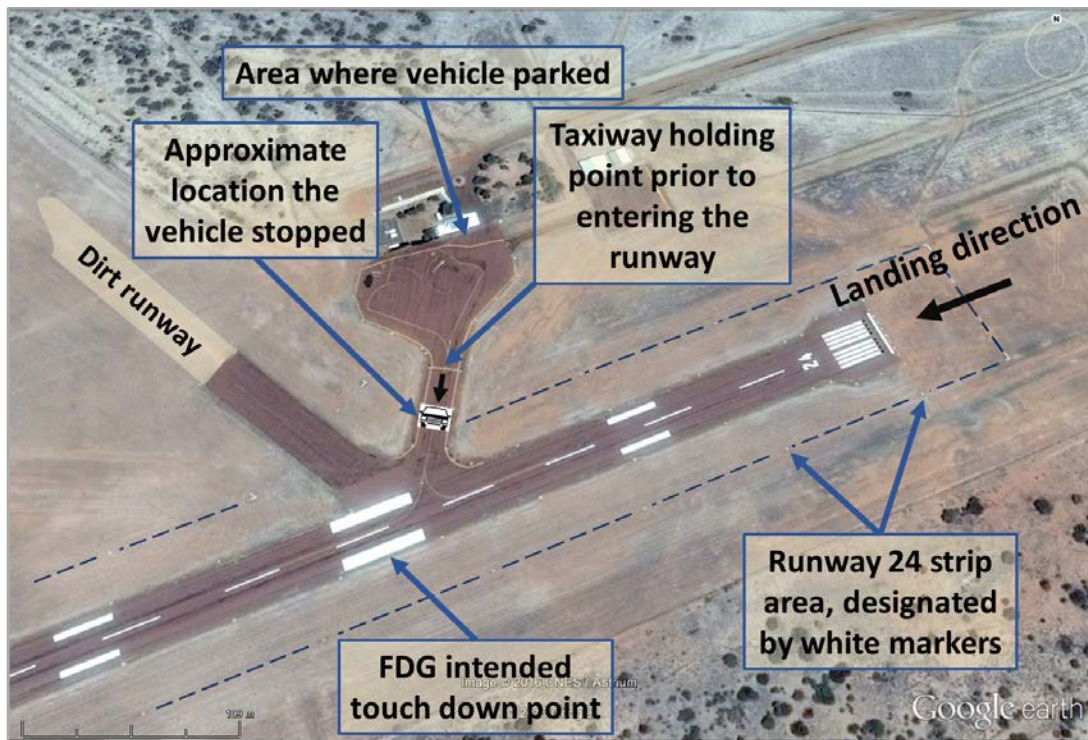
**Figure 1: Blackall airport runway 24**

At about 4.5 NM from Blackall, the pilot noticed the stationary ambulance flashing lights close to the terminal building. The terminal building was located about 90 meters from the runway holding point and about 190 m to the runway centre line (Figure 1).

At about the same time as the pilot initiated a missed approach, the ambulance driver saw the aircraft and stopped the ambulance near the runway white gable markers for runway 24 (Figure 1). The ambulance driver returned the vehicle back to the terminal and parked near the terminal building under the terminal floodlights with the vehicles flashing lights on.
