Aviation Short Investigations Bulletin

Issue 50

ATSB Transport Safety Report
Aviation Short Investigations
AB-2016-088
Final – 25 August 2016

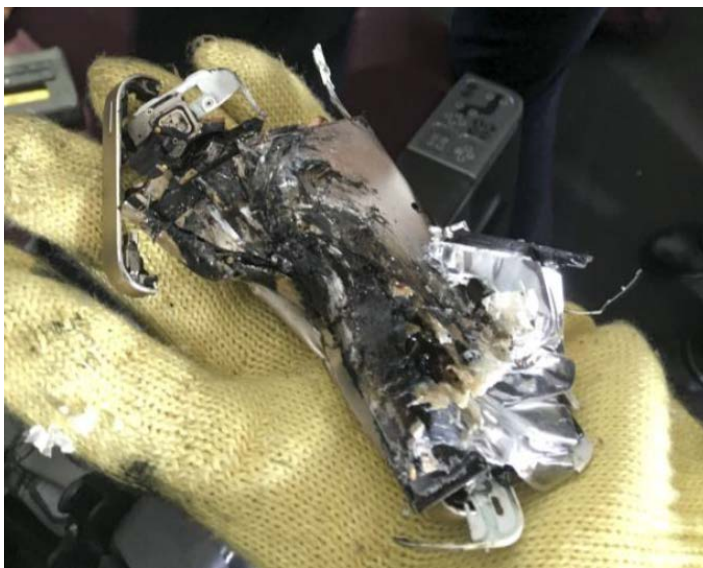
Figure 2: Crushed PED after removal from seat

The cabin crew located the source of the smoke at seat 19F, in Zone F, on the upper deck (Figure 1). The crew removed the seat cushions and covers from seat 19F while the CSM turned off the power to the centre column of the seats. When the seat was further dismantled, the crew found a crushed personal electronic device (PED) wedged tightly in the seat mechanism. The cabin crew assessed that the crushed PED contained a lithium battery.

By that time, the PED was no longer emitting smoke, however, a strong acrid smell remained in the cabin. The crew then manoeuvred the seat and freed the PED (Figure 2). The crew placed the PED in a jug of water, which was then put in a metal box and monitored for the remainder of the flight.

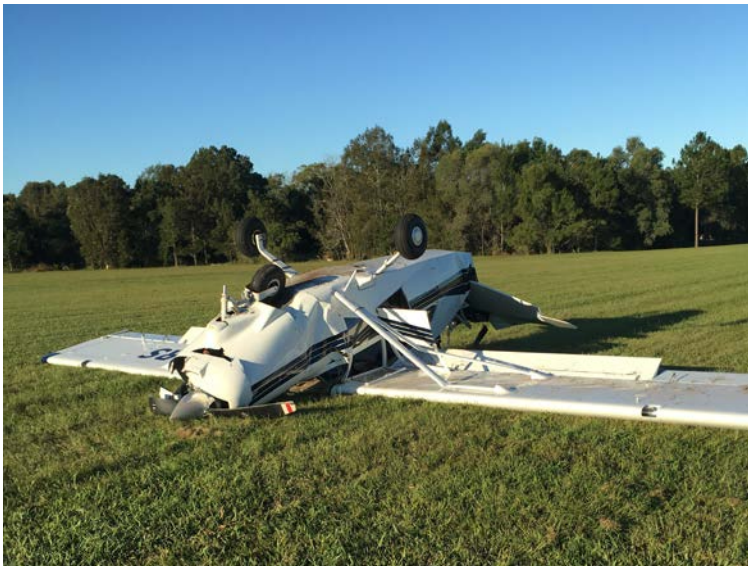
Figure 3: Accident site showing damage to VH-DRS

The pilot flared the aircraft for landing, the aircraft landed heavily and bounced into the air. As the aircraft landed again, the nose wheel touched down first (before the main landing gear) with sufficient force that the nose wheel strut fractured. The nose landing gear and propeller then dug into the ground and the aircraft rotated over its nose and slid a short distance inverted before coming to rest.

The pilot and one passenger were uninjured, the other passenger sustained minor injuries, and the aircraft sustained substantial damage (Figure 1).

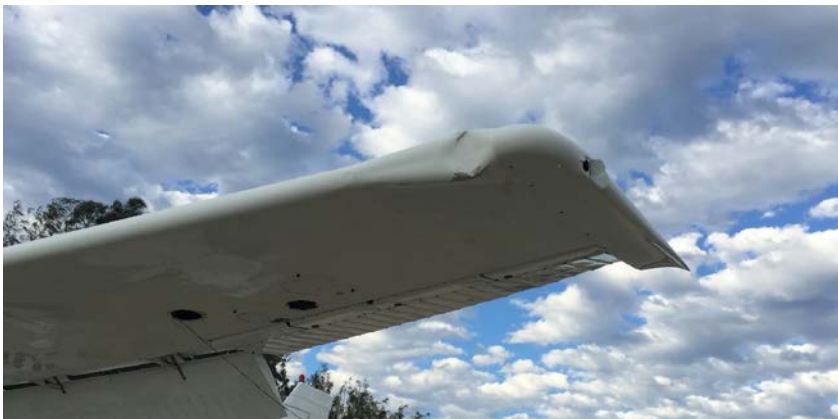
Figure 2: VH-NTK left wing damage

The pilot assessed the condition of the aircraft and elected not to evacuate the passengers. The aircraft was then towed to shore by a jet-ski. There were no injuries and the aircraft was substantially damaged (Figure 2 and 3).

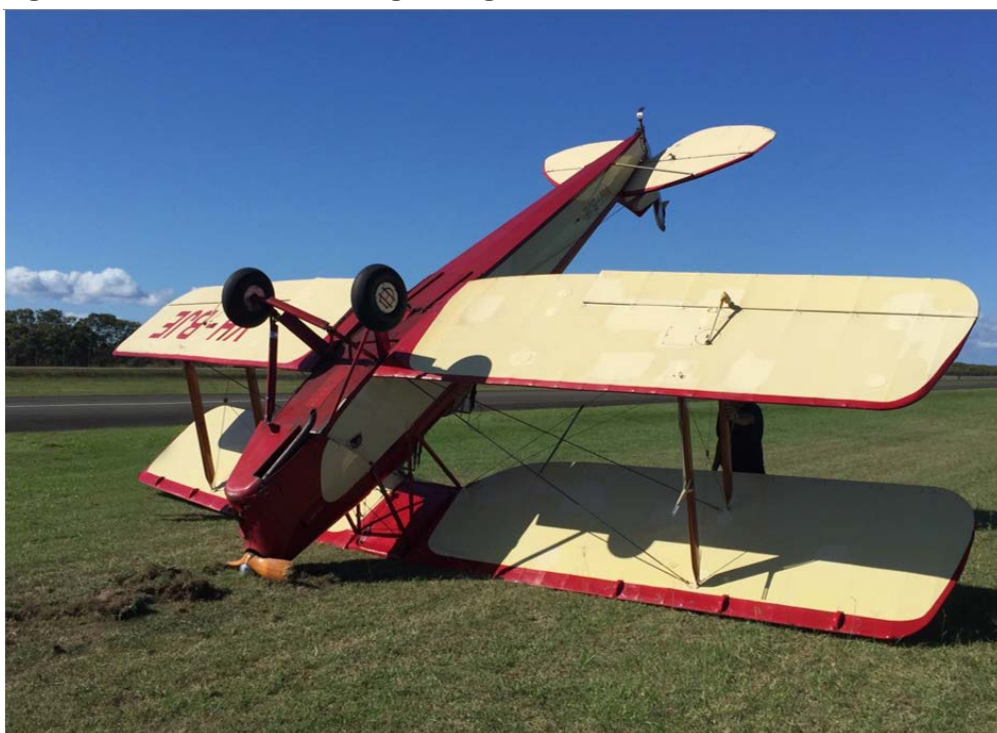
Figure 5: Accident site showing damage to VH-BJE

The pilot and passenger were uninjured. The aircraft sustained substantial damage.

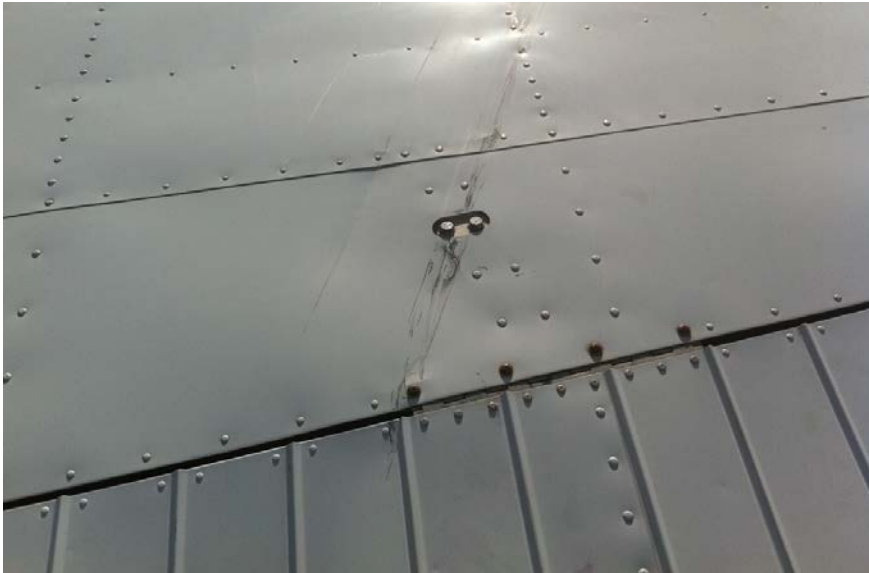
Figure 2: Damage to right wing of VH-SYH

The underside of the left wing of EWZ contacted the top of the right wing of SYH (Figure 2). EWZ came to a stop on the grass to the left of runway 35R. Both aircraft sustained minor damage and the pilots were uninjured (Figure 3).

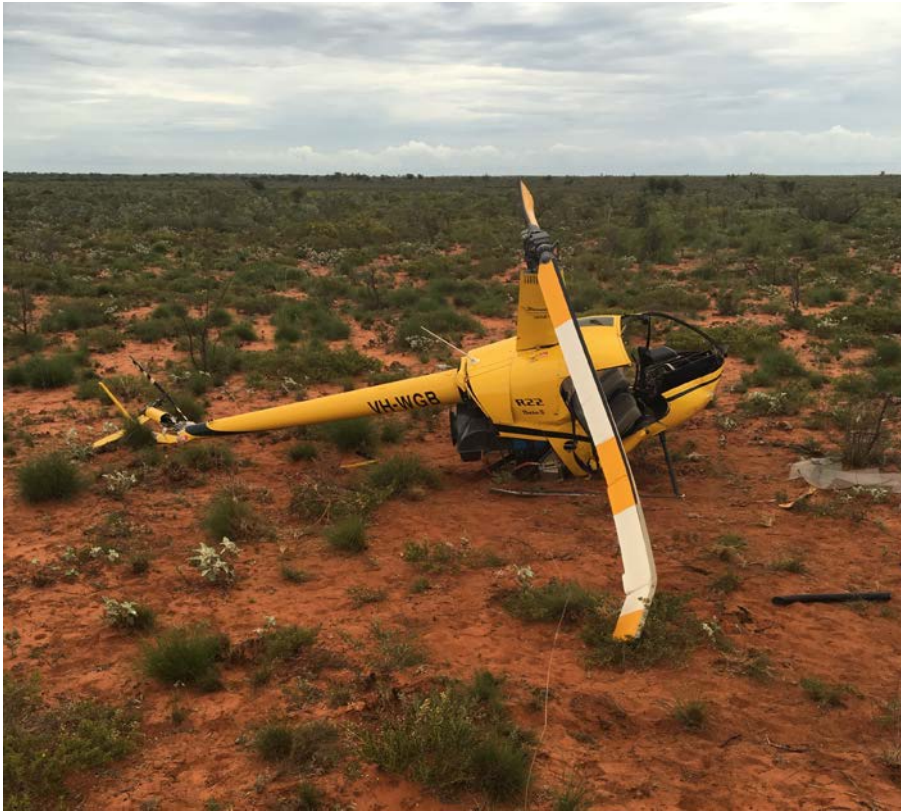
Figure 6: Accident site showing damage to VH-WGB

The helicopter collided with the ground in a level attitude. The helicopter skids and seat collapsed following ground contact. During the accident sequence, the main rotor blades severed the tail boom. The pilot's helmet struck the cyclic and the pilot sustained minor injuries. The aircraft was substantially damaged (Figure 1).

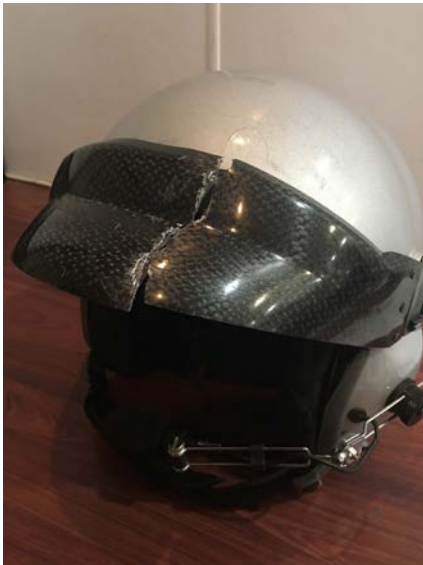
Figure 2: Damage to pilot’s helmet

- the wind was steady at about 15 kt from the south-east with occasional gusts to 20 kt
- the pilot was not sure what the 'kick' was, but thought it was due to the wind
- the pilot did not recognise a low gravity (weightless) situation and may have applied incorrect cyclic technique, resulting in the main rotor striking the tail boom
- the pilot thought that the tail boom was severed shortly after the kick because there was no response from the pedals to counteract the yaw and the helicopter immediately entered a nose down spiral
- the pilot's helmet was damaged during the collision, when it struck and broke the cyclic (Figure 2)
- wearing the helmet probably prevented a more serious injury from occurring.
