Navigation event involving Kavanagh Balloons E-240, VH-VBM

Port Phillip Bay, Victoria, 21 May 2016

ATSB Transport Safety Report
Aviation Occurrence Investigation
AO-2016-052
Final – 25 August 2016

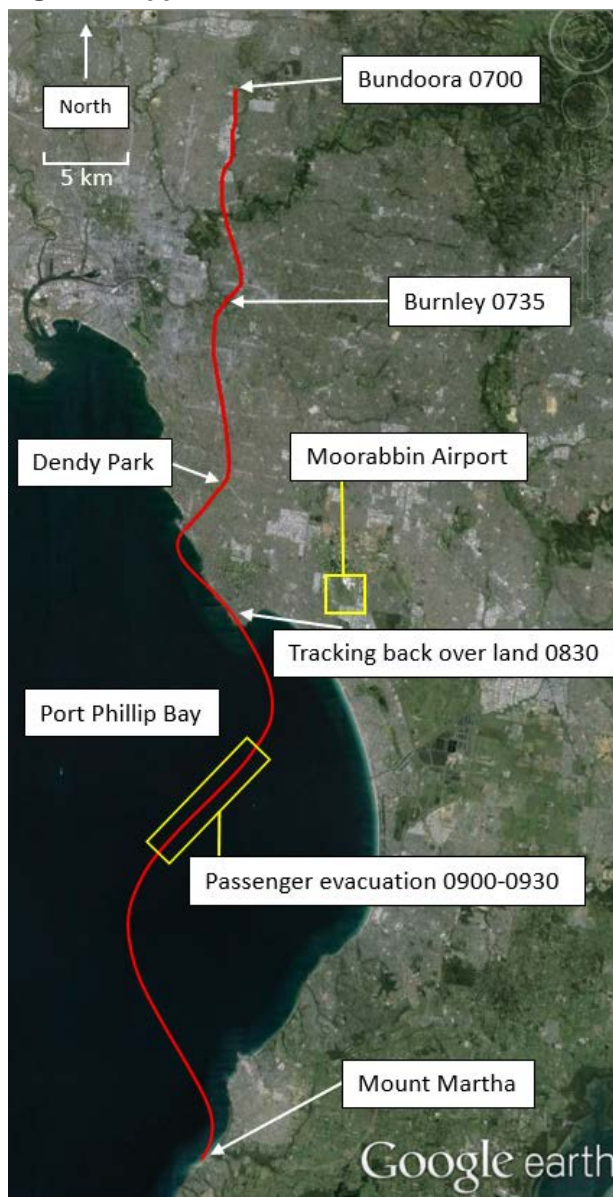
Figure 1: Approximate track of VH-VBM and relevant locations¹

On 21 May 2016, the pilot of a Kavanagh Balloons E-240, registered VH-VBM (VBM), planned to conduct a one-hour scenic flight from Bundoora, Victoria (Vic.) with nine passengers. Prior to commencing the flight, the pilot obtained the relevant weather forecasts and observations. The wind was from the north to north-west at 5 to 10 kt. The pilot therefore assessed the balloon would track in a southerly direction and nominated potential landing sites at Burnley and Dendy Park in Brighton (Figure 1).

At about 0700 Eastern Standard Time (EST), the balloon departed Bundoora in company with five other balloons. About 35 minutes later, the balloon arrived overhead Burnley. The pilot of VBM elected to continue to Dendy Park, along with another balloon from the same operator, to extend the flight to one hour. At that time, the pilots of four other balloons, which had been operating in company with VBM, elected to climb into a more westerly wind to track to Moorabbin Airport, Vic.

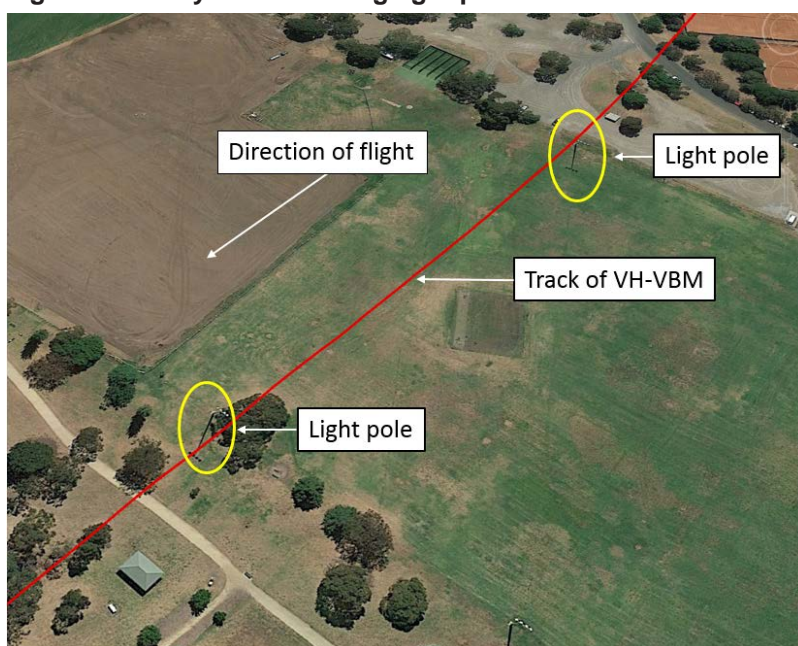
Figure 2: Dendy Park showing light poles

At about 0800, the balloon in company with VBM landed safely at Dendy Park. The wind speed was about 10 kt as VBM approached Dendy Park. As the balloon descended to land, the pilot sighted a light pole directly in the balloon's path (Figure 2). The pilot then lit the balloon's burners to climb over the pole, however, a second light pole stood directly in the balloon's path on the far side of the available landing area. Due to the balloon's height and the wind, the pilot assessed that the balloon may collide with the second pole if the pilot attempted a landing and therefore elected not to land in the park.

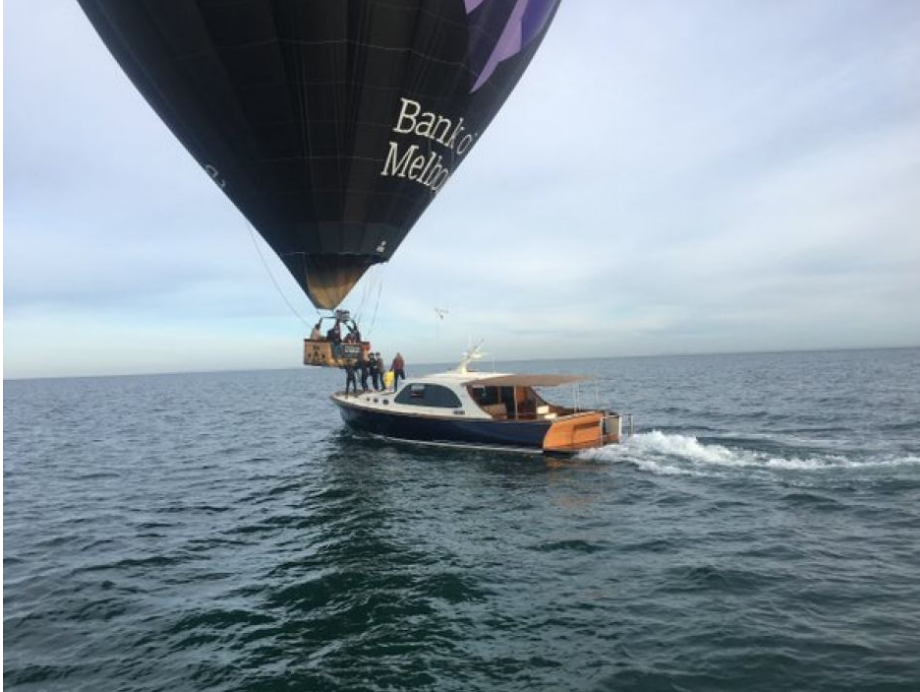
Figure 3: Evacuation of passengers from VBM to vessel

At about 0845, the pilot established contact with the crew of a nearby vessel. The pilot coordinated with the crew of the vessel to arrange the evacuation of passengers. The passengers evacuated one or two at a time onto the vessel over the next 30 minutes (Figure 3).
