Near collision involving Morgan Cheetah, 19-5456, and Grob G115, VH-ZTA

15 km NW of Serpentine (ALA), Western Australia, 15 April 2016

ATSB Transport Safety Report
Aviation Occurrence Investigation
AO-2016-038
Final – 8 September 2016

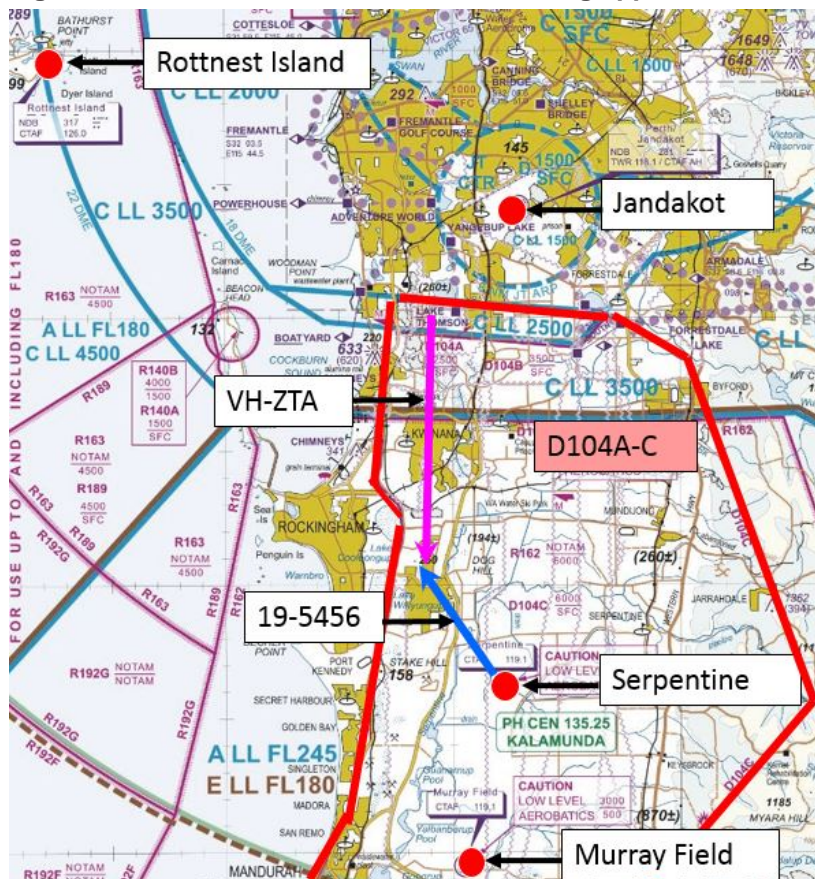
Figure 1: Perth Visual Terminal Chart showing approximate aircraft tracks

On 15 April 2016, an instructor and student of a Grob G115C2 aircraft, registered VH-ZTA (ZTA), were conducting a local training flight in the training area south of Jandakot Airport, Western Australia. The training area was marked as a danger area¹ on the Perth Visual Terminal Chart (Figure 1). It was the student’s first flight in the training area, and the instructor was briefing the student and identifying landmarks including the two aerodromes situated in the training area – Serpentine and Murray Field. The two aerodromes shared a common traffic advisory frequency (CTAF), and the instructor advised the student to broadcast on the CTAF stating the aircraft’s position and intentions when approaching 10 NM from either aerodrome, again when at 5 NM and also overhead.
