Near collision involving Pacific Aerospace CT4, VH-YCO, and Piper PA-28, VH-WJZ

24 km NW of Gunnedah Airport, New South Wales, 15 April 2016

ATSB Transport Safety Report
Aviation Occurrence Investigation
AO-2016-035
Final – 8 September 2016

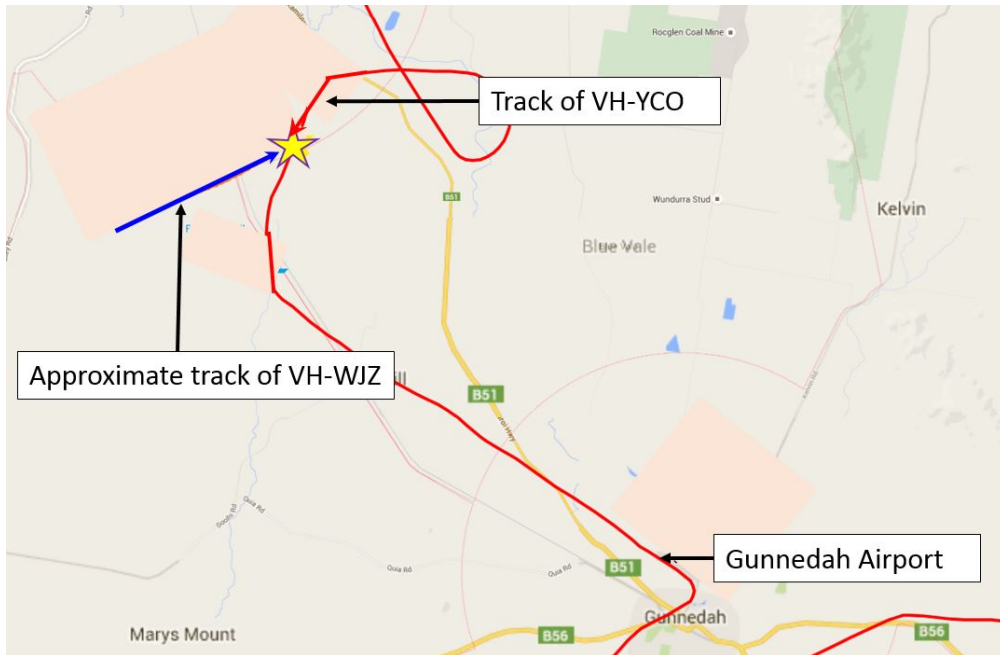
Figure 1: Recorded track of VH-YCO, approximate track of VH-WJZ, and approximate location of near collision

At about 1450 Eastern Standard Time (EST), YCO was 13 NM north-west of Gunnedah on the RNAV approach for runway 11, and at 4,500 ft above mean sea level (AMSL), when they were alerted by the aircraft's traffic collision avoidance device³ of another aircraft. The device indicated that the other aircraft was 200 ft below them and 2 NM away. The instructor looked south and within 20 seconds sighted WJZ at the same level. The instructor took control of the aircraft from the student, and conducted a 60° angle of bank turn to the left to avoid WJZ.

The instructor of WJZ sighted YCO when about 13 NM north-west of Gunnedah aerodrome at about 4,000 ft AMSL. YCO was then to their north in their 2 o'clock⁴ position. The instructor of WJZ conducted a left turn and reported sighting YCO commence a left. The aircraft passed at the same level about 150 to 200 m horizontally apart.
