Aviation Short Investigations Bulletin

Near collision special edition

Issue 51

AB-2016-085

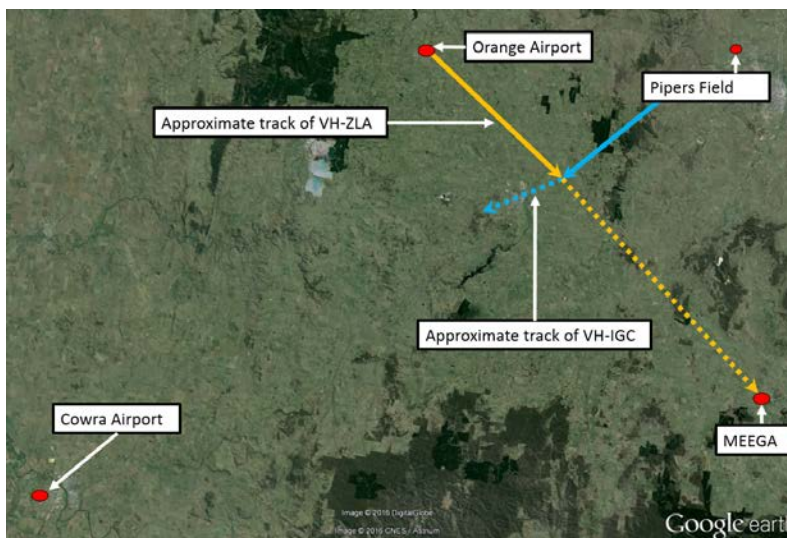
Figure 1: Approximate aircraft tracks and relevant locations

As the aircraft climbed through 2,000 ft above ground level, the first officer initiated a slight right turn onto the departure track of 123° to track towards the waypoint 'MEEGA'. The captain broadcast a departure call on the CTAF and then contacted air traffic control (ATC) on Melbourne Centre frequency, and in response received a clearance to enter controlled airspace. The lower limit of Class E airspace in this area was 8,500 ft AMSL.

When climbing through about 6,000 ft AMSL, the first officer saw a build-up of cumulus cloud ahead, and asked the captain to request a clearance to track 5 NM right of track to remain clear of it. As the captain started to read back the amended clearance from ATC, the aircraft was climbing through about 7,500 ft. The captain sighted the glider (IGC) ahead, just below the cloud base, and assessed there was a risk of collision. The captain immediately took control of the aircraft from the first officer, disconnected the autopilot and lowered the nose of the aircraft to ensure it passed below the glider. The flight crew estimated that the glider passed within about 100 m of the aircraft.

The glider IGC was descending through 8,560 ft AMSL, and 11 NM from Orange Airport, when the pilot of IGC sighted ZLA in their 3 o'clock position and climbing towards them. The pilot of the following glider also alerted the pilot of IGC to the aircraft on their discrete glider frequency. The pilot of IGC assessed that while ZLA was on a direct track towards IGC, due to its climb rate there was no risk of collision, and elected to continue on their current track. The pilot of IGC estimated that ZLA passed about 200 m below the glider.

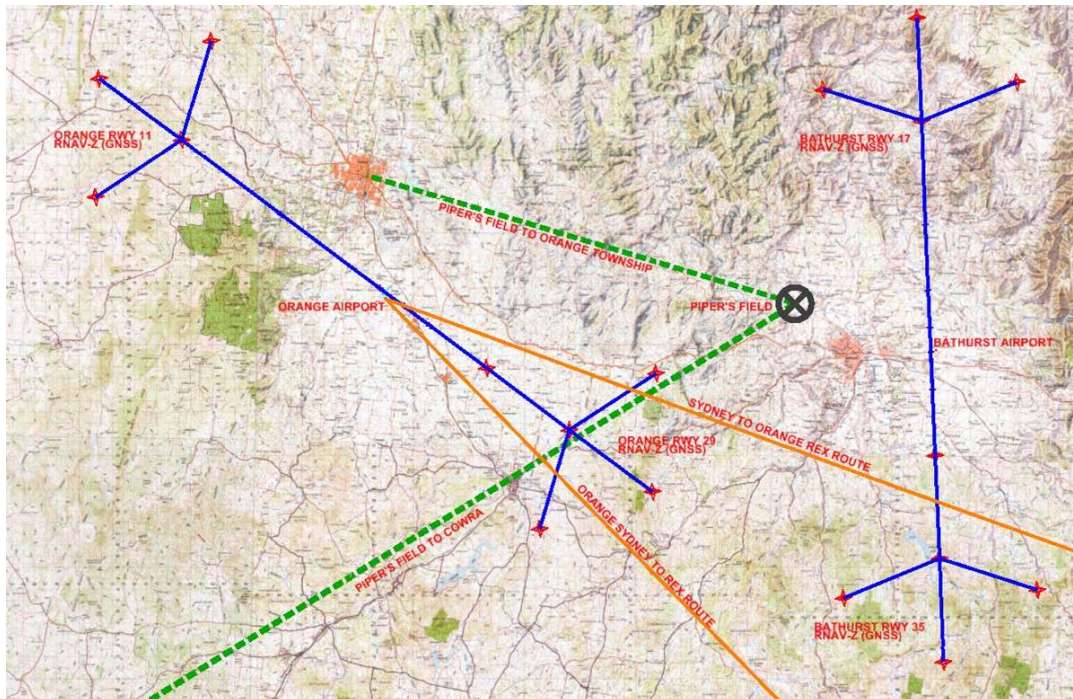
Figure 2: Regional Express Orange and Bathurst tracks relative to Pipers Field

Regional Express had special procedures to assist in maintaining separation with gliders for aircraft operating in the vicinity of Bathurst, NSW, and Narromine, but at the time of the incident, not for Orange. Orange had not been identified as a gliding location, unlike Bathurst and Narromine. These were published in the company's route manual, which detailed normal and special requirements of every aerodrome they operate into. The waypoints and tracks used for approaches to Bathurst, the location of Pipers Field aerodrome, and tracks to be avoided were published in the En Route Supplement Australia entry for Bathurst under Flight procedures.

The special procedures for Bathurst advised of a large amount of glider activity in the Pipers Field area. It stated that the VHF frequency the gliders use was 122.7. It included a map depicting preferred tracking from Bathurst to avoid Pipers Field, and which tracks to be avoided.

Due to increased glider traffic to the East of Orange it is recommended that if operationally possible a broadcast on 122.7 be made prior to top of descent and/or prior to taxi at Orange.

It would be very helpful if the gliders could maintain a listening watch on the Orange CTAF frequency when in the vicinity of the possible areas of conflict, so that we could have 'alerted see and avoid' separation.

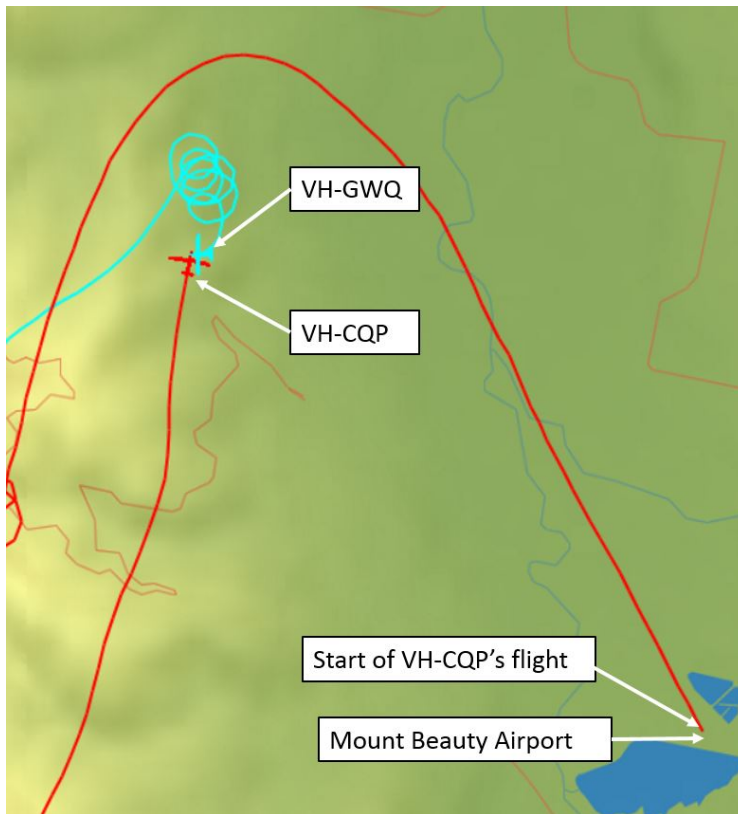
Figure 1: Relative tracks of gliders VH-GWQ and VH-CQP and positions at 1355:02

On 28 March 2016, at about 1306 Eastern Daylight-saving Time (EDT), a Schempp-Hirth Janus glider, registered VH-GWQ (GWQ) launched from Porepunkah Airfield, Victoria, for a pleasure flight. On board were two pilots. The pilot seated in the rear seat was the pilot in command for the flight. The glider tracked over Simmons Gap, to a ridge about 3 km north-west of Mount Beauty Airport (Figure 1). The pilots could hear and see other gliders being towed onto the ridge. They joined a thermal¹ and climbed in tight orbits ('thermalling') in a clockwise direction.

At about 1335, the pilot of a Rolladen-Schneider LS3-A glider, registered VH-CQP (CQP), launched from Mount Beauty Airport, Victoria, for a pleasure flight. At about 1355, the glider was 3 to 4 km north-west of the airfield and descending through about 4,000 ft, when the pilot heard an alarm sounding, but did not identify it as issuing from the FLARM collision avoidance system (see *FLARM* below) fitted to the glider. The glider was tracking to the north, and the pilot reported that

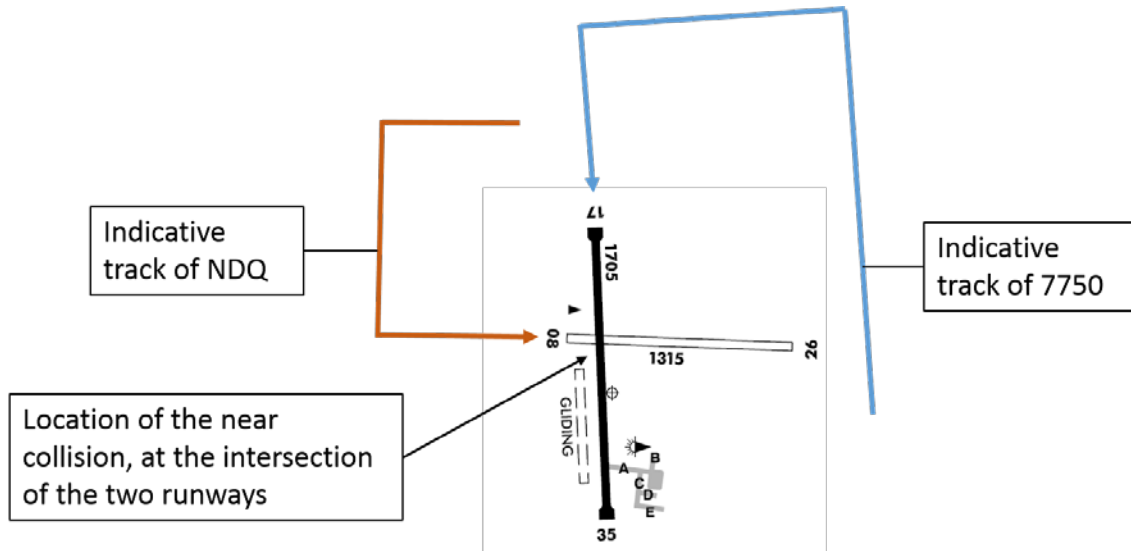
Figure 1: Layout of Bathurst aerodrome showing indicative tracks of 7750 and NDQ

The instructor in 7750 lost sight of NDQ as it passed overhead. As 7750 accelerated with a high power setting, the instructor elected to continue the take-off. The pilot of 7750 then conducted a circuit before landing safely.

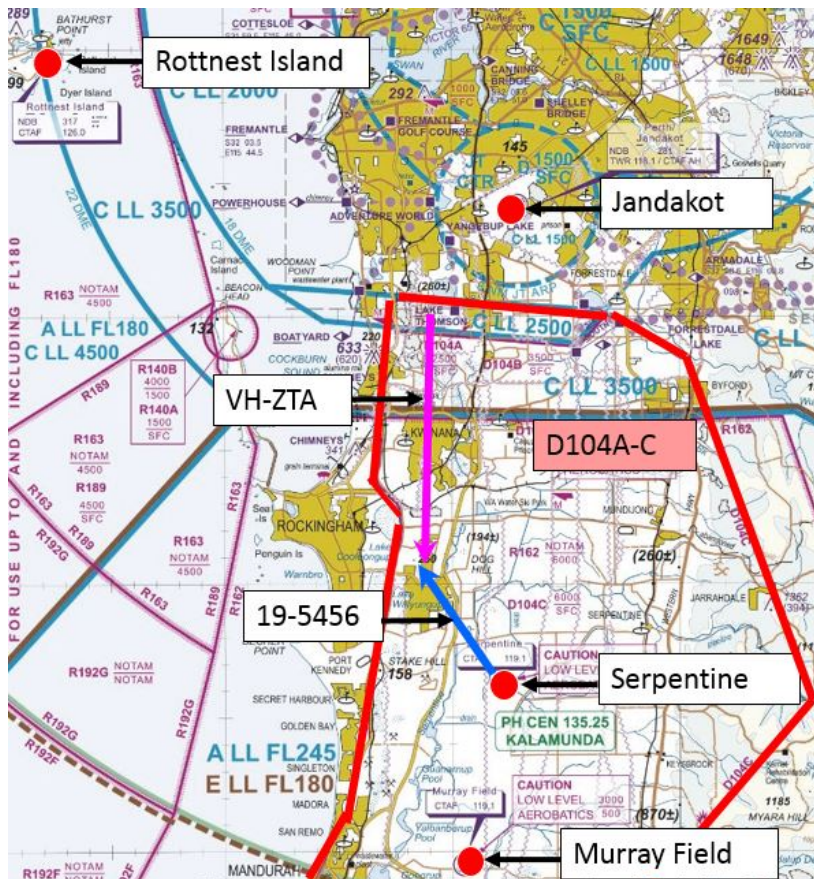
Figure 1: Perth Visual Terminal Chart showing approximate aircraft tracks

On 15 April 2016, an instructor and student of a Grob G115C2 aircraft, registered VH-ZTA (ZTA), were conducting a local training flight in the training area south of Jandakot Airport, Western Australia. The training area was marked as a danger area¹ on the Perth Visual Terminal Chart (Figure 1). It was the student's first flight in the training area, and the instructor was briefing the student and identifying landmarks including the two aerodromes situated in the training area – Serpentine and Murray Field. The two aerodromes shared a common traffic advisory frequency (CTAF), and the instructor advised the student to broadcast on the CTAF stating the aircraft's position and intentions when approaching 10 NM from either aerodrome, again when at 5 NM and also overhead.

When ZTA was north-west of Serpentine aerodrome and tracking south, the instructor broadcast that they were 10 NM from Serpentine at 2,500 ft and intended to pass abeam the aerodrome tracking south. The instructor then heard the pilot of another aircraft broadcast that they were departing Murray Field tracking north at 3,000 ft, and another pilot broadcast that they were near

Insufficient communication between pilots operating in the same area is the most common cause of safety incidents near non-controlled aerodromes. [CAAP 166-1\(3\)](#) provides advice in relation to making radio broadcasts to reduce the risk of coming in close proximity with other aircraft.

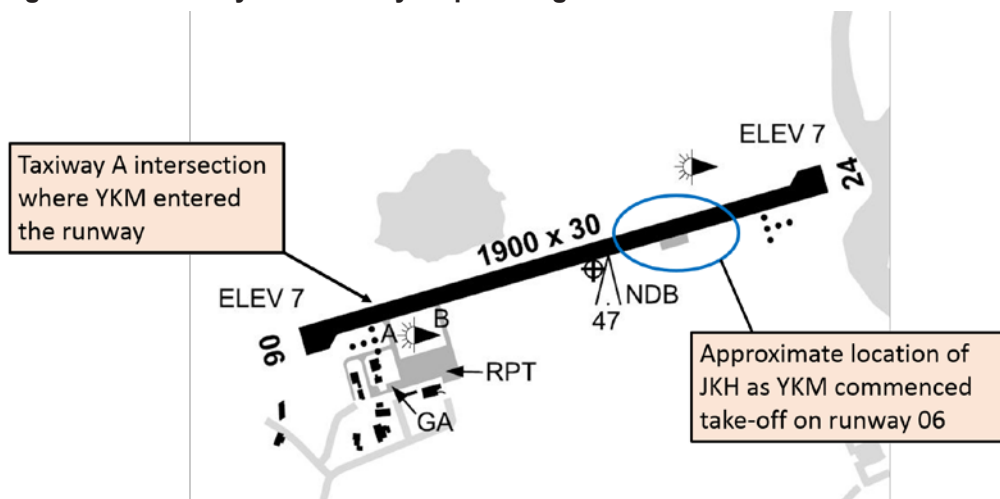
Figure 1: Ballina Byron Gateway Airport diagram

The pilot of YKM later found that although the aircraft radio was on, and was set to the CTAF, the radio microphone was not fully plugged in. In this condition, none of their broadcasts on the CTAF had been successfully transmitted.¹ The pilot of YKM had not heard any broadcast from JKH and did not see the helicopter on the runway, despite checking to see that the runway was clear before entering.

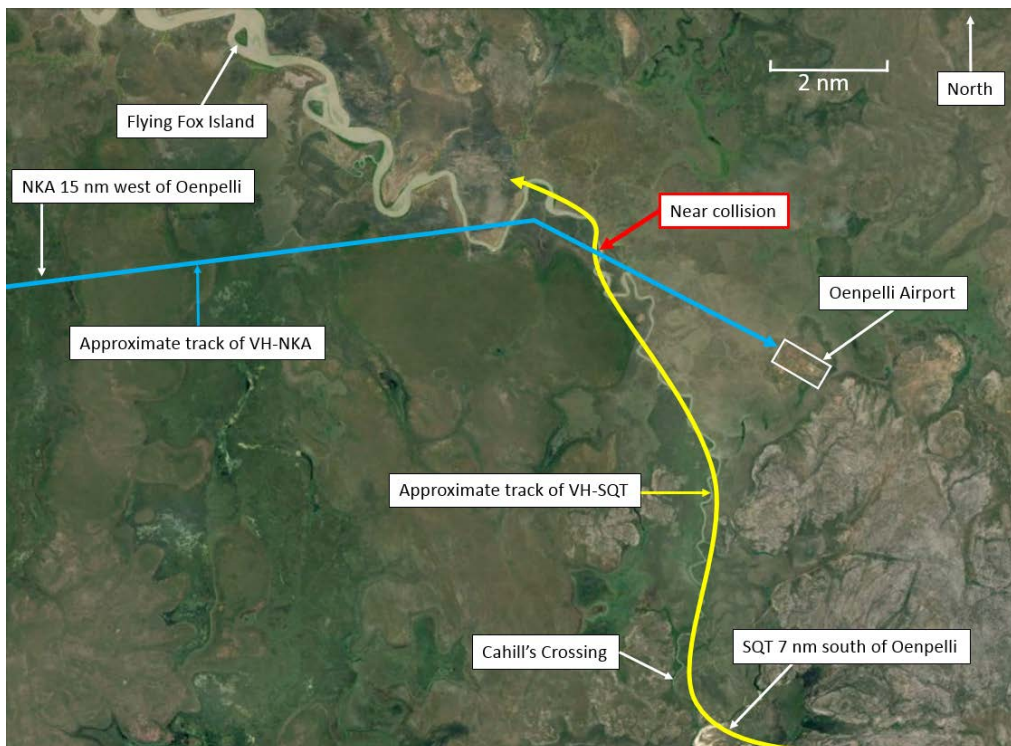
Figure 1: Overview of incident location

At about 0930, the PF in NKA assessed the expected weather conditions at Oenpelli and elected to make a straight-in² approach to runway 12. At this time, the PF made an inbound broadcast on the Jabiru-Oenpelli common traffic advisory frequency (CTAF), advising their position as 50 NM west of Oenpelli. The PF then descended the aircraft from the cruising altitude of 9,500 ft and made a further broadcast on the Jabiru-Oenpelli CTAF as the aircraft reached 15 NM from Oenpelli. The pilots of NKA received no response to these broadcasts.

At 0952, the PF in NKA established the aircraft on a 5 NM final approach leg to the runway at Oenpelli Airport at an altitude of 1,000 ft and configured the aircraft for landing. At the same time, the pilot of SQT continued to follow the East Alligator River north making continuous shallow turns left and right to maximise their passenger's view. As SQT began a right turn, the pilot observed the shadow of another aircraft (subsequently determined to be NKA) tracking towards the shadow of their own aircraft. The pilot of SQT continued the right turn and assessed the position of the sun in relation to the shadow on the ground to establish the position of NKA. The pilot of SQT sighted NKA in close proximity and instinctively descended the aircraft to avoid a collision.
