# Aviation Short Investigations Bulletin

Issue 46

**ATSB Transport Safety Report**  
Aviation Short Investigations  
AB-2015-148  
Final – 28 January 2016

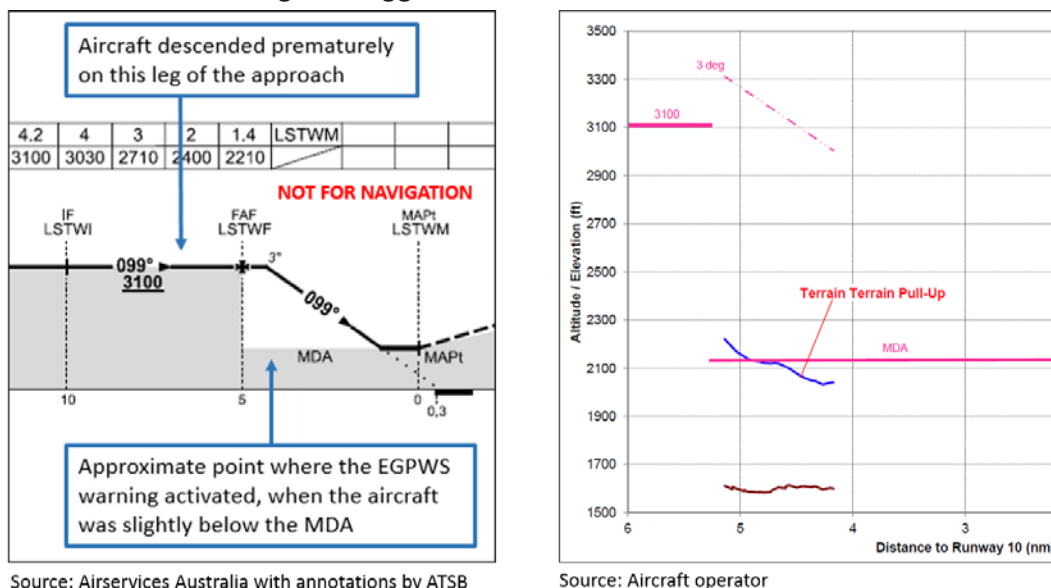
**Figure 6: Excerpt from approach chart and vertical profile of the aircraft (in part) showing where EGPWS warning was triggered**

During the RNAV (GNSS) approach to runway 10 at Leinster, the crew received an EGPWS ‘terrain terrain pull-up pull-up’ warning. They responded to that warning by commencing a missed approach. At the time the crew received the EGPWS warning, they were clear of cloud and could see the ground beneath, but there was wispy low cloud ahead, partially obscuring their view of the runway environment. The crew were assessing the conditions ahead, and the feasibility of safely continuing the approach, when the EGPWS warning activated. The crew elected to make a missed approach with go-around power, rather than conduct a terrain escape manoeuvre,<sup>13</sup> given that the missed-approach flight path of the aircraft was visually clear of terrain and obstacles.

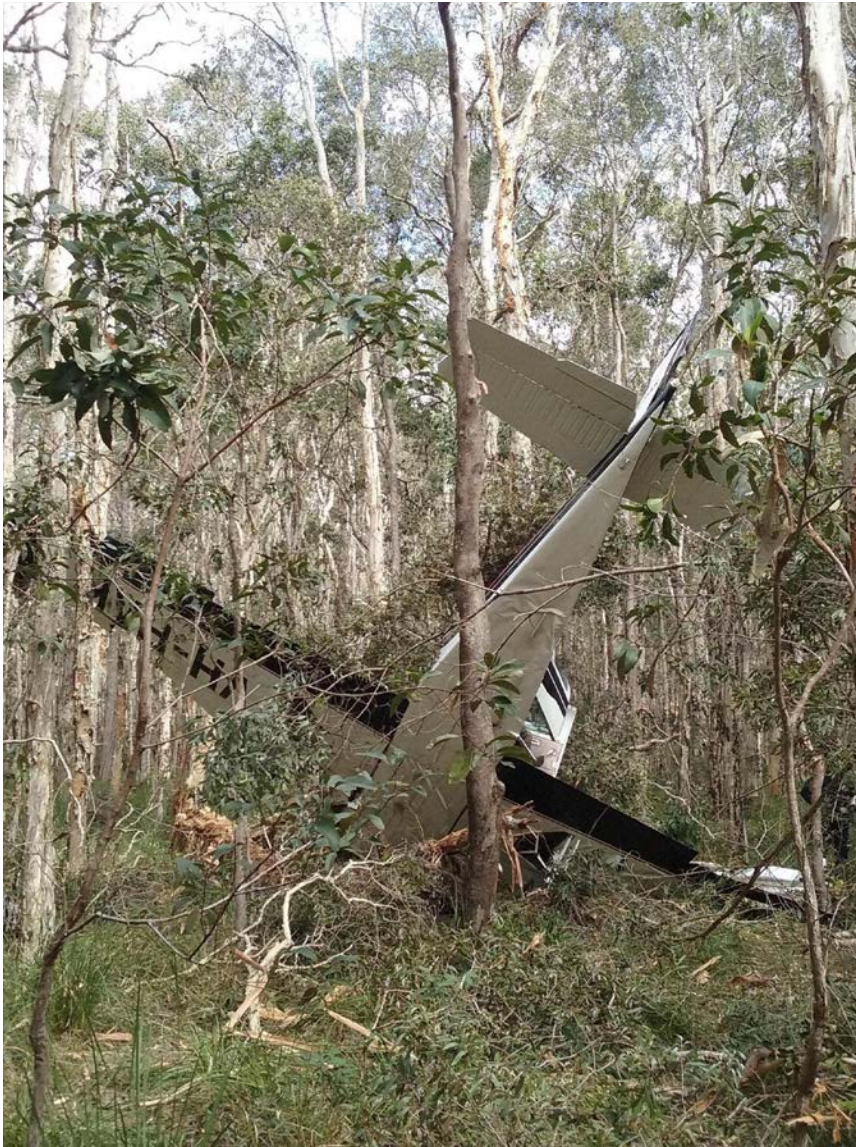
**Figure 2: Beech A36 aircraft, VH-PAK accident site**

About 800 m from the runway threshold, at about 150 ft above ground level, the aircraft's engine stopped. The pilot broadcast a Mayday<sup>1</sup> and conducted a forced landing (Figure 1). The aircraft collided with trees, resulting in substantial damage and the pilot was not injured (Figure 2).

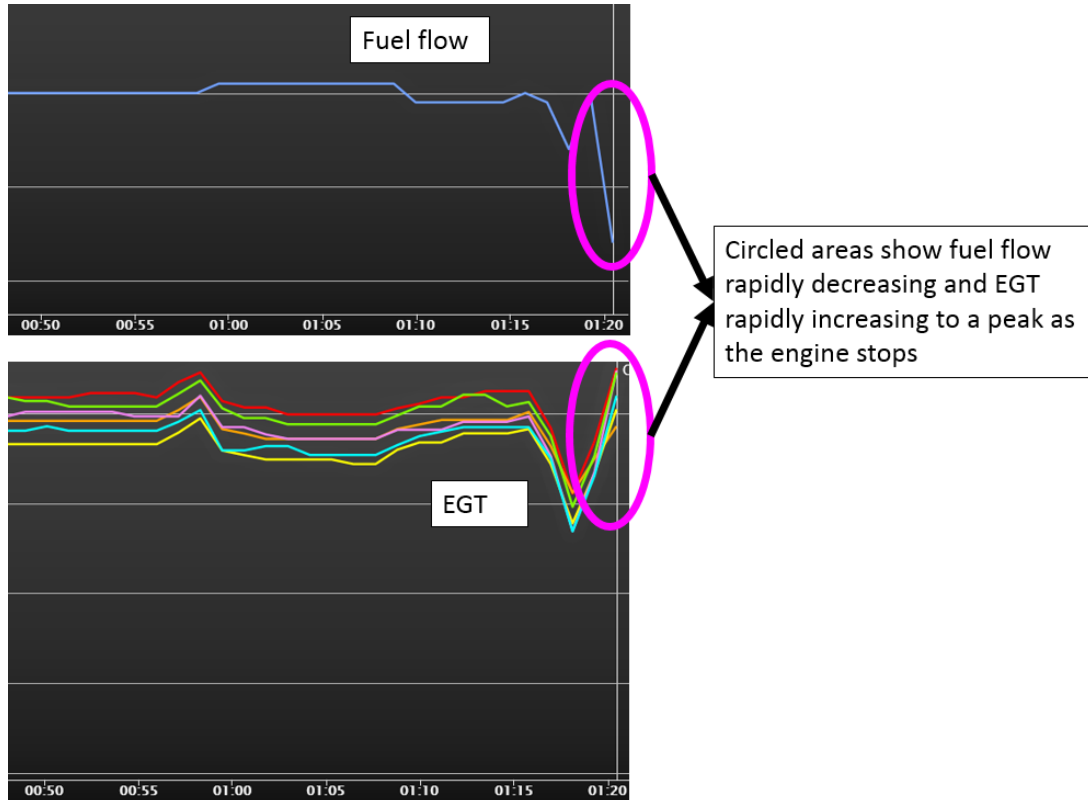
**Figure 3: Engine data**

The aircraft’s engine data was reviewed for the flight. Figure 3 shows the recorded exhaust gas temperatures (EGT) and fuel flow for the flight. During the cruise, the fuel/air mixture was leaned to achieve a fairly constant EGT around 1,500 ° Fahrenheit (816 °C). Towards the end of the flight, as the aircraft descended, the EGT decreased. About 2 minutes before the engine stopped, the EGT climbed rapidly. The peak EGT, of about 1,552 °F (844 °C), occurred as the engine stopped (Figure 3). Simultaneously, the fuel flow dropped to zero and the engine rpm increased rapidly. This is indicative of an overly lean fuel/air mixture, and is consistent with fuel starvation.

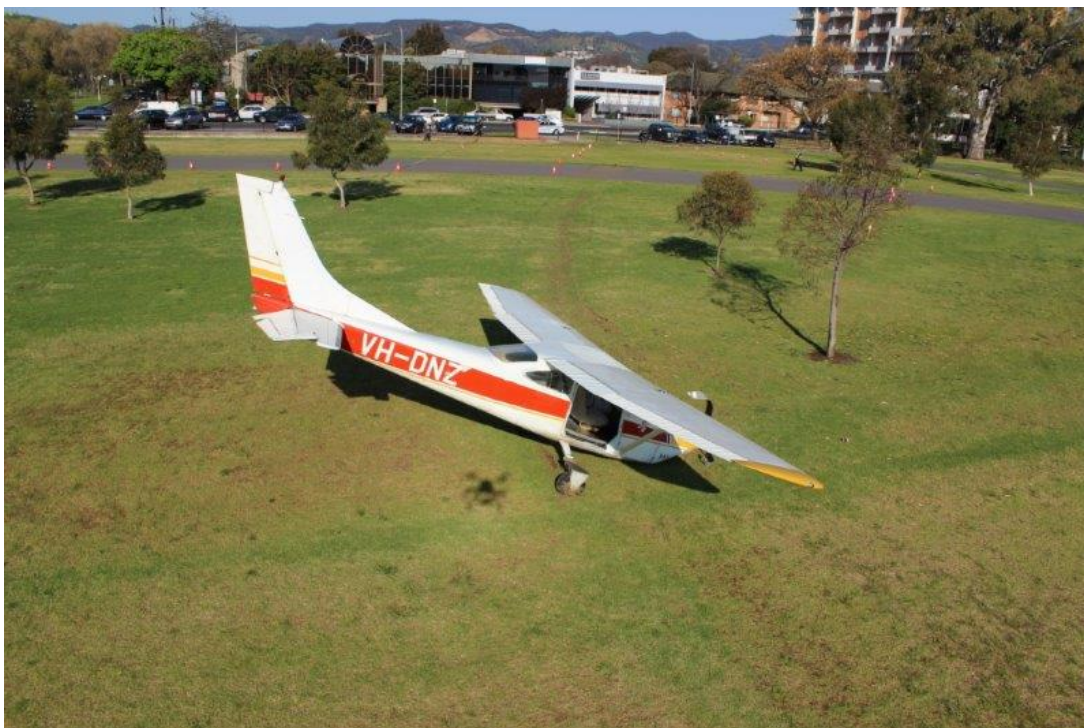
**Figure 3: Accident site showing damage to Cessna 182, VH-DNZ**

The pilot aimed to land the aircraft in ‘pit straight’ on the racecourse, which was directly into the north-westerly wind, but as the aircraft lined up with the straight, the pilot saw a car on the bitumen. The pilot conducted a turn to the right then to the left and landed the aircraft on grass. The pilot reported that it was a very heavy landing, and that the aircraft landed either flat or nose wheel first. The nose wheel broke off, the propeller struck the ground, and the aircraft slewed to the left. Two of the parachutists were ejected from the aircraft during the impact. Two of the parachutists sustained serious injuries, and two were uninjured. The pilot sustained minor injuries and the aircraft was substantially damaged (Figure 3).

A representative of the Australian Parachute Federation aircraft committee inspected the aircraft following the accident. The representative found that the aircraft impacted the ground very heavily in a nose-down attitude. About half a litre of fuel was drained from the system after the aircraft was removed from the site.

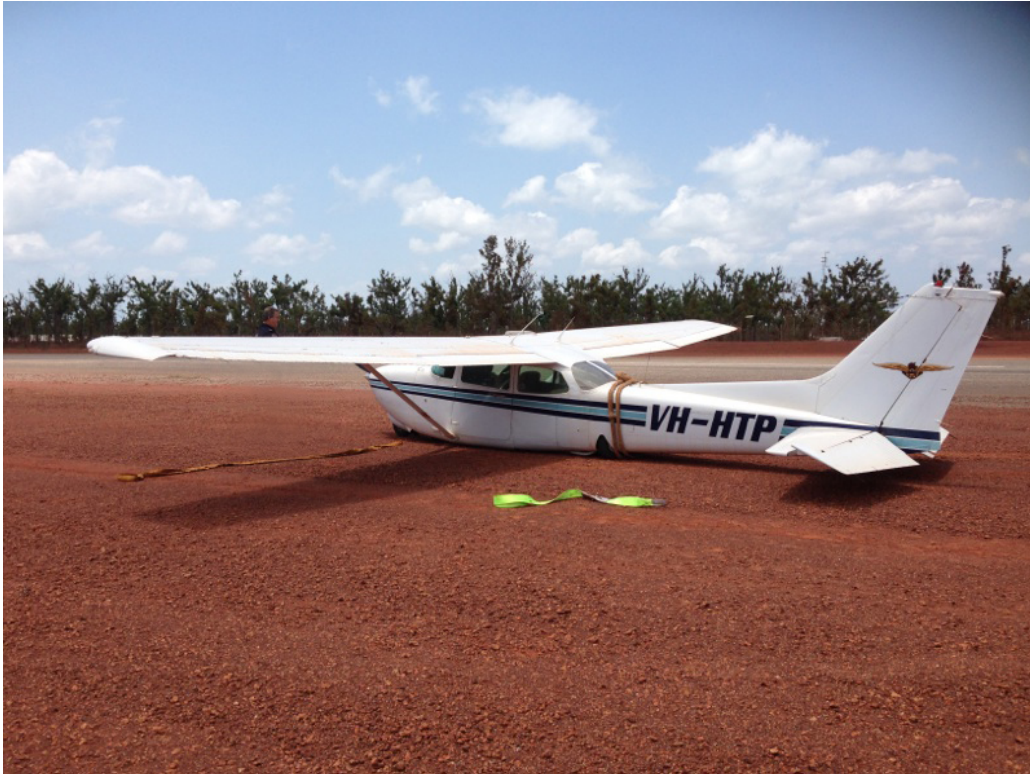
**Figure 2: Cessna 172RG aircraft, VH-HTP accident site**

The pilot and passengers were uninjured, and the aircraft sustained substantial damage (Figure 2).

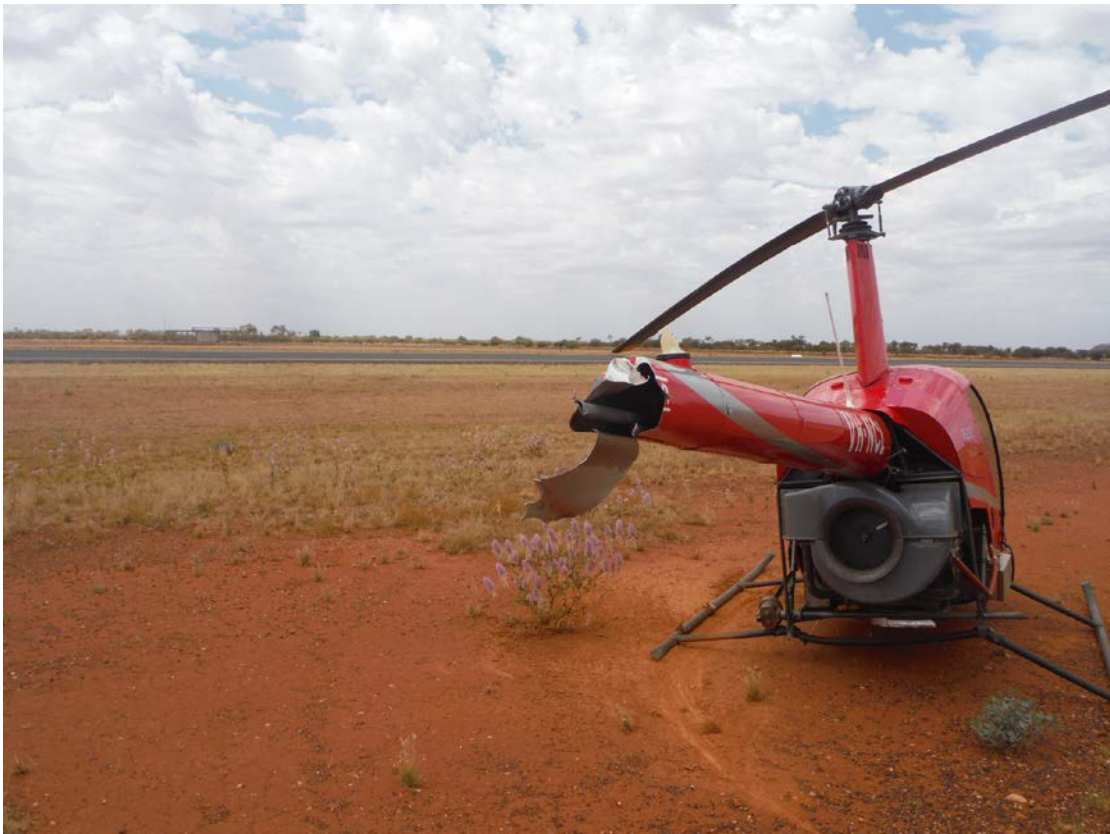
**Figure 1: Accident site showing damage to VH-NCL**

At about 0830 Western Standard Time (WST), the helicopter lifted off to about 10 ft above ground level, and the pilot commenced hover-taxiing. As the helicopter started to move forwards, it encountered a gust of wind from behind and sank rapidly. The helicopter landed heavily, then bounced and rotated rapidly to the right. During the accident sequence, the main rotor blade severed the tail, and the helicopter sustained substantial damage (Figure 1). The pilot and passenger were not injured.
