# Depressurisation involving Fokker F28, VH-NHF

49 km W of Newman Airport, Western Australia, 7 June 2016

**ATSB Transport Safety Report**  
Aviation Occurrence Investigation  
AO-2016-057  
Final – 28 September 2016

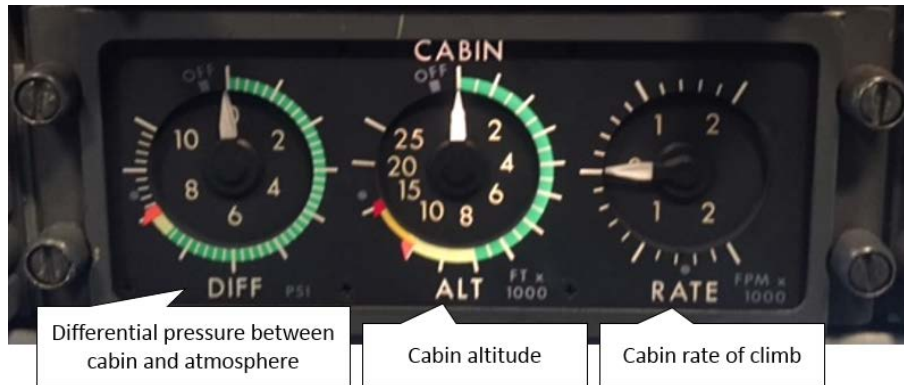
**Figure 1: F28 cabin pressure gauges**

The cabin crew believed the noise was coming from the forward lavatory, so one cabin crewmember inspected the lavatory, but could not identify where the noise was coming from. The PM checked the aircraft pressurisation indications located on the cockpit overhead panel and noticed that the cabin altitude<sup>3</sup> indicated 6,000 ft as expected, but the cabin pressure rate of climb had increased from about 200–300 ft/min to about 500 ft/min<sup>4</sup> (Figure 1). This indicated to the PM that they were losing cabin air faster than the pressurisation system could pressurise the aircraft.

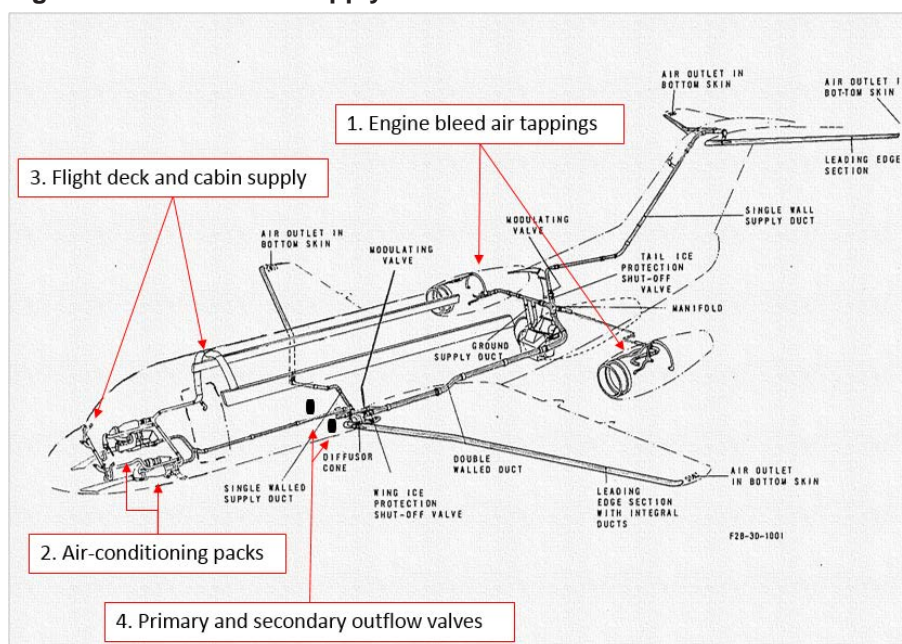
**Figure 2: F28 bleed air supply**

Bleed air is compressed air taken from the compressor stage of the engine. Bleed air is used for several functions including pressurisation, air-conditioning and anti-icing. For pressurisation, the bleed air is supplied to the two air-conditioning packs located underneath the floor of the flight deck, which are used to control the temperature of the air prior to distribution into the flight deck and cabin (Figure 2).

When one pack is selected off, the respective pack main valve shuts off bleed air supply and the other pack increases its output flow rate to 140 per cent of the normal flow rate. A single pack is capable of maintaining cabin altitude by itself at the maximum operating altitude of FL 350. Air-conditioning pack 1 is located underneath the floor of the flight deck on the left-hand side, which is just forward of the forward lavatory.

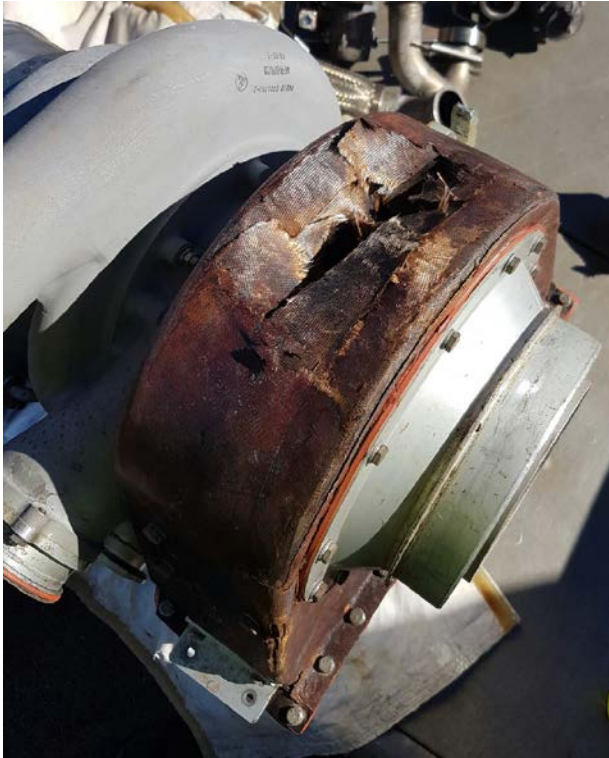
**Figure 3: Ruptured plenum duct**

- There was a ‘massive leak’ from the inlet and outlet of air-conditioning pack 1. Pack 1 was removed and a large hole found in the plenum duct<sup>13</sup> (Figure 3). The plenum duct and primary and secondary heat exchanger were replaced on pack 1. Aircraft pressurisation was then tested and found to be serviceable (including operations with either pack 1 or pack 2 turned off).

Air-conditioning pack 1 is located on the left side of the aircraft underneath the floor of the flight deck, just aft of the left seat, which places it close to underneath the floor of the forward lavatory. The pack 1 plenum duct likely ruptured at about FL 305 to produce what the aircraft captain described as a loud ‘whooshing’ noise and what the cabin manager described as a ‘suction’ noise. According to [Flight Safety Foundation Human Factors and Aviation Medicine](#), the immediate

The subsequent maintenance investigation found duct leaks from both air-conditioning systems. However, only the leak from air-conditioning pack 1 triggered an alert to the pilots, and that fault was associated with an overheat condition. In accordance with the operator comments, the rapid increase in the cabin pressure altitude rate of climb, which occurred when the flight crew turned pack 1 off, indicates that pack 2 alone could not supply a sufficient quantity of air to the distribution ducting to maintain cabin altitude. The systems were only able to re-pressurise the aircraft following the descent to 10,000 ft (the demands on the pressurisation system were substantially reduced)<sup>14</sup> and the successful reset of pack 1.

All parts removed from the number 1 air-conditioning pack will be forwarded to the manufacturer, or authorised repair organisation, for further technical investigation to determine the cause of the failure of the plenum duct.
