Incorrect configuration involving Boeing 717, VH-YQV

Canberra Airport, Australian Capital Territory, 20 June 2016

ATSB Transport Safety Report
Aviation Occurrence Investigation
AO-2016-065
Final – 28 September 2016

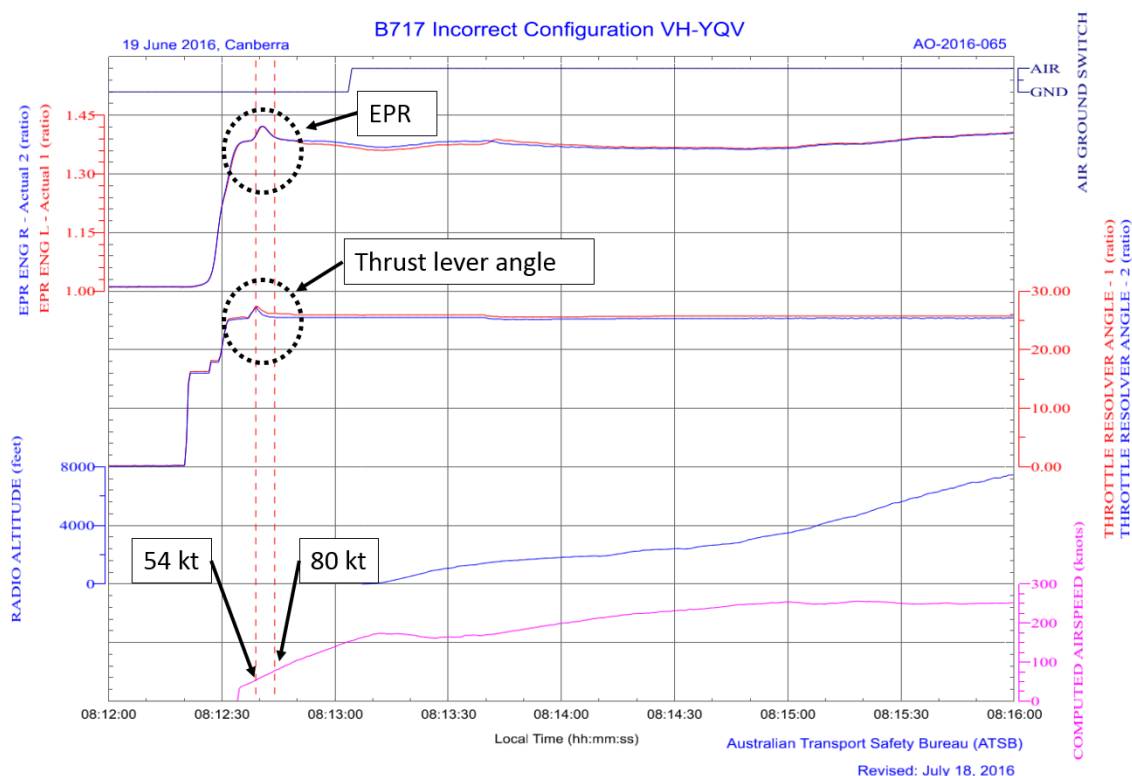
Figure 1: Graph of flight data from the incident flight

The aircraft operator provided the ATSB with a copy of the quick access recorder (QAR) data for the incident flight. As depicted in Figure 1, the data showed the thrust lever angle set at about 25° and the EPR at 1.38 early in the take-off run. After about 4 seconds at that setting, the thrust lever angle increased to about 26° as the commanded EPR, followed closely by the actual EPR, increased to 1.41. However, after about 4 seconds at 1.41 and a further 6 seconds at 1.39, the EPR reduced to 1.38 and thrust lever angle to about 25°, where they remained for the take-off.

This indicates that although the first officer manually moved the thrust levers forward, as the auto-throttle system was engaged, it then overrode the manual thrust lever position and returned the EPR to the value set in the FMS, which was the target thrust setting. At the time, the computed airspeed was 54 kt. When the airspeed reaches 80 kt in the take-off roll, the auto-throttle system mode changes from 'take-off thrust' to 'take-off clamp' mode. In clamp mode, the auto-throttle servo does not have power and the thrust levers do not move automatically. However, in take-off thrust mode (prior to 80 kt), the flight crew would have to disengage the auto-throttle system to set the thrust manually, or maintain pressure on the levers until the airspeed reached 80 kt.

The operator will remind pilots to use a new TOLD card in the event that the card data is being changed and comprehension of these changes is not clear. Pilots will be advised of the investigation by its inclusion in the company's staff safety magazine.
