Engine failure involving Piper PA-28, VH-IPO

Mangalore Airport, Victoria, 16 June 2016

ATSB Transport Safety Report
Aviation Occurrence Investigation
AO-2016-059
Final – 28 September 2016

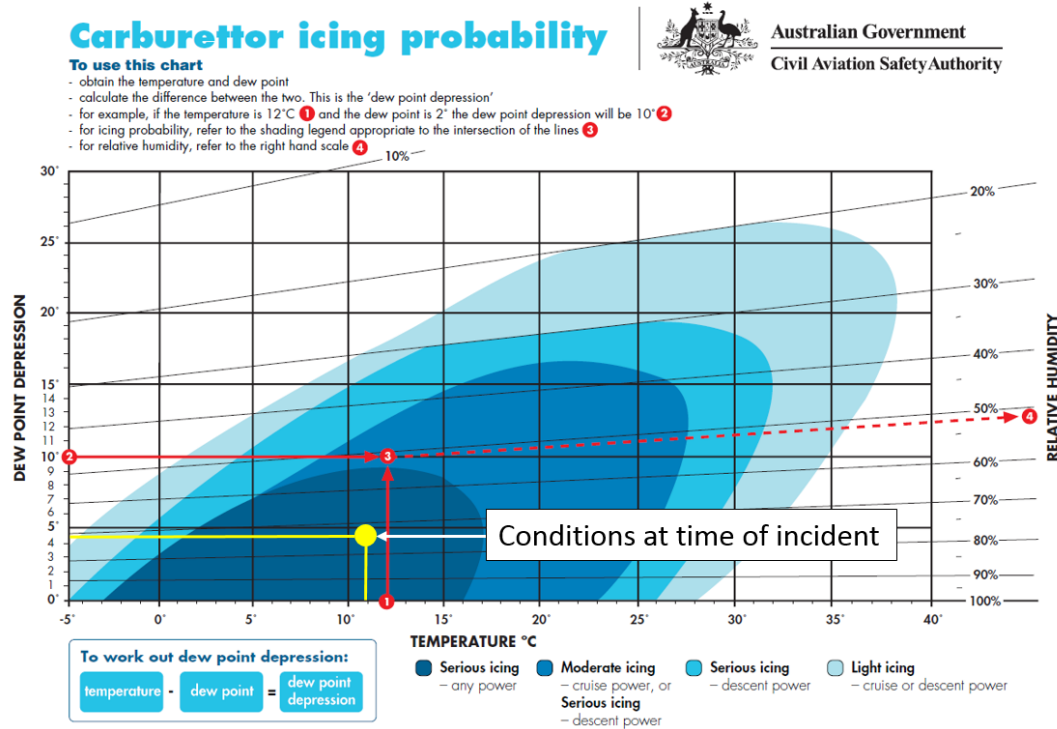
Figure 1: Carburettor icing probability chart showing prevalent conditions in yellow

On the morning of the engine failure, the Mangalore aerodrome weather information service reported the following weather conditions.

Time	Temperature	Dew point
1000	8.6 °C	8.6 °C
1015	9.4 °C	9.1 °C
1030	9.6 °C	7.5 °C
1045	10.1 °C	7.3 °C
1100	10.6 °C	6.9 °C
1115	10.9 °C	6.5 °C

The carburettor icing probability chart shows the conditions at Mangalore Airport placed IPO in the serious icing zone for carburettor icing at the time of the incident (Figure 1). Carburettor icing could be expected at any power setting.

When operating in conditions conducive to carburettor icing, pilots should use carburettor heat to prevent and remove ice build-up. After selecting carburettor heat, engine performance may deteriorate further as the ice is melted before engine performance returns to normal. This may take up to 30 seconds.
