Flight path management occurrence involving B737, VH-YID

55 km from Adelaide Airport, South Australia | 9 May 2015

ATSB Transport Safety Report
Aviation Occurrence Investigation
AO-2015-041
Final – 7 October 2016

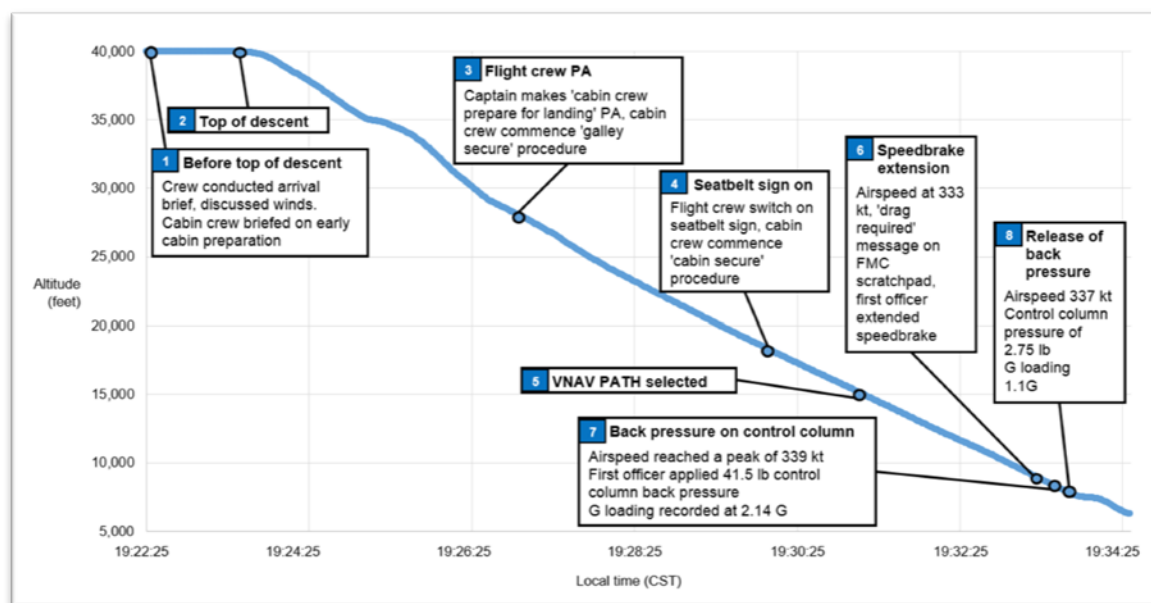
Figure 1: Sequence of events on descent, including the flight and cabin crew actions plotted against altitude and time

As the aircraft passed through 10,000 ft, the airspeed started to increase above 320 kt and at 8,400 ft the message 'drag required' displayed on the flight management computer (FMC) scratchpad as per system design. In response, the FO extended the speed brake, making an effort to do so slowly and smoothly. The captain observed this action, initially concerned that the FO may extend the speed brake too quickly. However, the captain was satisfied that the speed brake was appropriately extended and that the increasing airspeed trend was being managed. The captain's attention was then turned to other tasks. Over the next 6 seconds the airspeed continued to increase, and the FO recalled seeing the speed trend vector on the primary flight display (PFD) extend beyond the aircraft's maximum certified speed (V_{MO}).⁴

In an effort to avoid an overspeed, the FO pulled back forcibly on the control column in order to raise the nose, overriding the autopilot and activating the control wheel steering – pitch (CWS-P). This technique was routinely used to manage overspeeds on descent. On this occasion the FO reported feeling greater than usual resistance when raising the nose due to the already low pitch angle. The FO then recalled feeling a 'pinch' as the autopilot reverted to CWS-P, along with a sudden pitch change and a high g loading⁵ on the aircraft. In response, the FO abruptly released the back pressure on the control column, rapidly unloading the g loading. At that moment, the cabin crew had almost completed securing the cabin and were about to take their seats. They reported experiencing what they thought to be turbulence, and two cabin crew in the rear galley

lost their footing. This resulted in one of the cabin crew impacting the galley floor heavily, sustaining an injury to their knee.

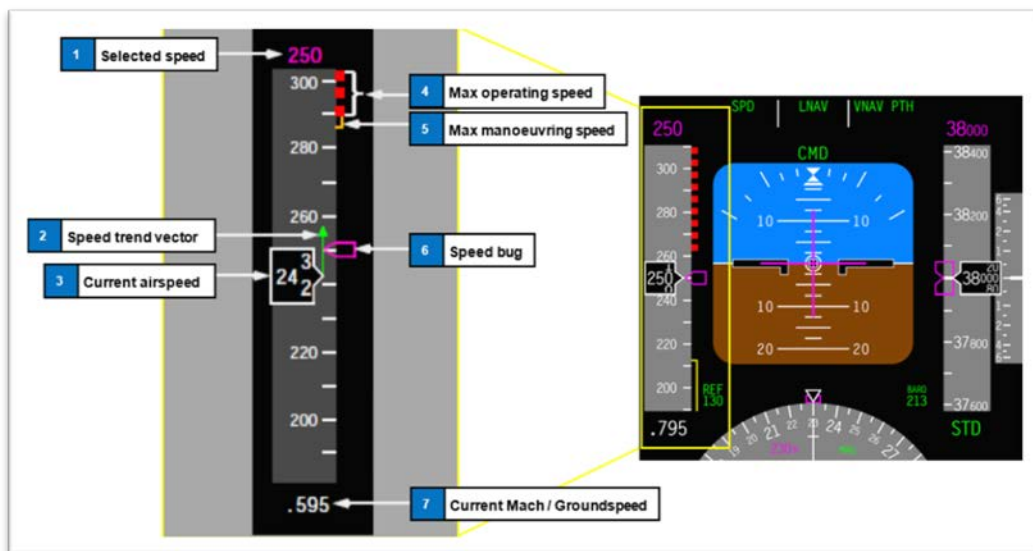
The maximum operating indicated airspeed (V_{MO}) represents the maximum certified limiting speed of the aircraft. V_{MO} for the B737-8FE is 340 kt. An overspeed warning sounds if the aircraft exceeds V_{MO} .
