Locomotive runaway at the Sydney Operations Yard

Chullora, New South Wales | 23 September 2015

ATSB Transport Safety Report
Rail Occurrence Investigation
RO-2015-017
Final – 11 October 2016

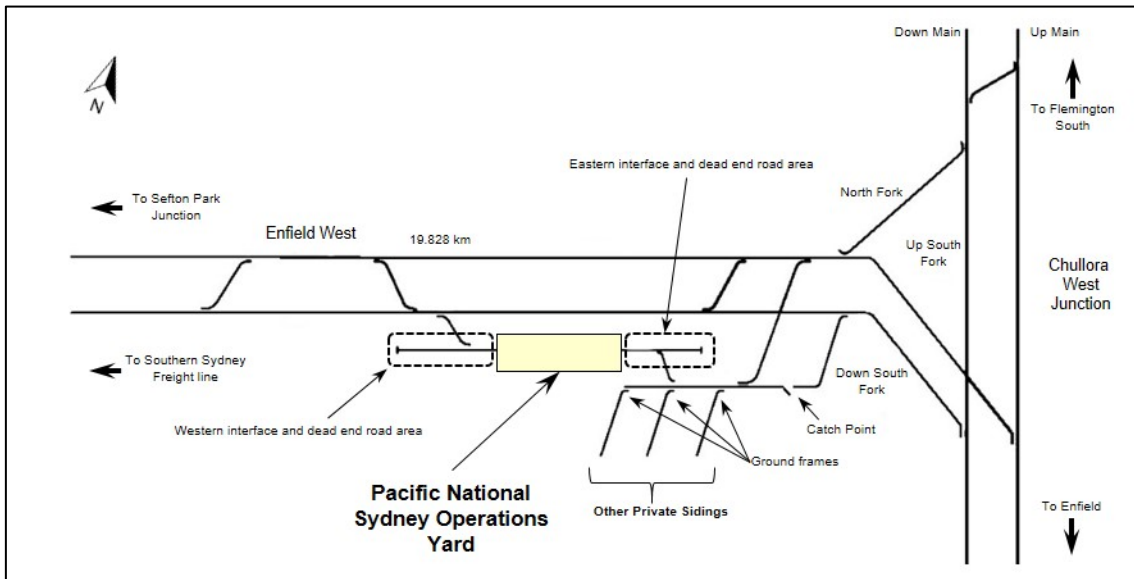
Figure 3: Track arrangement at Chullora West Junction

A motorised catch point¹⁰ was located at the eastern boundary of the Chullora interface area to protect the ARTC network from an uncontrolled rolling stock movement (runaway) from the private sidings entering the Down south fork and Down Main line. The ARTC controlled the signals, catch-point, and all other motorised point machines at the Chullora West Junction remotely from the NCCS.

Figure illustrates the main line track arrangement at Chullora Junction including the interface connections to the Pacific National Sydney Operations Yard and other private sidings. Source: Australian Rail Track Corporation annotations by ATSB

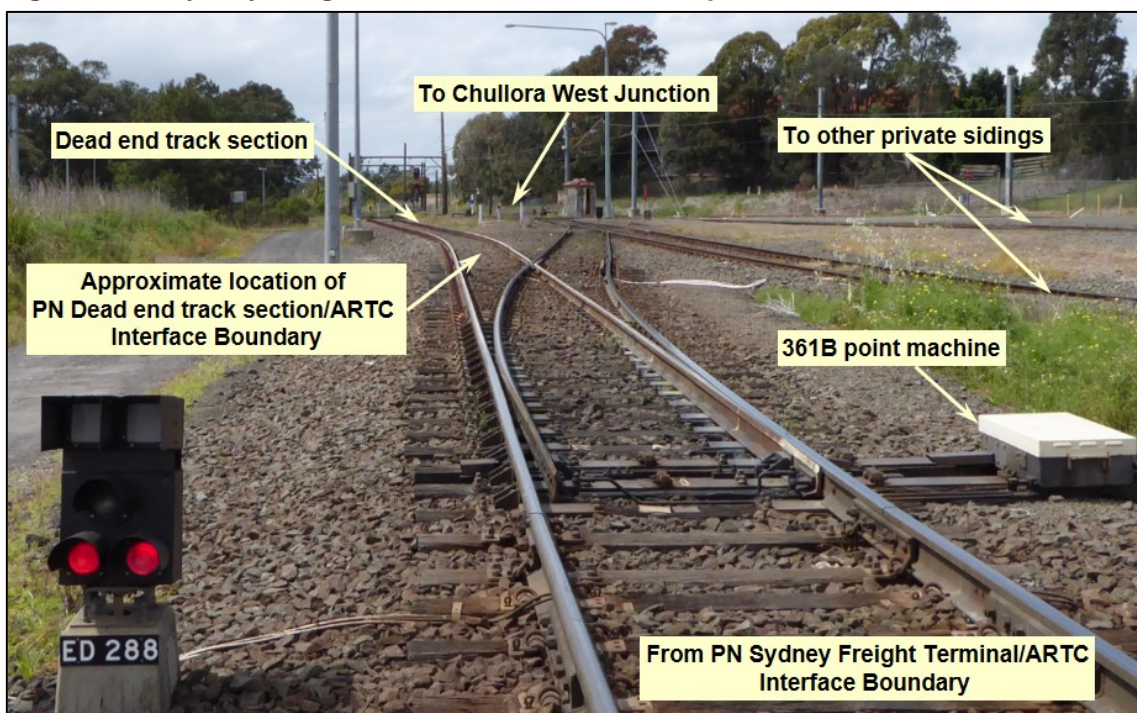
Figure 4: PN Sydney Freight Terminal eastern interface point and dead end road

At the eastern end of the SFT, motorised points adjacent signal ED288 provided the control mechanism to divert rolling stock toward a dead end track section (shunt neck) and away from the ARTC network (Figure 4). The signalled route selected determined the orientation of the motorised points. At the time of the uncontrolled movement, the route was set to allow access between the ARTC network and the SFT.

Interface point at the eastern end of the PN Sydney Freight Terminal. Signal ED288 and the motorised point machine were controlled by the ARTC from the Junee control centre. The points should be positioned as shown to route any uncontrolled movement toward the dead end and away from the roads of the other private sidings and main lines at Chullora West Junction. Source: Australian Transport Safety Bureau

The Australian Rail Track Corporation have issued instructions for the restoration of points at the interface following each movement and commenced investigation into the feasibility of automatic resetting of the points at that location.

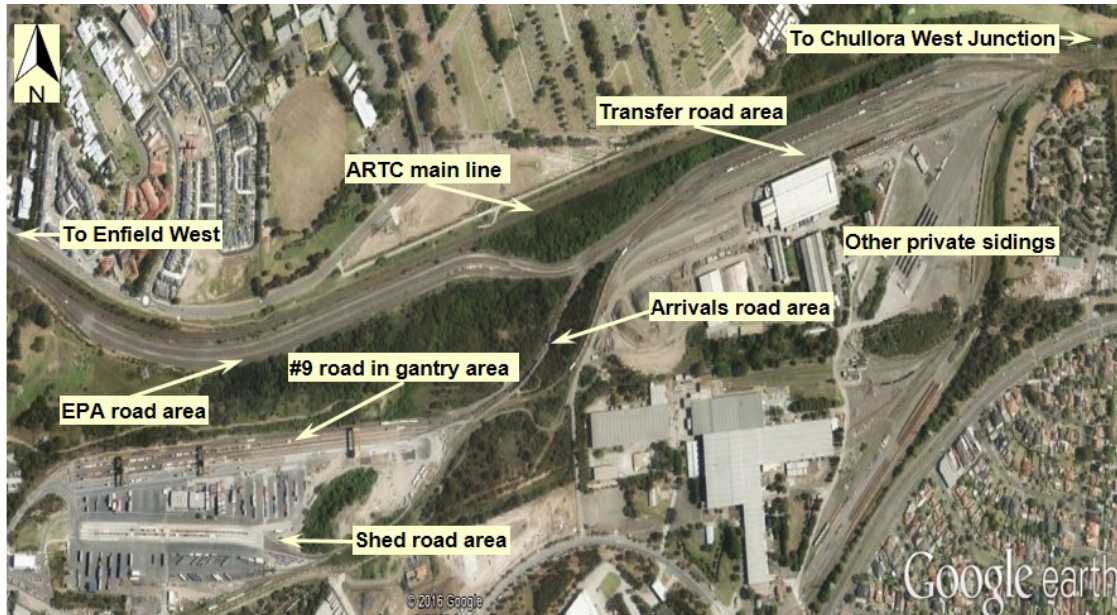
Figure 5: Pacific National Sydney Freight Terminal

At the top of the grade in the Gantry area, four of the roads (#5, 6, 7 and 8) were equipped with a manually operated derail mechanism to prevent unauthorised access into or to capture an uncontrolled movement from the respective road. Road #9 was not equipped with a derail mechanism.

View of the Pacific National Sydney Freight Terminal showing the relative location of the EPA and Gantry road areas. The uncontrolled movement of locomotives NR24 and NR12 commenced at the #9 road in the gantry area before travelling through the transfer road area and toward Chullora West Junction. Source: Google, annotated by ATSB
