Pilot incapacitation involving Cessna 208, VH-NTQ

Near Horn Island, Queensland, 12 July 2016

ATSB Transport Safety Report
Aviation Occurrence Investigation
AO-2016-075
Final – 14 October 2016

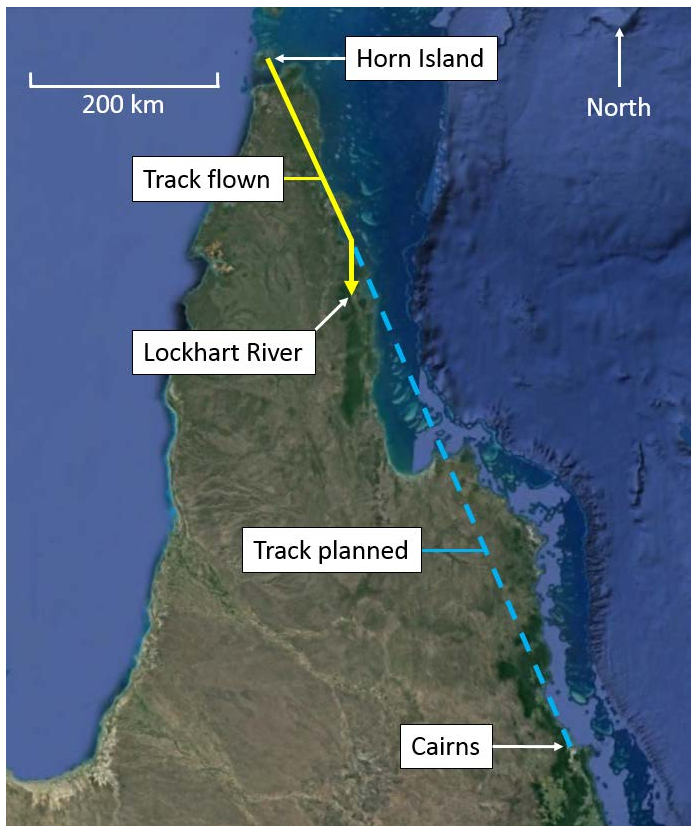
Figure 1: Overview of planned flight

About 20 NM north of Lockhart River, the aircraft approached a significant over-water segment. The pilot assessed that the symptoms would not pass and elected to divert to Lockhart River (Figure 1).
