# Aviation Short Investigations Bulletin

Issue 53

**ATSB Transport Safety Report**  
Aviation Short Investigations  
AB-2016-121  
Final – 14 October 2016

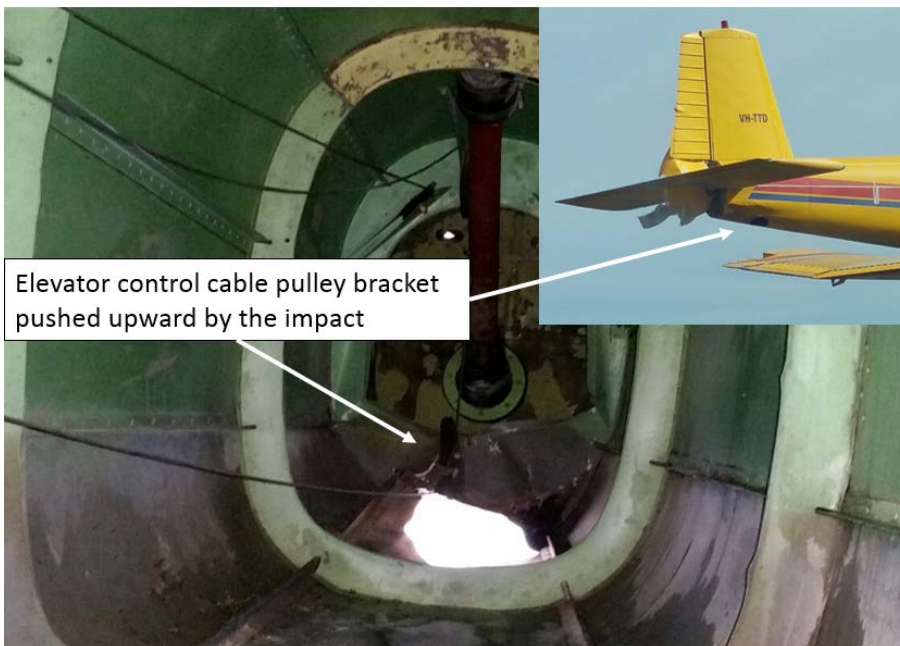
**Figure 2: VH-TTD elevator control cable pulley**

- The structural frame supporting the lower elevator control cable pulley was pushed up about 10 cm (Figure 2).
- The centre section just aft of the hopper (Figure 3) had about 12 mm of water in it and the drain hole for the centre section was blocked by fertiliser. The repair organisation assessed that the size of the drain hole was inadequate and that a larger hole with a removable bung would be preferable.
- The flap control cable had failed at the rear flap pulley and the failure appeared to be due to corrosion (Figure 4).

Elevator control cable pulley bracket pushed upward by the impact

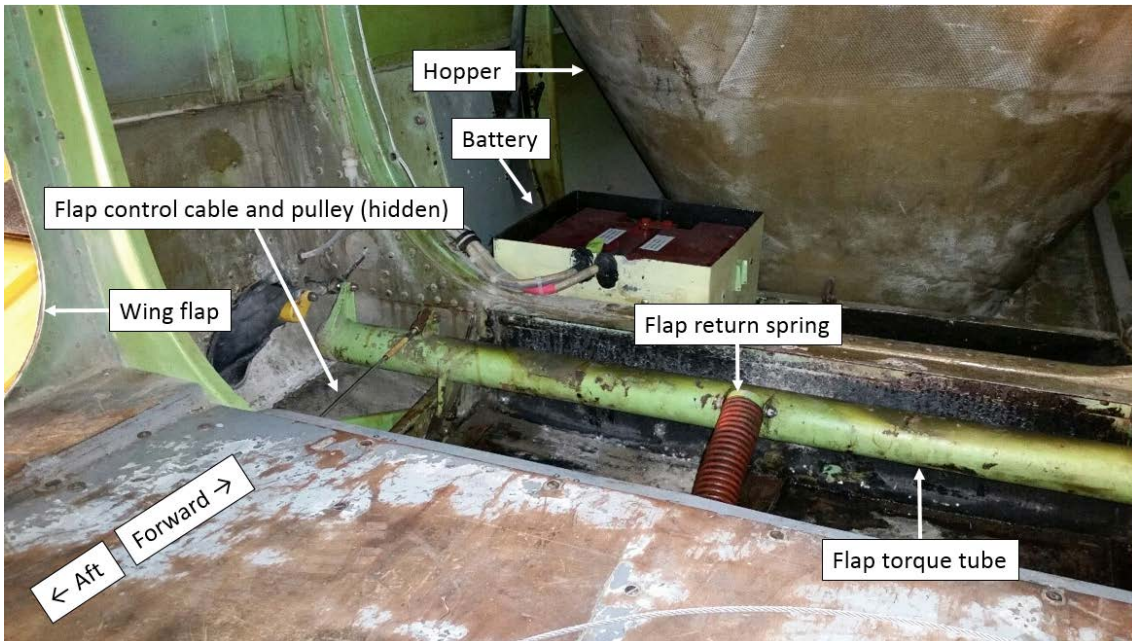
**Figure 3: VH-TTD centre section**

Entrapped water, fertiliser and potentially, the previous use of an unsealed lead-acid battery,<sup>7</sup> all contributed to a corrosive environment within the centre section of the aircraft, and corrosion of the flap cable.

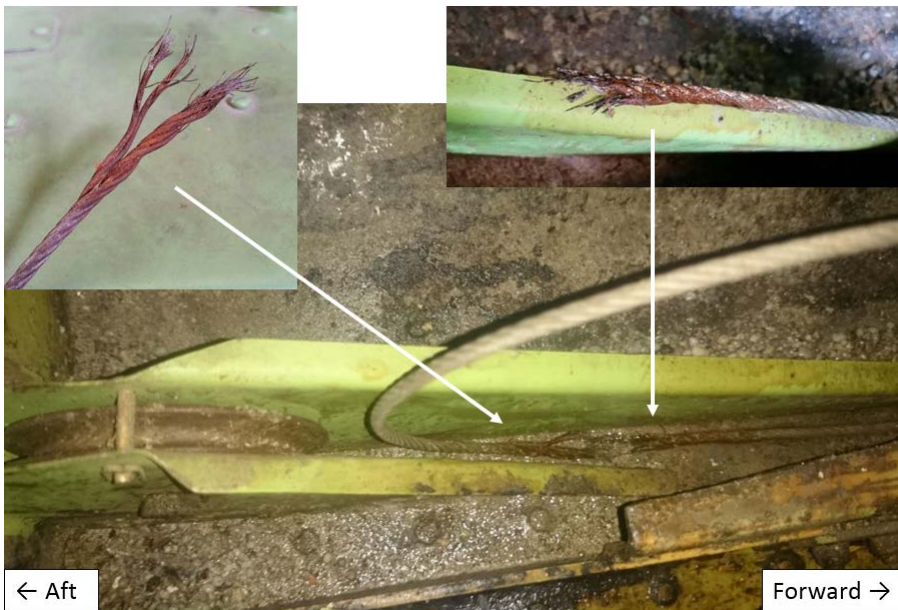
**Figure 4: VH-TTD broken flap cable**

The ATSB notes that the corrosion present on the flap control cable at the location of the failure takes a considerable amount of time to develop. The corrosion was confined to the working length of the cable that was in contact with the flap control system rear pulley, which is considered to be a critical fatigue area. The failed cable was comprised of woven steel wires plated with zinc or tin. The cable was confirmed to be the correct type for the application.

Over time, in the absence of a suitable lubricant, the plating can wear due to frictional contact with the pulley. This will render the cable susceptible to corrosive attack and elevate the likelihood of a fatigue failure. The flap control cable was not removed during the last periodic inspection, which could have detected the corrosion damage. Nor was grease applied to the working length of the cable, or the rear flap pulley, during the last few inspections to mitigate against the development of corrosion.

This incident highlights the need for maintenance organisations to periodically review the recommended practices published by both the manufacturer and the regulatory authorities. The Schedule 5 system of maintenance details what inspections are required, but does not prescribe how they should be performed. Reference to the relevant industry standard practices can improve the quality of maintenance conducted and ensure an organisation's practices remain up-to-date with the respective standards, which are periodically updated to incorporate new knowledge.

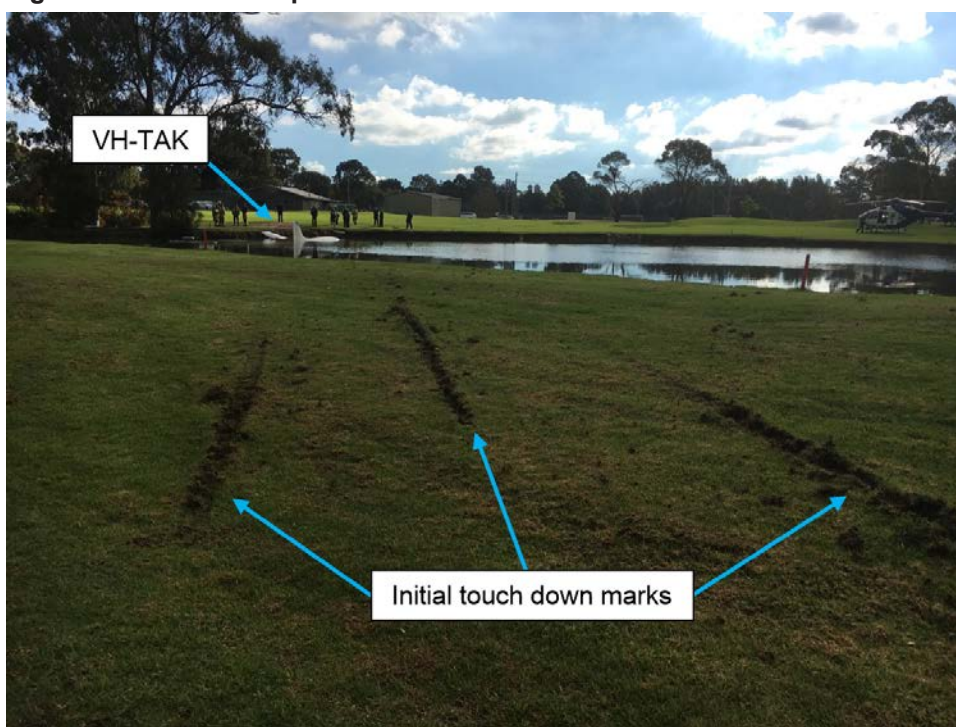
**Figure 2: Touch down point**

TAK landed on the up slope of a mound at the edge of a small lake and bounced back into the air (Figure 2). The pilot then attempted to fly the aircraft over the lake, but soon assessed that it did not have sufficient speed or height to clear the lake, and directed the occupants to brace for impact. TAK landed in the lake on the main wheels. The nose of the aircraft struck the water and submerged momentarily, before returning to the surface. After the aircraft stopped, the occupants immediately exited the aircraft through the door on the right side. They climbed over the fuselage and along the left wing to the edge of the lake (Figure 3). The pilot and occupants were uninjured and the aircraft was substantially damaged.

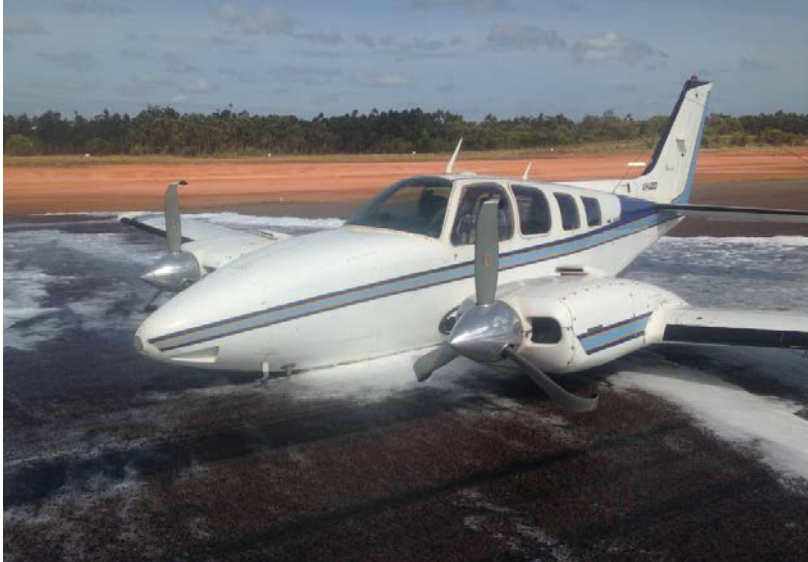
**Figure 1: VH-UZO after the wheels up landing**

A post-accident examination of the landing gear system found that the gear box shaft bearing had fractured. This bearing secures and aligns the shaft worm drive, which attaches both the emergency handle mechanism and the electric motor to the gear box. Failure of the bearing allowed the shaft worm drive to disconnect from the gearing. The drive became jammed, causing further damage to the gear box. Damage to the gear box prevented normal operation and caused the electric motor to overload and trip the circuit breaker. The bearing failure also prevented the emergency handle from connecting to the gear box.

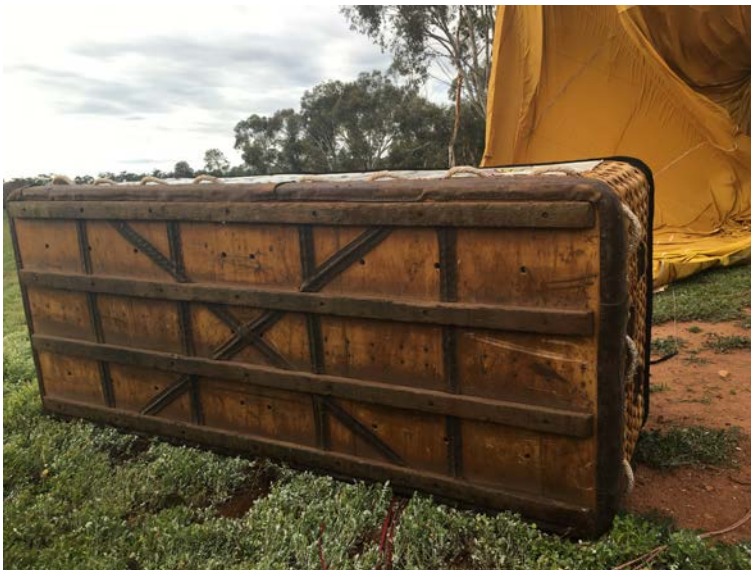
**Figure 1: Final resting position of VH-LPG**

The pilot was seriously injured and air lifted to the Royal Perth Hospital. One passenger received a minor injury and the balloon sustained minor damage.

Installation and use of a pilot restraint harness, in accordance with the balloon and harness manufacturers' recommendations, will reduce the risk of a pilot being thrown out of the balloon basket during landing.
