Grounding of *Maersk Garonne*

Fremantle, Western Australia | 28 February 2015

ATSB Transport Safety Report
Marine Occurrence Investigation
319-MO-2015-002
Final – 17 October 2016

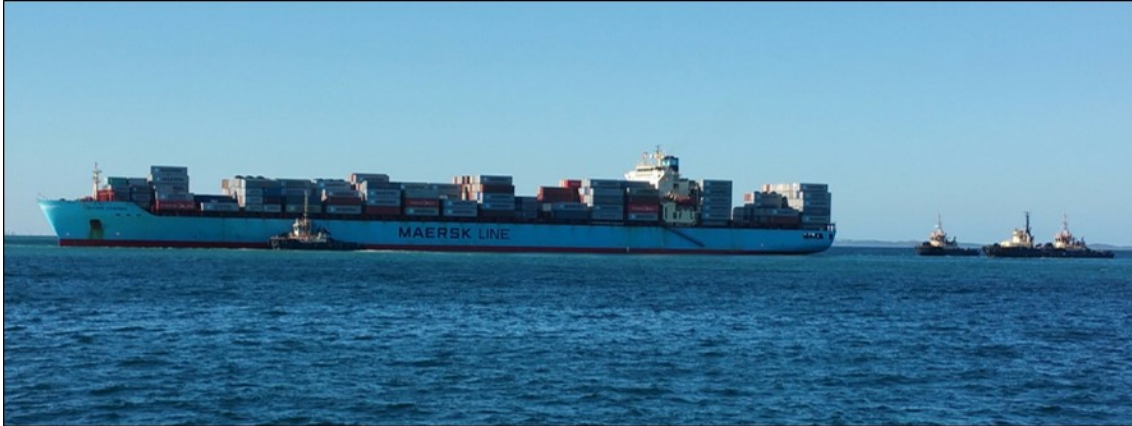
Figure 1: *Maersk Garonne* aground and being assisted by tugs

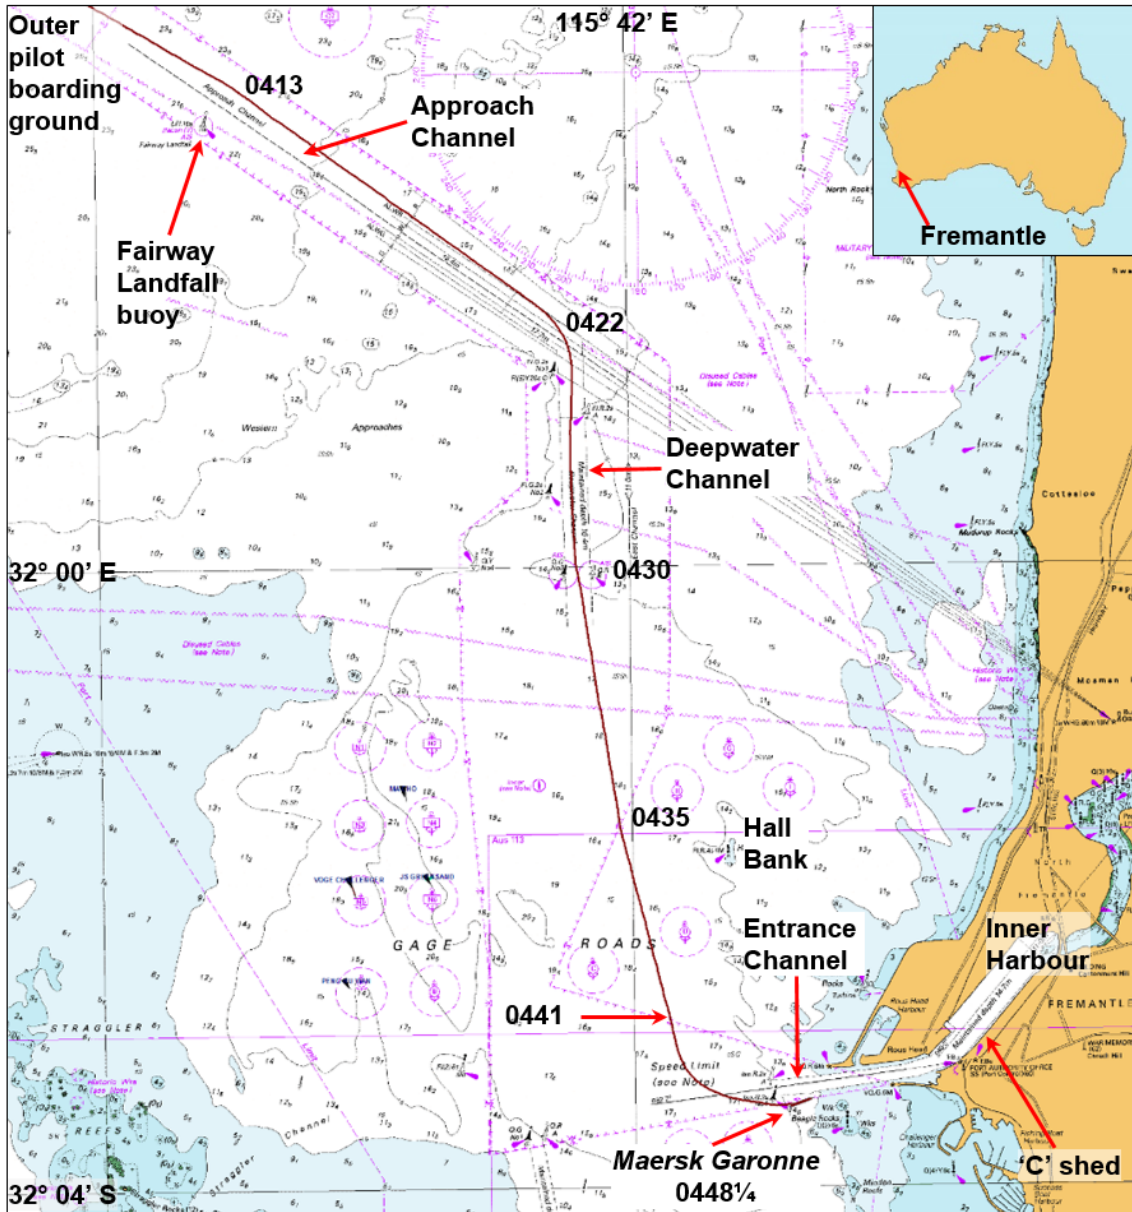
Figure 2: Section of navigational chart Aus 112 showing *Maersk Garonne*’s track

At 0413, the ship passed the Fairway Landfall buoy (Figure 2) and continued in a south-easterly direction at 14 knots,⁸ toward the DWC, about 3 miles⁹ off. At 0422, the pilot ordered 10° of starboard rudder and at 0426, a heading of 178°.

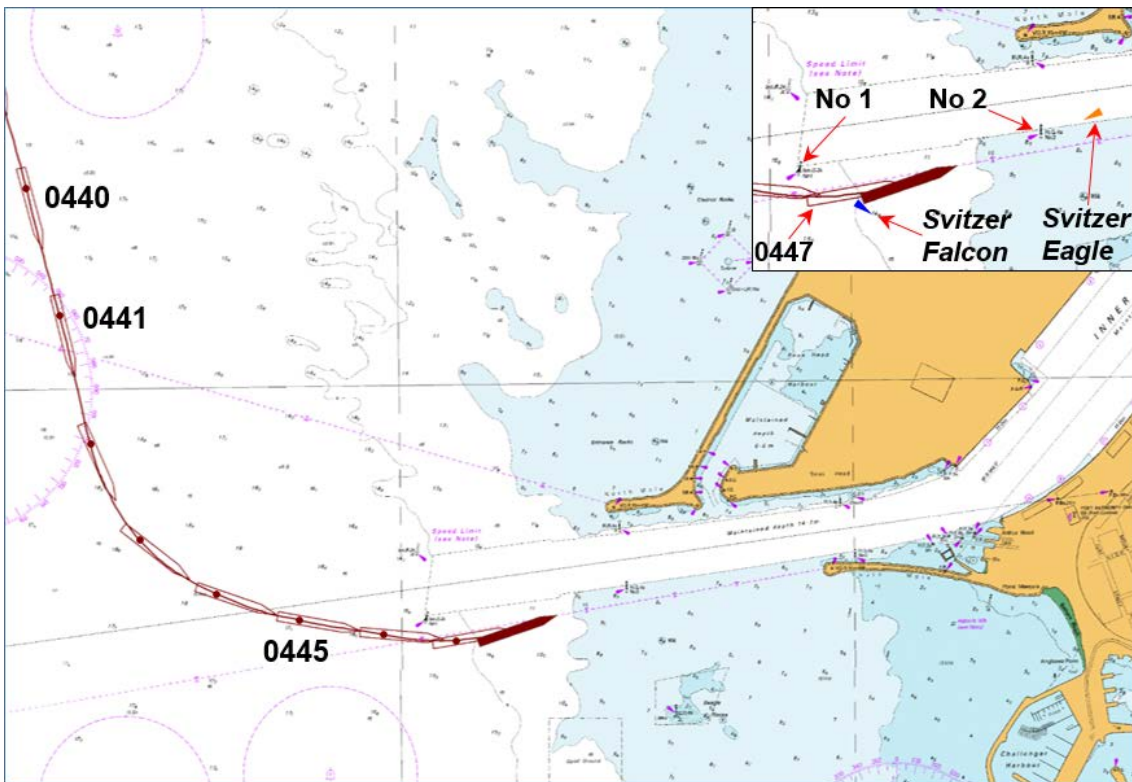
At 0441, the pilot ordered 20° of port rudder and slow ahead on the main engine to commence the turn to the entrance channel (Figure 3). Thirty seconds later, he ordered hard to port to slow the ship for entry into the channel.

going to keep that one to port, then I'll come in between the two greens'. The 'first green buoy' was the starboard hand buoy No. 1 and the other 'green' was beacon No. 2 (Figure 3 insert). After communicating this intention of taking the ship south of the entrance channel and entering it later, the pilot advised *Svitzer Falcon's* master to pass down the ship's port side.

Figure 3: Section of navigational chart Aus 113 showing *Maersk Garonne's* track from 0440 at one-minute intervals (inset shows the grounded ship and the tugs at 0448½)

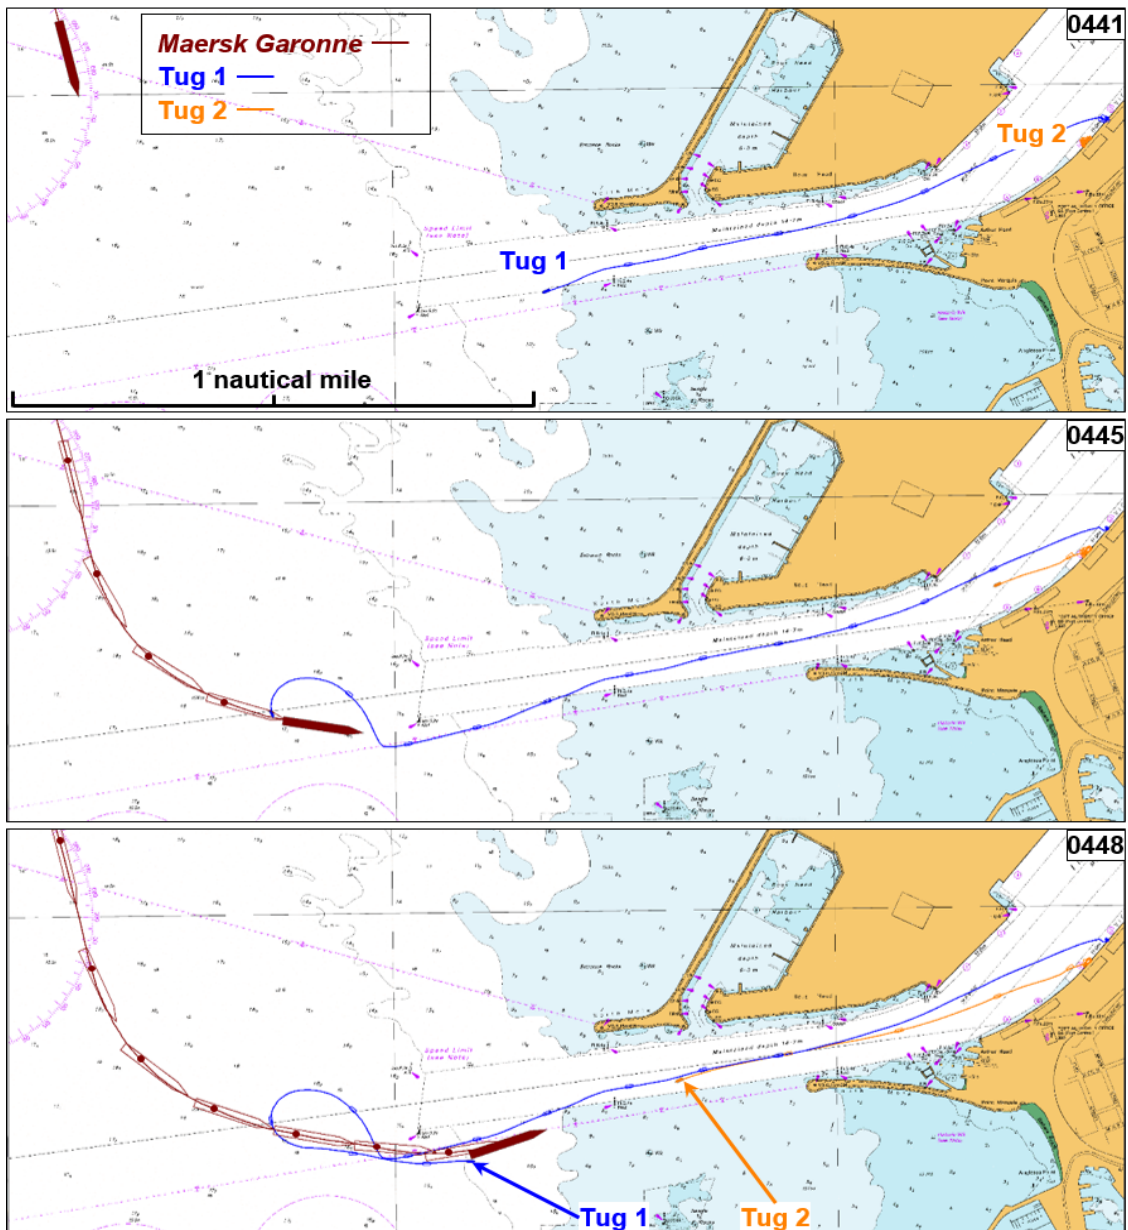
Over the next 35 minutes, the pilotage generally progressed as intended by the pilot. However, as the ship exited the Deepwater Channel (DWC), the pilot conducted the ship to the east of both the planned track on the ship's chart and his own intended track on the MPX form. At no stage did the ship's bridge team members challenge the pilot regarding this deviation from the plan.

Figure 4: Sections of navigational chart Aus 113 showing the progress of *Maersk Garonne* and the tugs from 0441

Then, as the ship approached the entrance channel, the pilot became concerned that it would arrive there before the two harbour tugs were in position. After some radio communications with one of the tug masters, the pilot decided to delay the ship's entry into the channel.

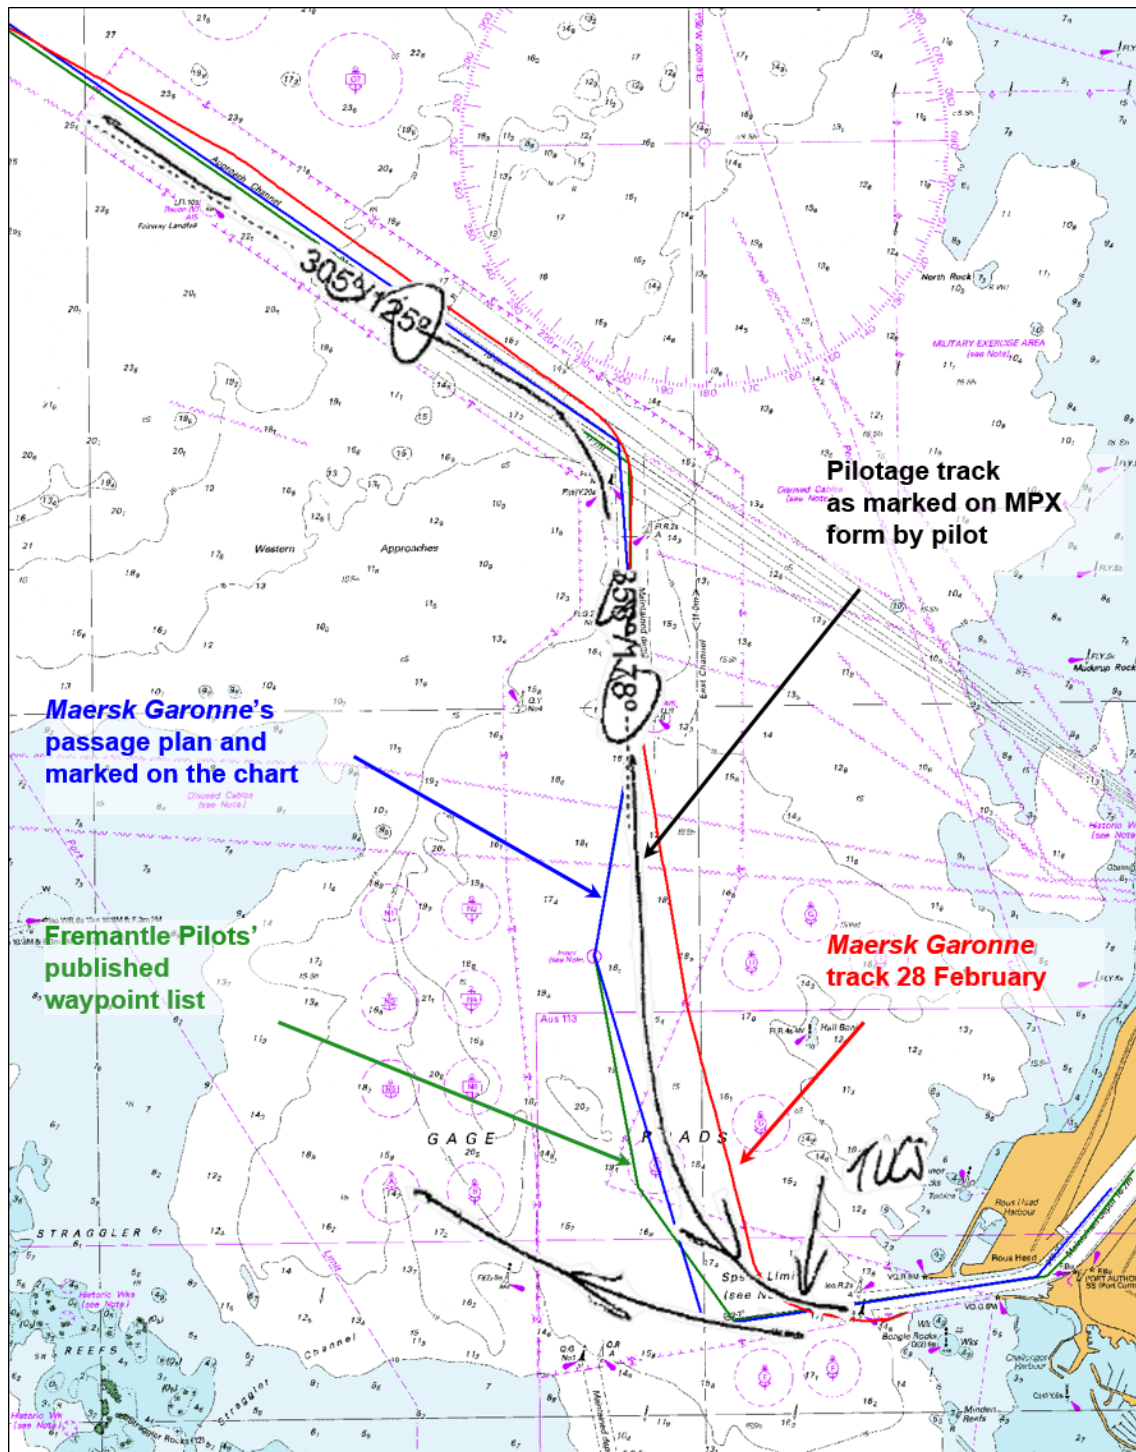
All tracks were within the approved Fremantle Ports transit corridor, however, the analysis showed that none of the tracks was consistent with FP's published waypoint list (green line in Figure 6). The analysis also showed that *Maersk Garonne's* track on 28 February was at the eastern extremity of the others. Had the ship followed the published track it would have been 6 cables further to the west. This would then have provided more time and distance for the second tug to be on station, or its position to be verified, and for the pilot to consider aborting the approach.

Figure 5: Comparison of *Maersk Garonne's* intended and actual tracks on 28 February

Fremantle Pilots has also reviewed and updated its pilotage procedures with more clearly defined course requirements. The procedures also require the 'recommended course from Deep Water Channel to be 180 (T)' and that 'the vessel is to be in line or nearly in line with the Inner Harbour entrance leads at least 7 cables from the Entrance Buoys'. The company further advised that 'limits have been set on the Inner Harbour Passage Plan and the Bridge Team can challenge the Pilot if the vessel falls outside these limiting distances.'

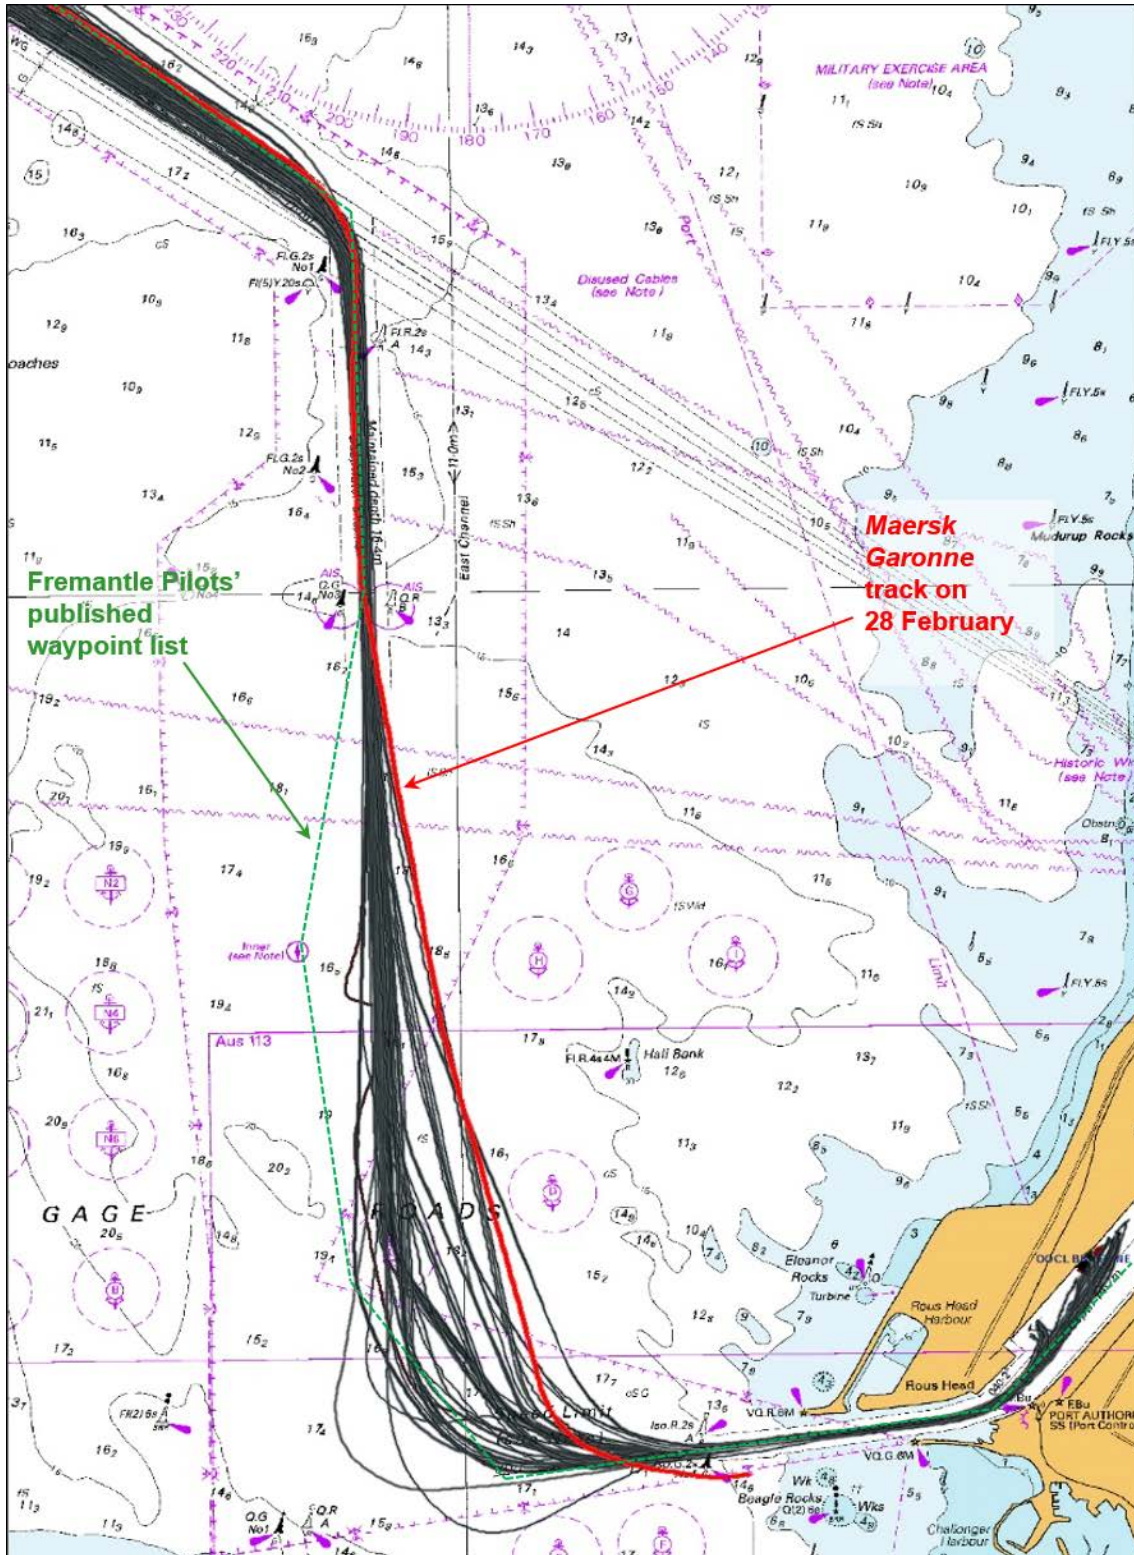
However, *Maersk Garonne* transited the DWC at about 16 knots. The pilot maintained this speed until south of Hall Bank, when the main engine speed was reduced to half ahead. The ship's speed reduced slowly until the pilot started the turn towards the entrance channel, at which time it was 14.5 knots. The pilot intended to maintain a higher speed to improve the ship's manoeuvrability as in his experience the ship did not turn well at slow speed.

Figure 6: Inbound pilotage tracks of ships greater than 250 m in length in the 2 months preceding the grounding

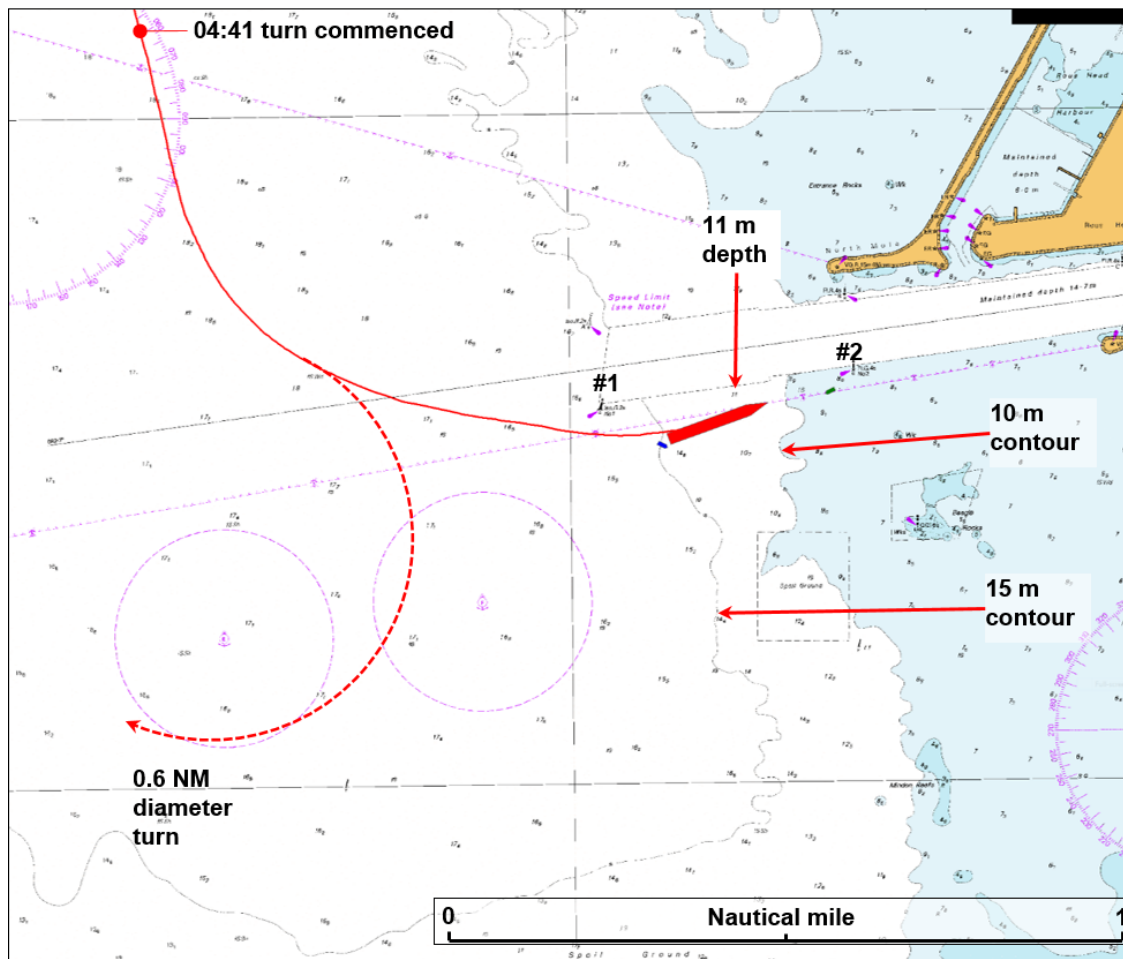
No contingency plans were recorded or discussed. Therefore, when the tugs were not on station as the pilot expected, he did not have any preplanned or practised manoeuvres to fall back on. He then had to make decisions quickly and under increasing levels of stress. This resulted in manoeuvring the deep draught ship into charted shallow waters outside the marked channel.

Figure 7: Maersk Garonne's track with the ship's turning circle overlaid

Fremantle Pilots has advised the ATSB that it is reviewing and updating the company's safety management system and associated procedures and guidelines, including emergency response procedures and job hazard analyses. As part of this, the company conducted ship simulator exercises to assess abort and emergency manoeuvre options. Pilots are also conducting monthly
