Aircraft preparation event involving Airbus A330, VH-QPC

Brisbane Airport, Queensland, 4 August 2016

ATSB Transport Safety Report
Aviation Occurrence Investigation
AO-2016-092
Final – 22 November 2016

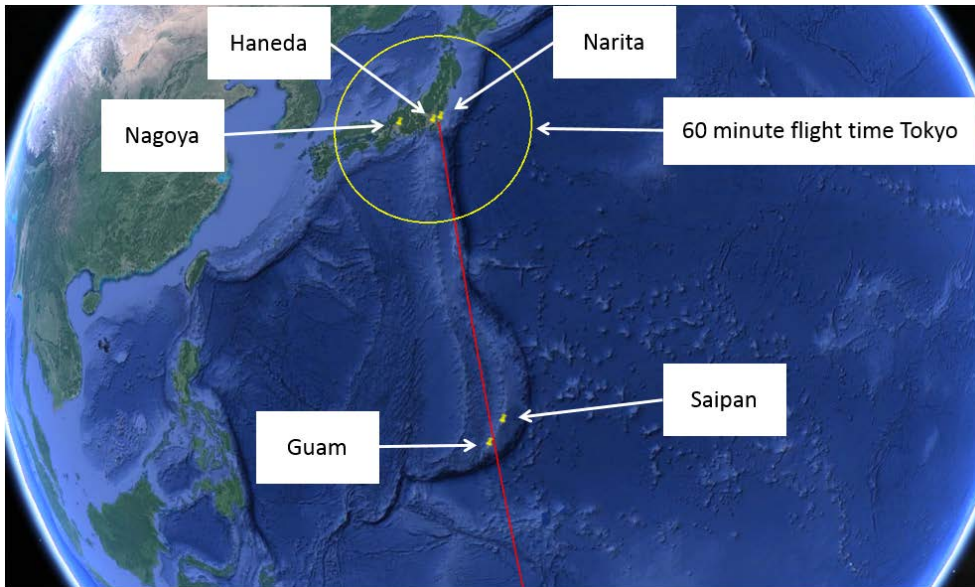
Figure 1: QF61 Destination and EDTO alternates

The flight dispatcher, responsible for flight planning, started building the flight plan for QF61 at about 0800 Eastern Standard Time (EST) at the company integrated operations centre (IOC). In addition to the destination of Narita Airport, the flight plan included two destination alternate¹ airports, Haneda Airport, Tokyo, Japan and Saipan International Airport, Saipan (Figure 1). Saipan Airport was also the extended diversion time operations (EDTO)² alternate airport (see *Extended diversion time operations*).
