Runway collision with arrestor cable involving Raytheon B200, VH-ZCJ

Tindal Airport, Northern Territory, 9 August 2016

ATSB Transport Safety Report
Aviation Occurrence Investigation
AO-2016-098
Final – 22 November 2016

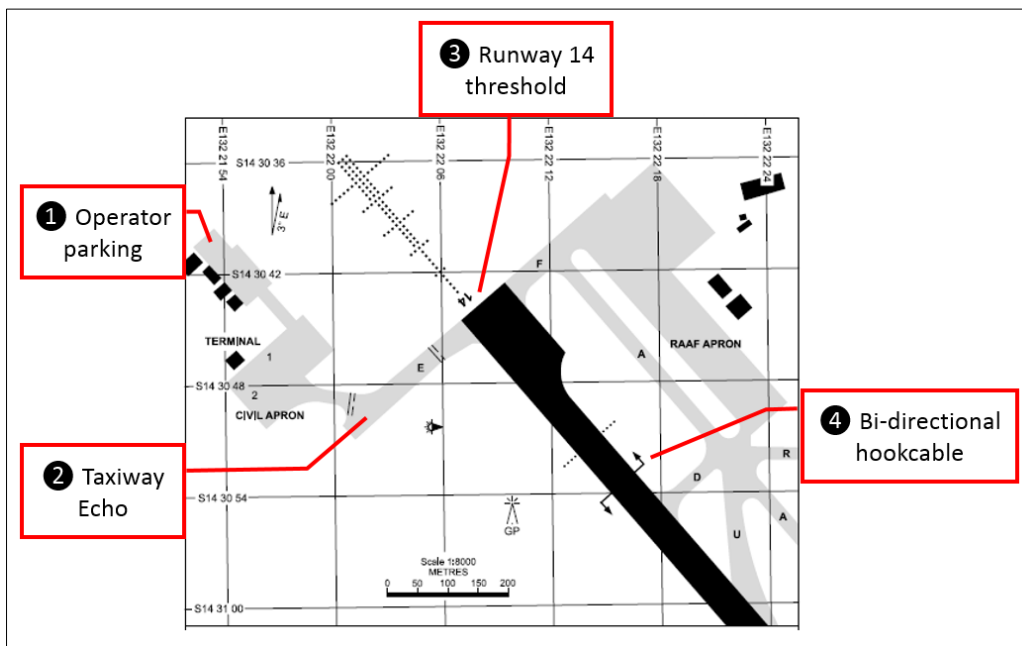
Figure 1: Tindal airport apron diagram

The patient was loaded on board ZCJ at about 2250. At about 2300, the Tindal ATC tower closed and procedures for operating at non-controlled aerodromes then applied. The pilot taxied ZCJ for departure at 2309. They entered runway 14 from taxiway echo (Figure 1), lined up for departure ensuring they used the entire runway length available and applied power. At about 70 kt, the pilot performed their 'cross check of airspeed indicators'. At this time there were no warning indications, so the pilot committed to continue the take-off.

The Tindal Airport aircraft arrestor system (AAS) is used to stop military jets that have a malfunction, which may otherwise cause them to overrun the runway. In this case, the jet will lower a hook at the rear of the aircraft to catch the cable. The AAS includes two cables, one positioned at either end of the runway and displaced from the respective threshold as displayed on the airport diagram of runway 14 (Figure 1).

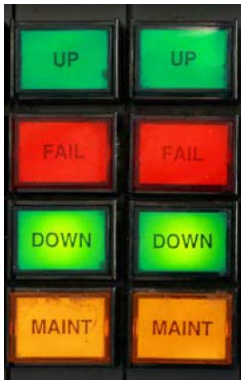
Figure 2: Tower control console cable pushbuttons

There are four pushbutton selection/indicator lights on the tower control consoles (Figure 2). They comprise two green UP and DOWN pushbuttons, an amber maintenance pushbutton and a red fail pushbutton. The maintenance pushbutton is used to pass AAS control between the tower and runway site control location.

When AAS control is passed to the runway site control, the amber maintenance pushbutton will illuminate to indicate the runway site have control of the AAS. The red fail pushbutton will also flash, and be accompanied by an audible clicking. This is a warning to the tower controllers that they do not have control of the AAS. The warning is cancelled by manually depressing the fail pushbutton. In maintenance control, the tower console UP and DOWN pushbuttons are indicator lights only, which will respond to cable position changes made at the runway location.

Tindal ATC did not notice the discrepancy with the handover. They cycled the cable to check serviceability, then continued with normal cable operation for the remainder of ATC services. The cable was in the DOWN position for the arrival of ZCJ. When the Tindal ATC tower closed at 2300, the controller closing the tower performed the procedural steps, which included (1) ensuring the cable is set to DOWN on their control console, and (2) once confirmed DOWN, select AAS control to maintenance. The ATC procedural steps did not include checking the position of the cable after the maintenance selection.

There are no differences in the maintenance and fail pushbutton light indications if the cable changes position after control is passed to maintenance. However, the DOWN pushbutton green light would extinguish after about one second and the UP pushbutton green light would illuminate after about 10–15 seconds.

It is likely that when the Tindal Airport tower closed and passed AAS control to maintenance, the runway 14 threshold AAS cable raised into the UP position in response to the existing site control switch selection, and this was not detected by ATC during the tower closing procedure.

ATC training is to be reviewed to ensure indication of DOWN position after hookcable is switched to maintenance position.
