Derailment of freight train 9T92

Near Julia Creek, Queensland | 27 December 2015

ATSB Transport Safety Report
Rail Occurrence Investigation
RO-2015-028
Final – 9 December 2016

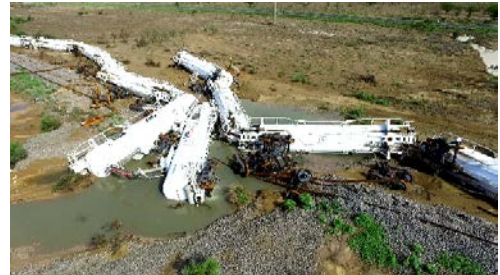
Derailed at track washout

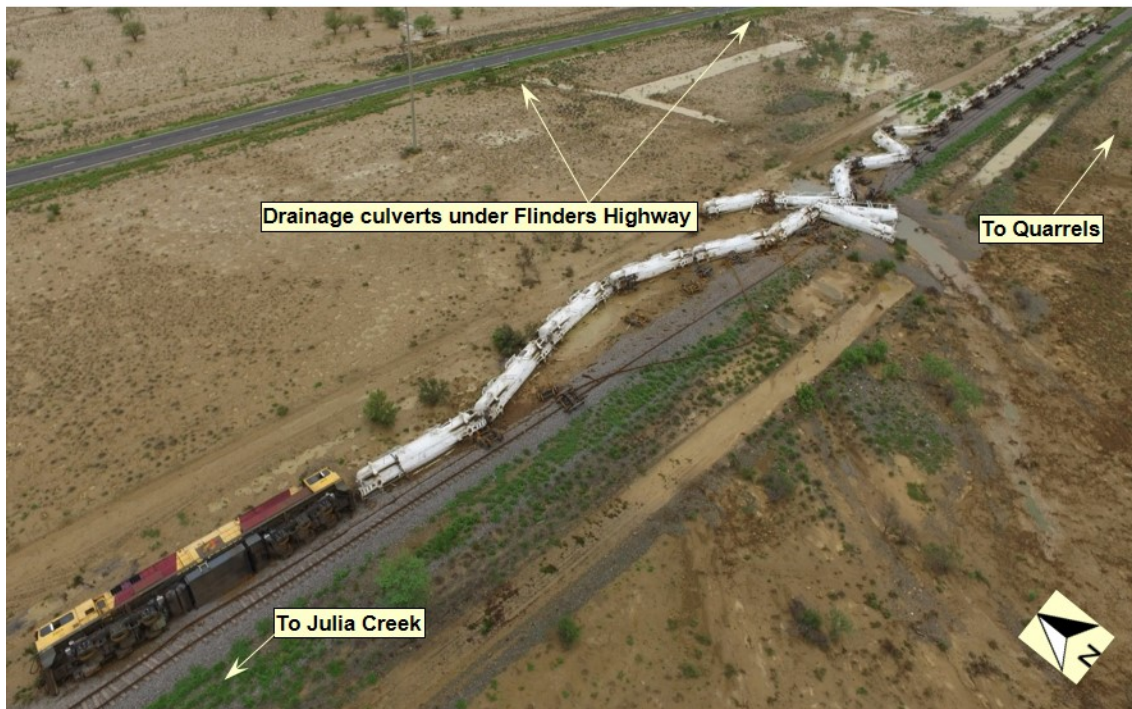
Figure 2: Derailed train 9T92

The derailed locomotive 2814 and 26 trailing tanker wagons of 9T92 laying to the north of the railway about 20 km east of Julia Creek. The floodwaters present at the time of derailment had receded, however pooled water is still visible in the drainage channels from culverts under the Flinders Highway leading toward the washout of the track formation. Source: Queensland Police Service

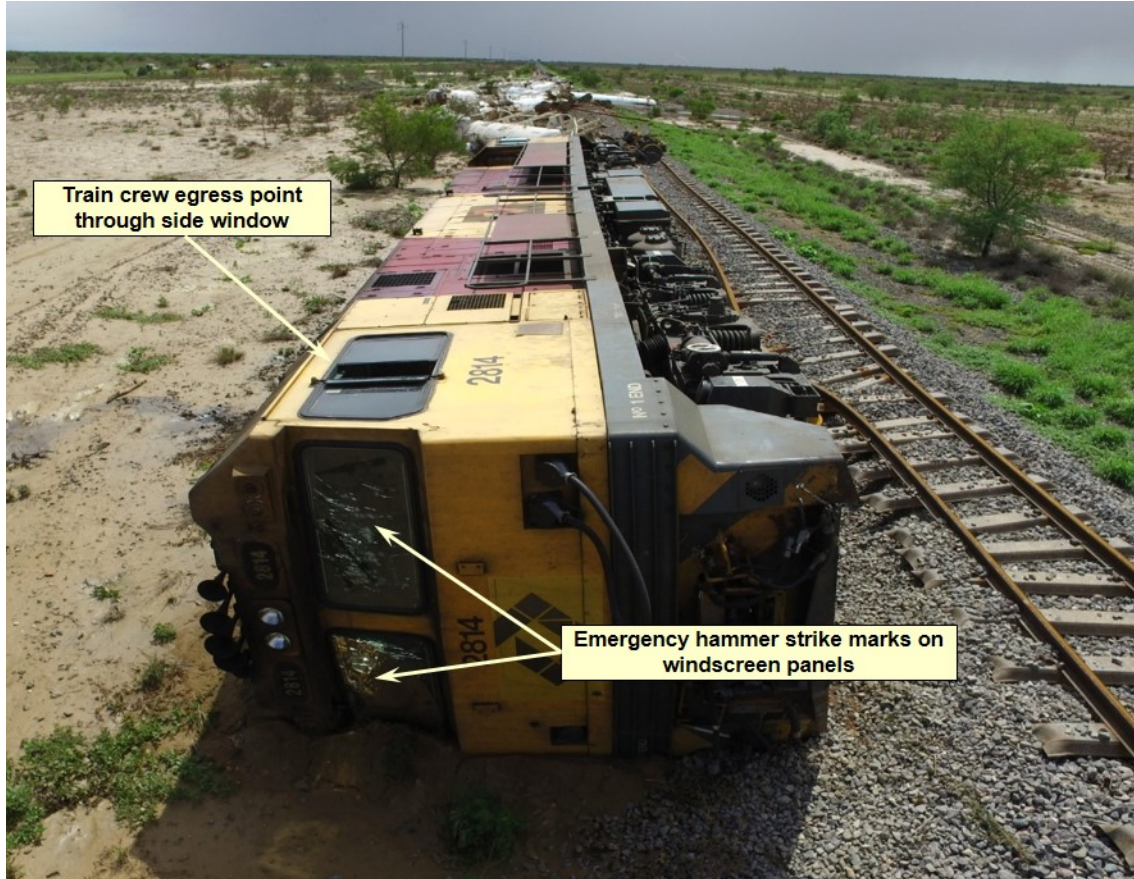
Figure 3: Derailed locomotive 2814

Immediately after the derailment, floodwater entered the cabin, before settling to a depth of about 600 mm. To escape the cab, the train crew attempted to break the front windscreens using the emergency hammer. After repeated strikes, they were unable to open an escape route through the windscreens, so the crew decided to climb up and out of the locomotive's side window (Figure 3).

Derailed locomotive 2814 situated on the northern side of the track. The damage to the inside surface of both windscreens was from numerous strikes using the supplied emergency hammer. The train crew were unable to break out the windscreens. The train crew escaped from the locomotive through climbing up and out the sliding side window. Source: Queensland Police Service

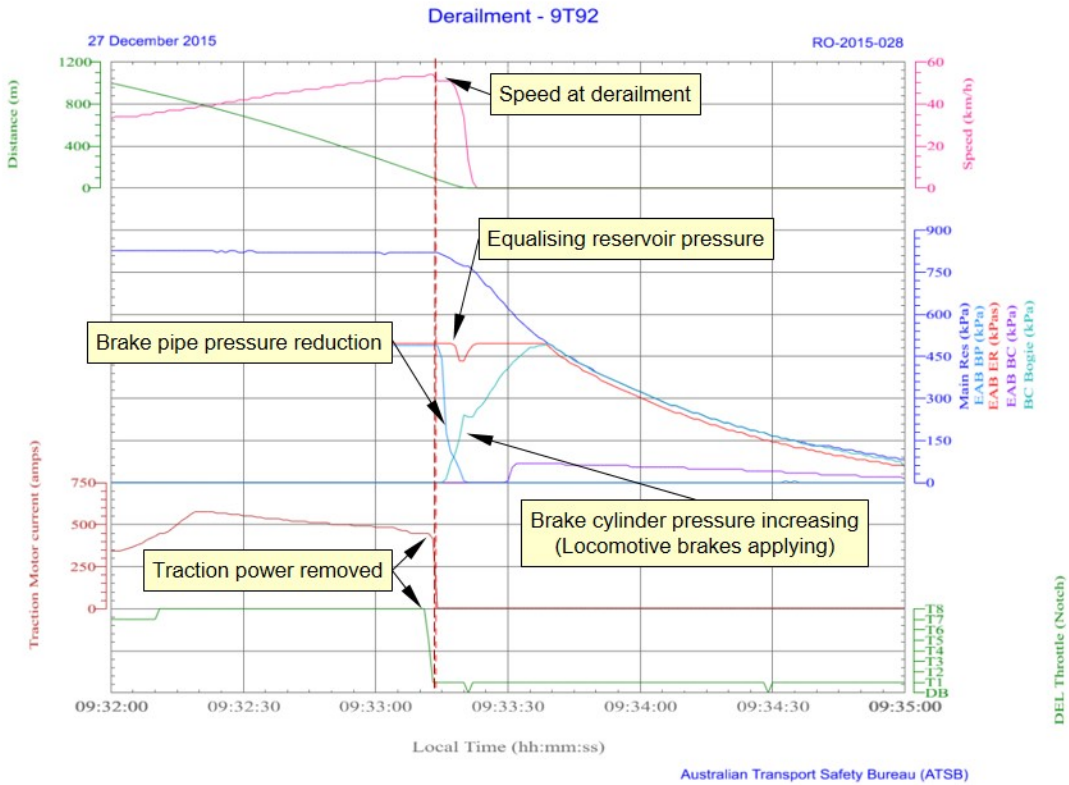
Figure 4: Locomotive 2814 data log plot

Plot of locomotive 2814 data log parameters. Plot illustrates driver actions in removing traction power immediately before train 9T92 enters the washed out track section. A rapid reduction in air pressure in the brake pipe occurs as train 9T92 traverses the washout and derails. Source: ATSB

Analysis of the data logger and ATP recordings by Aurizon engineering and maintenance staff showed that the reduction in brake pipe pressure did not correspond with a reduction in the equalising reservoir pressure. The movement of the brake handle by a driver toward the service or emergency position would typically cause both these pressures to reduce in unison.

The recorded events illustrate that a brake application, via the movement of the drivers brake handle to the emergency position (as recounted by the driver), did not cause the rapid reduction in brake pipe pressure. The reduction in brake pipe pressure was more likely due to a loss in brake pipe continuity during the derailment. The locomotive’s automatic brake control valve sensed the reduction in brake pipe pressure and began to apply the brakes on the locomotive.

While there is variance between the driver’s recollection and the data log analysis, the exact cause for brake pipe pressure reduction (brake handle or brake pipe continuity) had no material effect on the outcome of 9T92 entering the washout and derailing.

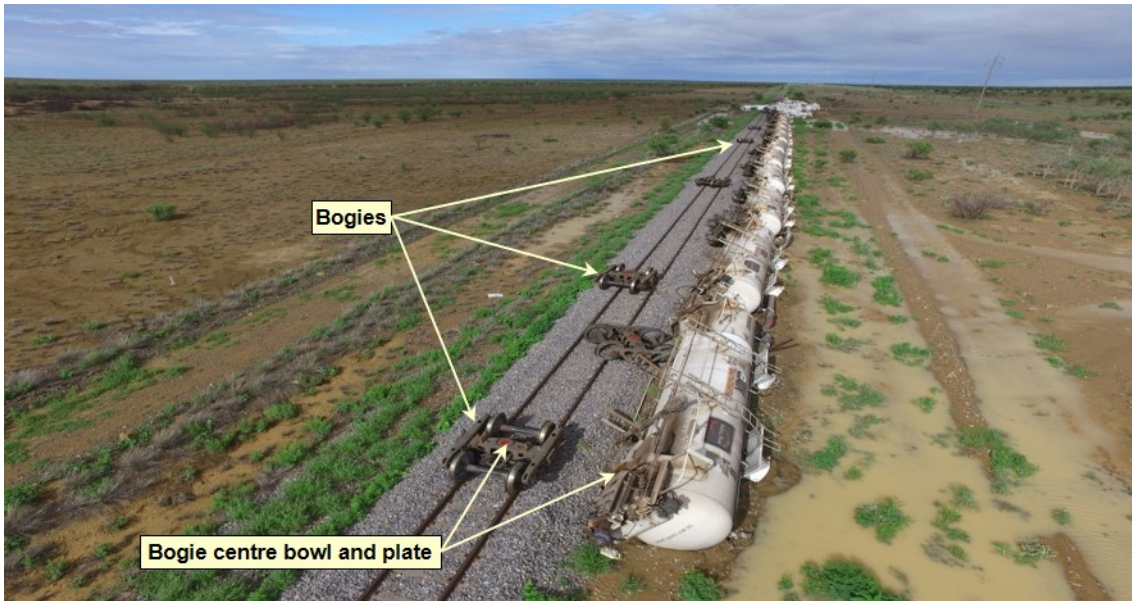
Figure 6: Domino effect derailment of GATX tanker wagon string

View of rear of 9T92 of the tanker wagons that derailed due to the 'domino-effect'. A number of the associated bogies remained in situ on the track adjacent to the corresponding position of the tanker unit bogie mounting point. Source: Queensland Police

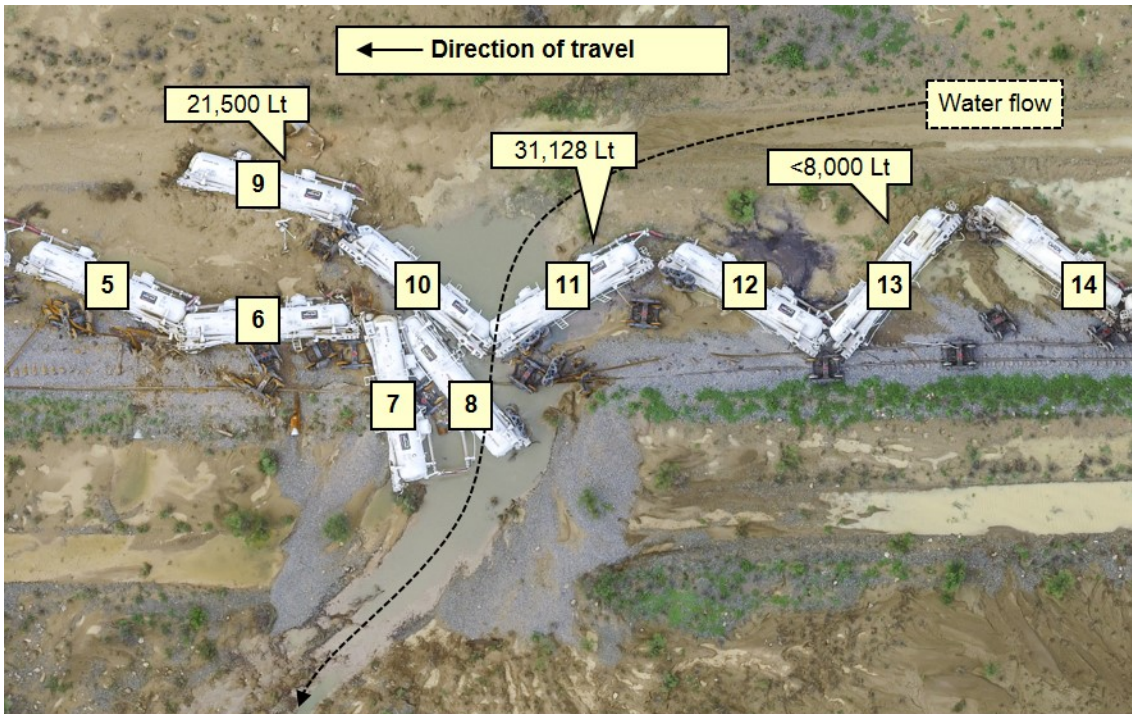
Figure 7: Acid hot zone

Derailment damage to tanker wagons in positions nine, eleven, and thirteen of the train caused sulphuric acid to escape (21,500 litres, 31,218 litres, and slightly less than 8,000 litres, respectively). The acid, 98 per cent pure, mixed with the surrounding floodwater and began to etch the damaged external surface of the tanker vessels within the acid pool hot zone⁷ (Figure 7).

This image identifies the wagons that leaked product before restoration. Wagon 9 leaked 21,500 litres, wagon 11 leaked 31,218 litres (all contents), and wagon 13 leaked less than 8,000 litres. Source: Queensland Police Service. Annotated by ATSB

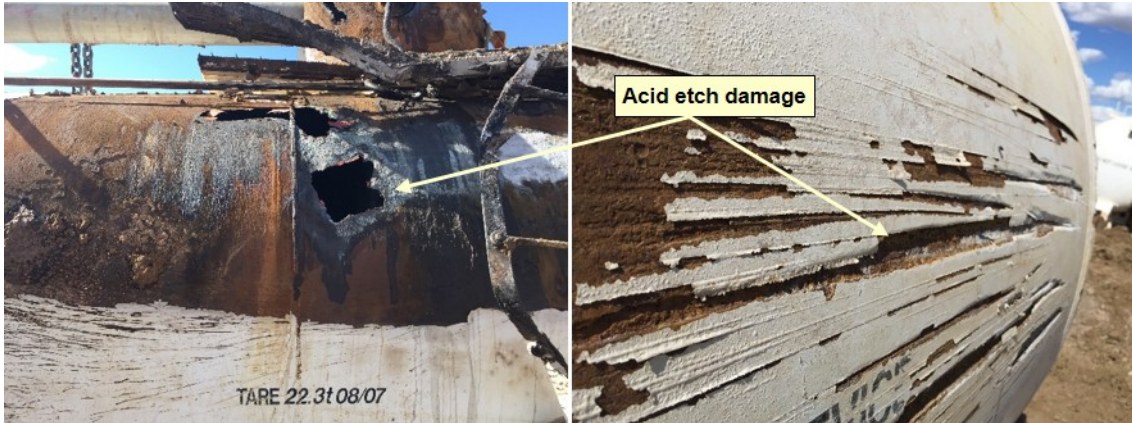
Figure 8: Acid etch damage to GATX tanker vessel

The etching resulted in further leakage of product, exacerbating the acid etching of the already damaged surfaces (Figure 8).

Images of acid etching to external surface of tanker vessel of GATX tanker wagon OZSY 44688. This tanker wagon was in position 11 of the train. Following the derailment, this tanker wagon was within the acid hot zone and lost all contents. Source: Incitec Pivot. Annotation by ATSB

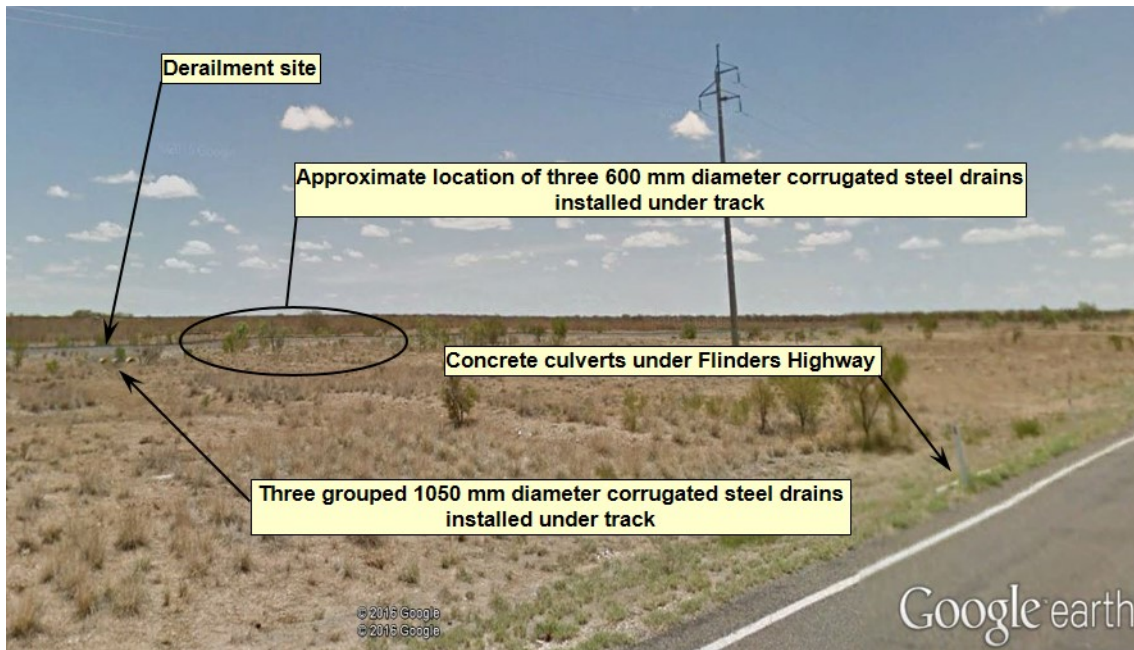
Figure 9: Under-track drainage at the derailment site

Location of the derailment as it appeared before the event - viewed in a south-westerly direction from the Flinders Highway. Rainwater runoff flows from the catchment to the north, passes through a series of concrete culverts under the highway and toward the railway formation. A series of circular corrugated steel pipes installed under the track formation allows water to then flow into the watercourses located to the south of the railway. Source: Google Earth, annotated by ATSB

Queensland Rail (QR) advised that the group of three 1050 mm corrugated steel pipes were installed during the re-construction of the Mount Isa line completed in the early 1960s. In the 1980s a flood occurred that resulted in scouring of the formation adjacent the three existing pipes. This event resulted in the addition of the three 600 mm corrugated steel pipes to the west.

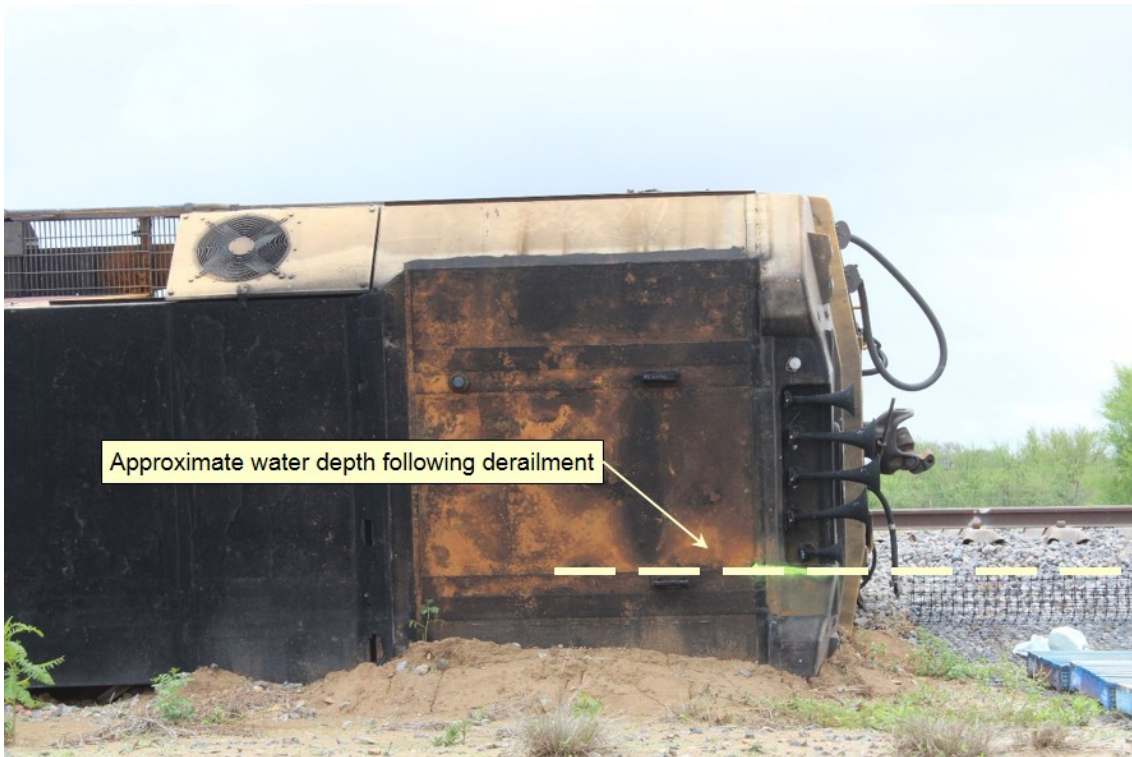
Figure 13: Approximate water depth following derailment

Watermark on the locomotive indicating the depth of the floodwater. Source: Queensland Rail

Based on the observed depth of water following the derailment, and evidence of sediment and scouring south of the track from water outflow (from under track drains and the washout), it was likely the level of floodwater that damaged the track formation was higher than was present at the time of the derailment. It is likely that water had banked up against the track formation, and the water level receded once the formation had washed away.

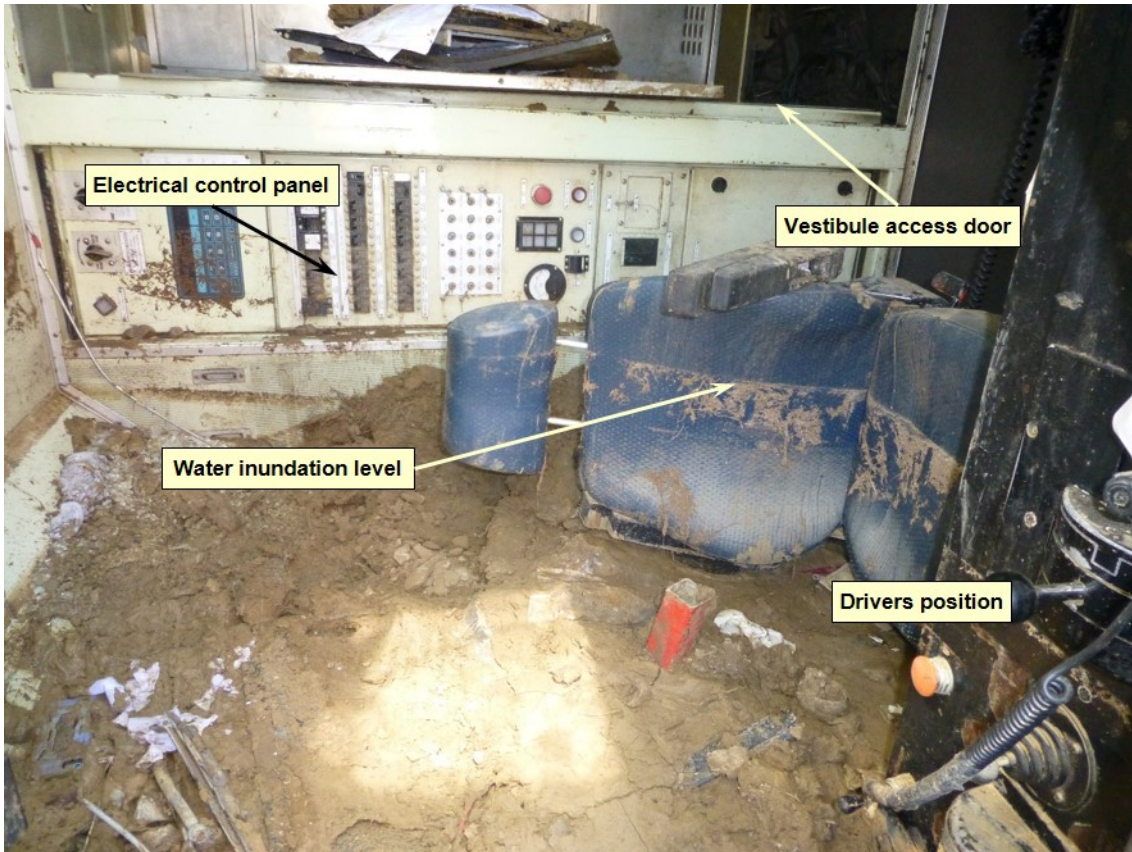
Figure 26: Locomotive 2814 cab

Image showing drivers side seating position and vestibule access door at the rear of the cab post derailment. Floodwaters and sediment entered the locomotive cab to a depth of 600 mm inundating communications and electrical systems. Debris in vestibule door was placed in vestibule during recovery operations. Source: ATSB

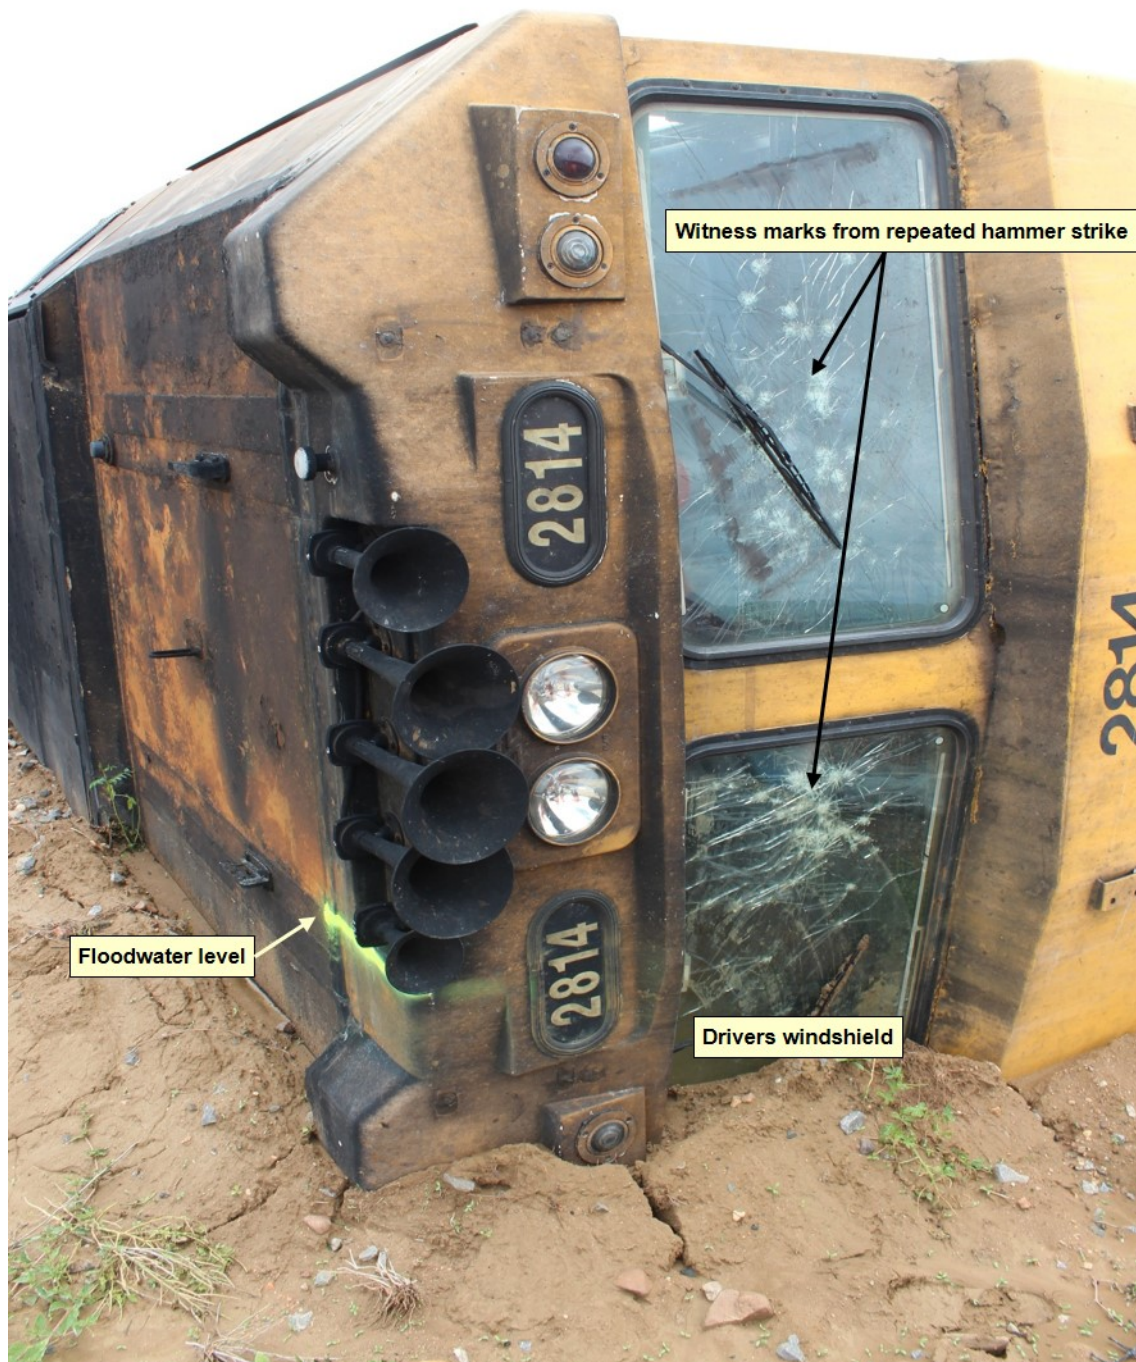
Figure 27: Damage to windscreens of locomotive 2814

Image of leading locomotive 2814 in its final resting place and indicative water level. The image displays repeated attempt by train crew to smash out the windscreens with the emergency hammer. Source: Queensland Rail
