Hydraulic leak involving Boeing 787, 9V-OFG

Melbourne Airport, Victoria, 8 September 2016

ATSB Transport Safety Report
Aviation Occurrence Investigation
AO-2016-114
Final – 14 December 2016

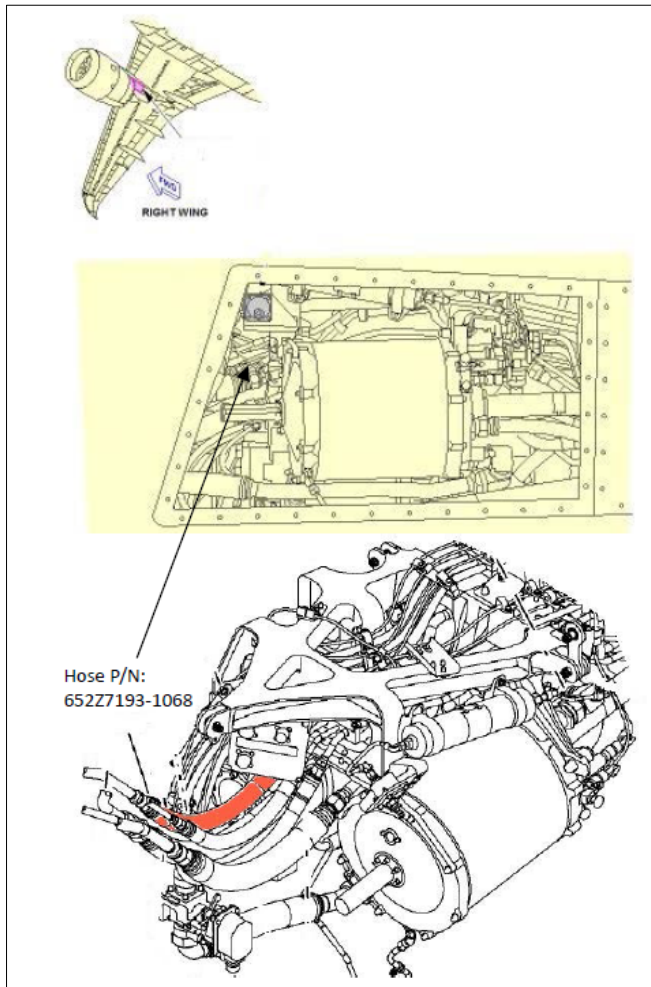
Figure 3: Location of hydraulic hose

During the turn-around inspection, another company maintenance engineer noted that the right hydraulic system was at the refill level. The engineer conducted leak checks on the right hydraulic system and found a damaged hydraulic hose in the right engine pylon hydraulic bay (Figures 2 and 3). The damaged hose was located downstream of the right engine thrust reverser stow line.

The failed hose was part of the thrust reverser retraction circuit and is otherwise isolated during flight. The thrust reverser circuit is the only location where this part is installed on the aircraft. Boeing note that the leak has previously been observed either as drip from the aft fairing of the engine pylon after flight, or during landing as a mist sprayed from the engine exhaust during thrust reverser retraction. Boeing has advised operators to heighten their awareness of the issue, and in the event of an observed leak at the aft pylon fairing module, to check the incident part number hose for a rupture. Boeing has recorded several in-service failures of this part number hose and investigated the fault with the part manufacturer.

A 'capture and control in production' process was introduced. This process has identified and screened out defective parts. Their own investigation has identified the likely root causes of the failures and identified the population of hoses affected. They have communicated recommended actions to aircraft operators, which describes how to identify and replace potentially affected hoses.

As per the aircraft manufacturer's recommendations, a 787 fleet check was conducted, potentially affected hoses identified, and replacement hoses ordered.

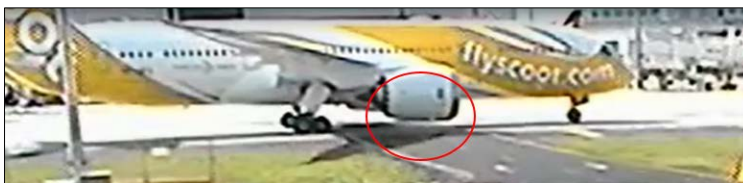
Figure 4: Aircraft stopped for inspection

At the time that the aircraft stopped for a visual inspection by ARFF, what was reported as smoke appears to be mist emanating from the vicinity of the engine oil breather (Figure 4). The presence of mist is consistent with the Boeing investigation into the failures of the affected hydraulic hose that indicates a rupture of this hose. However, the location of the mist suggests the source could have been (by itself or in addition to the hydraulic fluid) due to the engine oil breather. This is because the mist was also consistent with what Rolls Royce had previously noted as a visible white-coloured mist that can be observed emanating from the engine oil breather as a result of incomplete air/oil separation.

- The reported engine smoke was probably mist from the right hydraulic system leaking hydraulic fluid into the engine exhaust, or mist from the engine oil breather as a result of incomplete air/oil separation, or a combination of both conditions.
