# Depressurisation event involving de Havilland DHC-8, VH-XFP

67 km N Perth Airport, Western Australia, 7 August 2016

**ATSB Transport Safety Report**  
Aviation Occurrence Investigation  
AO-2016-093  
Final – 14 December 2016

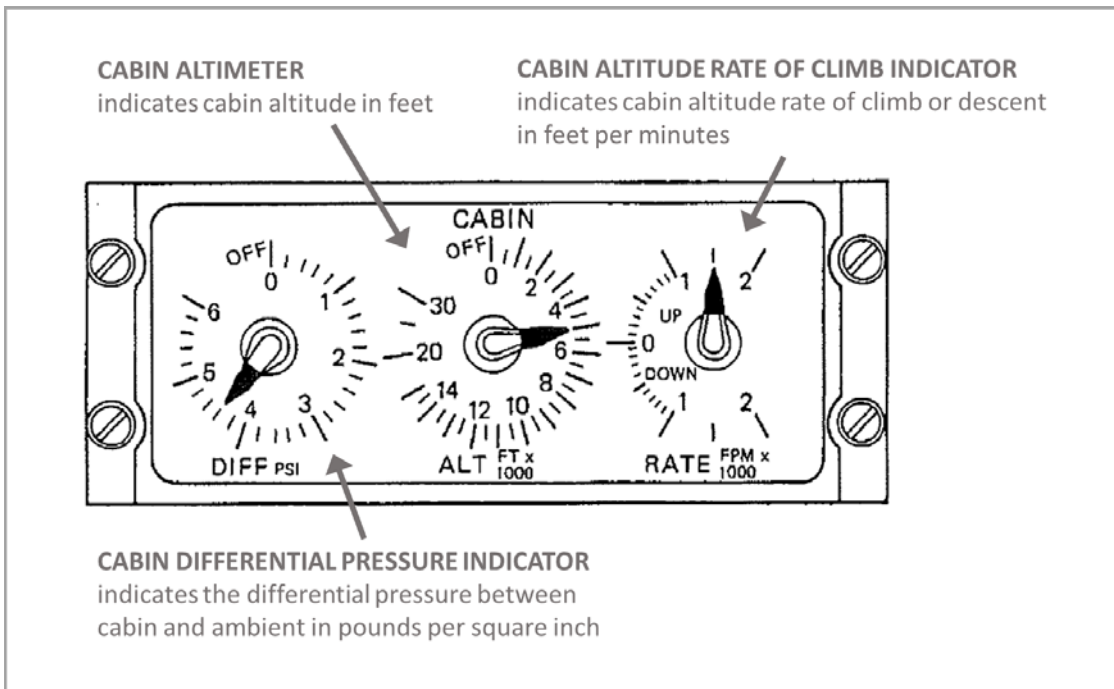
At about 10,000 ft, the flight crew conducted the transition checklist items that included checking the cabin pressurisation system and noted that everything was operating normally. The captain observed that the cabin altitude<sup>1</sup> was about 4,000 ft, the rate of climb was between 250 ft and 500 ft, and the maximum differential pressure between the outside air pressure and the cabin air pressure was about 2.5 to 3 psi (Figure 1).

**Figure 1: Cabin pressure indicator panel showing the cabin differential pressure, cabin altimeter and cabin altitude rate of climb indicators**
