Aviation Short Investigations Bulletin

Issue 55

ATSB Transport Safety Report
Aviation Short Investigations
AB-2016-161
Final – 14 December 2016

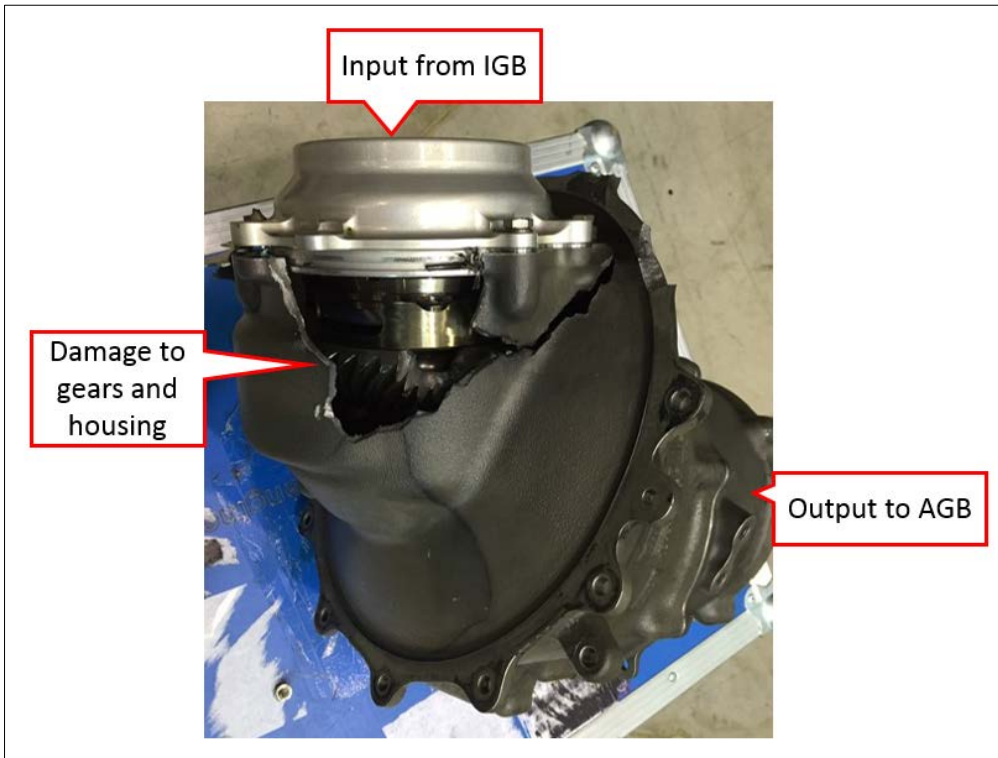
Figure 2: Transfer gearbox damage

On inspection, the TGB housing was found to be fractured (Figure 2). The TGB oil screen was found with metallic debris and the engine oil DMS sensor was found with metallic debris (Figure 3). The manufacturer’s inspection of the TGB failure indicated it was consistent with a known failure mode of the TGB described in their service bulletin (SB) 72-0298.

Pre-modified TGBs have a radial bevel gear with potential resonance modes (see *Resonance*) in the engine operating range. Excitation of resonance modes may lead to a gear fracture, which can result in engine oil loss and an in-flight shut down. The SB modification introduces a new damper ring groove to the radial bevel gear and a damper ring to mitigate the excitation of the resonance modes.

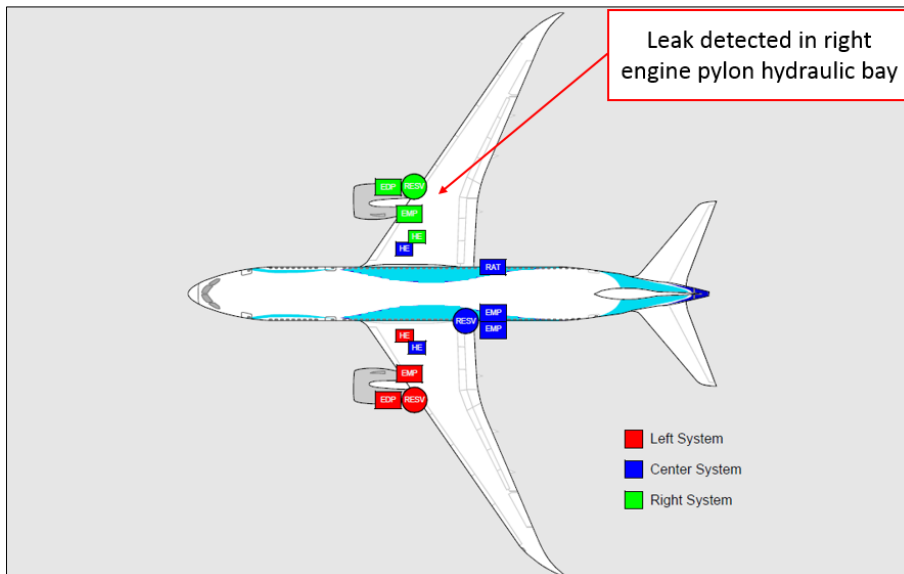
Figure 2: Location of aircraft hydraulic systems and leak

During the turn-around inspection, another company maintenance engineer noted that the right hydraulic system was at the refill level. The engineer conducted leak checks on the right hydraulic system and found a damaged hydraulic hose in the right engine pylon hydraulic bay (Figures 2 and 3). The damaged hose was located downstream of the right engine thrust reverser stow line.

During the turn-around inspection of the aircraft, the right hydraulic system fluid level was found to be low due to a ruptured hydraulic hose. This hydraulic hose is only installed in the engine thrust reverser retraction circuit and is otherwise isolated in flight. The flight data indicated that the reduction of fluid in the right hydraulic system, consistent with a hydraulic fluid leak, coincided with the thrust reverser retraction after landing.

As per the aircraft manufacturer's recommendations, a 787 fleet check was conducted, potentially affected hoses identified, and replacement hoses ordered.

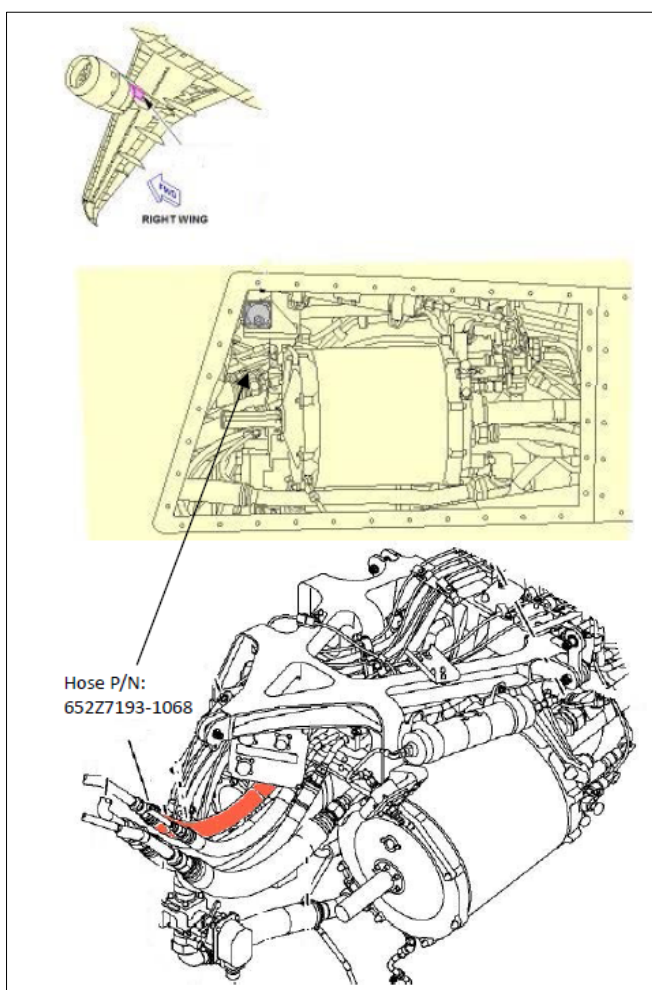
Figure 3: Location of hydraulic hose

The failed hose was part of the thrust reverser retraction circuit and is otherwise isolated during flight. The thrust reverser circuit is the only location where this part is installed on the aircraft. Boeing note that the leak has previously been observed either as drip from the aft fairing of the engine pylon after flight, or during landing as a mist sprayed from the engine exhaust during thrust reverser retraction. Boeing has advised operators to heighten their awareness of the issue, and in the event of an observed leak at the aft pylon fairing module, to check the incident part number hose for a rupture. Boeing has recorded several in-service failures of this part number hose and investigated the fault with the part manufacturer.

A 'capture and control in production' process was introduced. This process has identified and screened out defective parts. Their own investigation has identified the likely root causes of the failures and identified the population of hoses affected. They have communicated recommended actions to aircraft operators, which describes how to identify and replace potentially affected hoses.

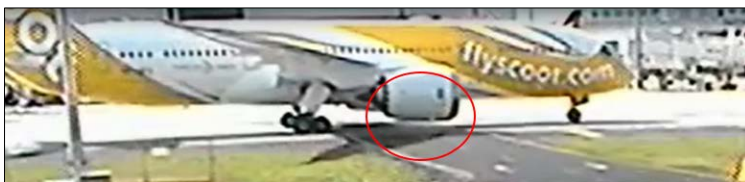
Figure 4: Aircraft stopped for inspection

At the time that the aircraft stopped for a visual inspection by ARFF, what was reported as smoke appears to be mist emanating from the vicinity of the engine oil breather (Figure 4). The presence of mist is consistent with the Boeing investigation into the failures of the affected hydraulic hose that indicates a rupture of this hose. However, the location of the mist suggests the source could have been (by itself or in addition to the hydraulic fluid) due to the engine oil breather. This is because the mist was also consistent with what Rolls Royce had previously noted as a visible white-coloured mist that can be observed emanating from the engine oil breather as a result of incomplete air/oil separation.

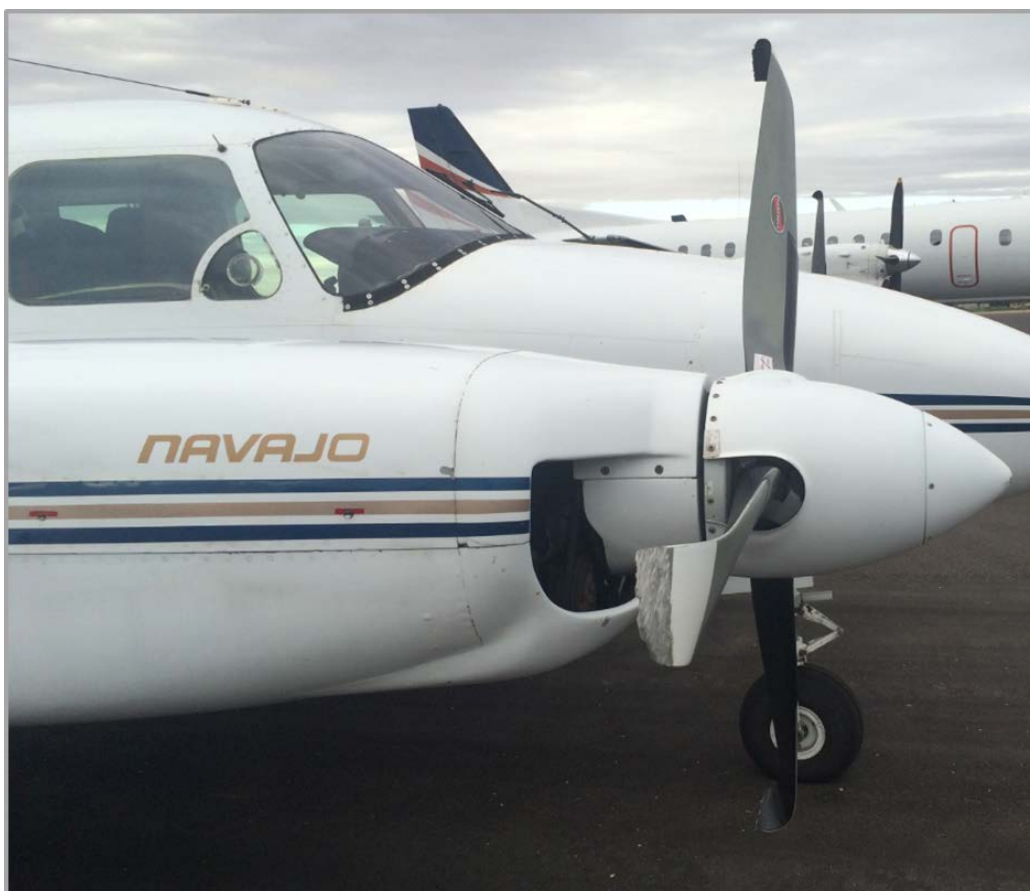
Figure 3: Damage to ETW propellers

The pilot conducted a circuit, selected and held the landing gear handle in the down position and the aircraft landed without further incident. The pilot and passengers were uninjured and the aircraft had minor damage to the propellers (Figure 3).

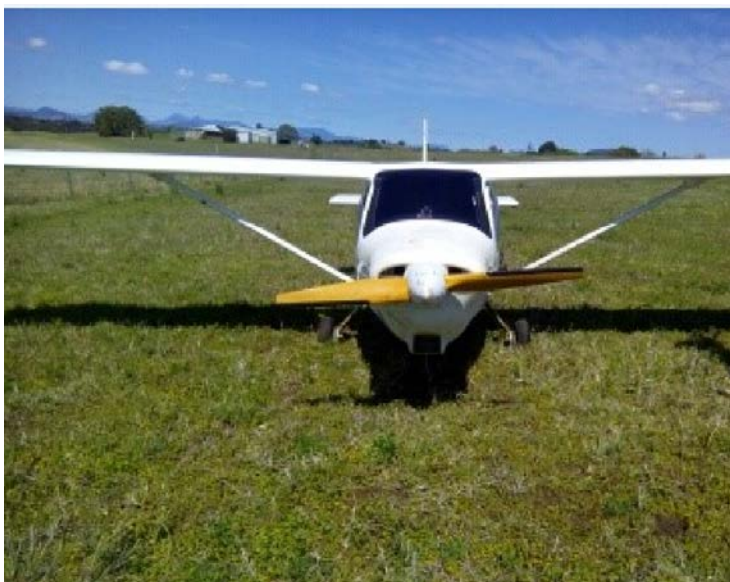
Figure 3: 19-5503 after the forced landing

The pilot identified a paddock to the north of their position as suitable for a forced landing. They manoeuvred the aircraft to conduct a forced landing into the paddock (Figure 1). The pilot ensured that turns made during the forced landing were not tight and of low bank angle to avoid an aerodynamic stall. Late in the ground roll, the nose wheel dug into the soft surface (Figure 2), the aircraft tipped onto its nose and the right wingtip struck the ground. The aircraft then stopped and settled onto its wheels. The pilot was not injured and the aircraft sustained minor damage.

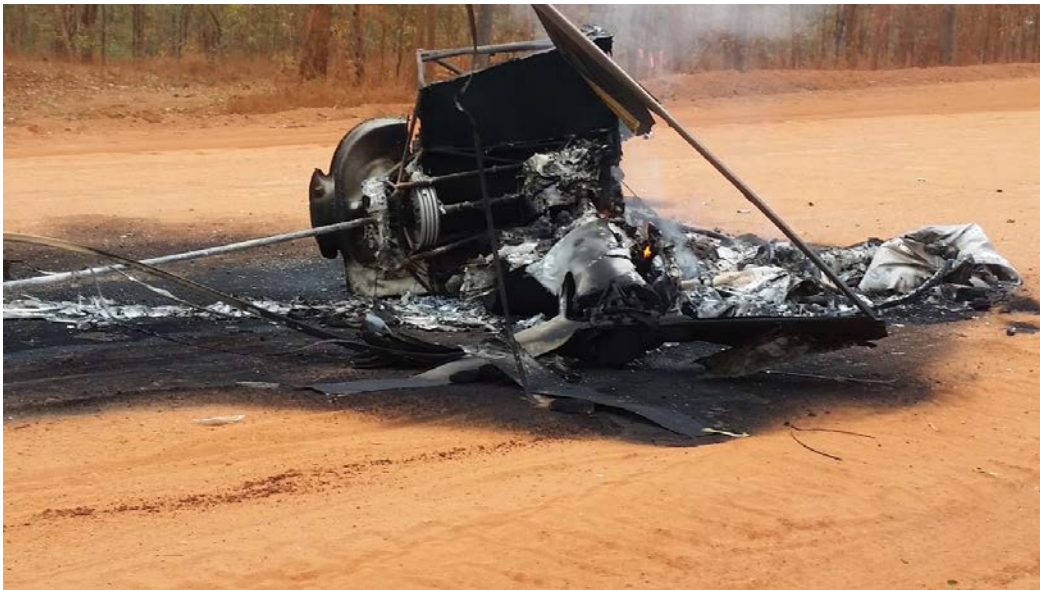
Figure 4: Accident site showing VH-PFX destroyed by post-impact fire

As the helicopter slid along the ground, it caught fire. The pilot exited with minor injuries and the helicopter was destroyed (Figure 1).
