# Aircraft separation issues involving Embraer ERJ 190, VH-ZPJ, and GippsAero GA-8, VH-XGA

near Mildura Airport, Victoria, 31 May 2016

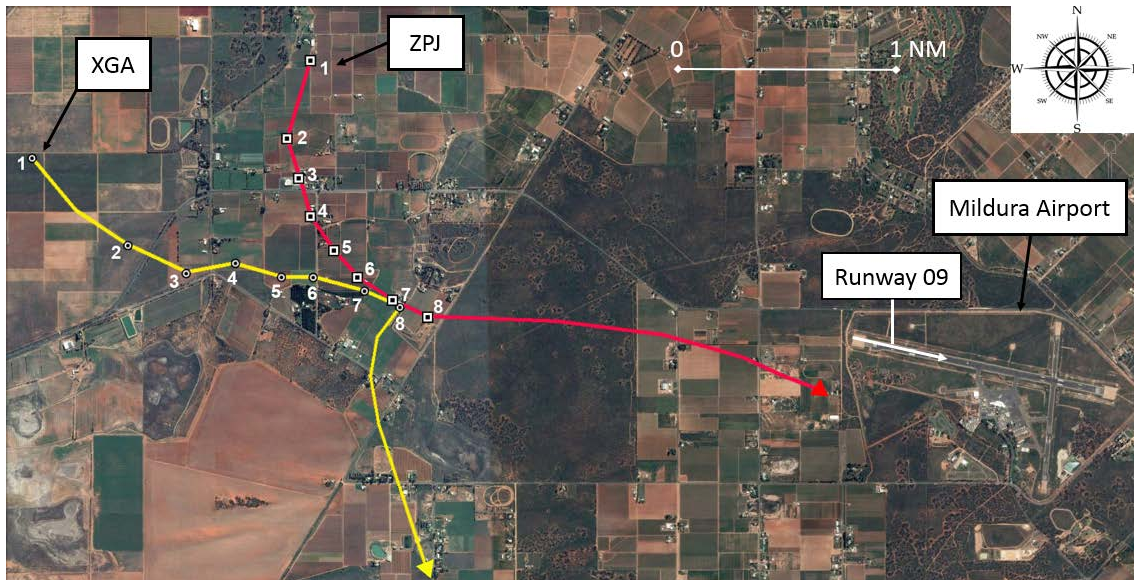
**Figure 1: Traffic conflict between ERJ 190 (VH-ZPJ) and GA-8 (VH-XGA)**

The PF on board ZPJ decided to discontinue their approach to land on runway 09, as they were too late for their turn onto final and therefore not in a stabilised condition.<sup>4</sup> However, the PM indicated to the PF that they could not execute a go-around manoeuvre because there was another aircraft joining the circuit on crosswind (the light twin-engine aircraft). The PF decided that continuing the approach to land was not an option and therefore executed the go-around to the south of runway 09, maintained separation from the other traffic on crosswind and then landed from the subsequent circuit. During the go-around manoeuvre, the aircraft's TCAS detected XGA pass about 200 ft above and 0.125 NM behind ZPJ (position 7 & 8 in Figure 1).

Source: Google earth, annotated by ATSB based on Virgin Australia Airlines TCAS data (numbers indicate the relative positions of the conflict aircraft at the same time)

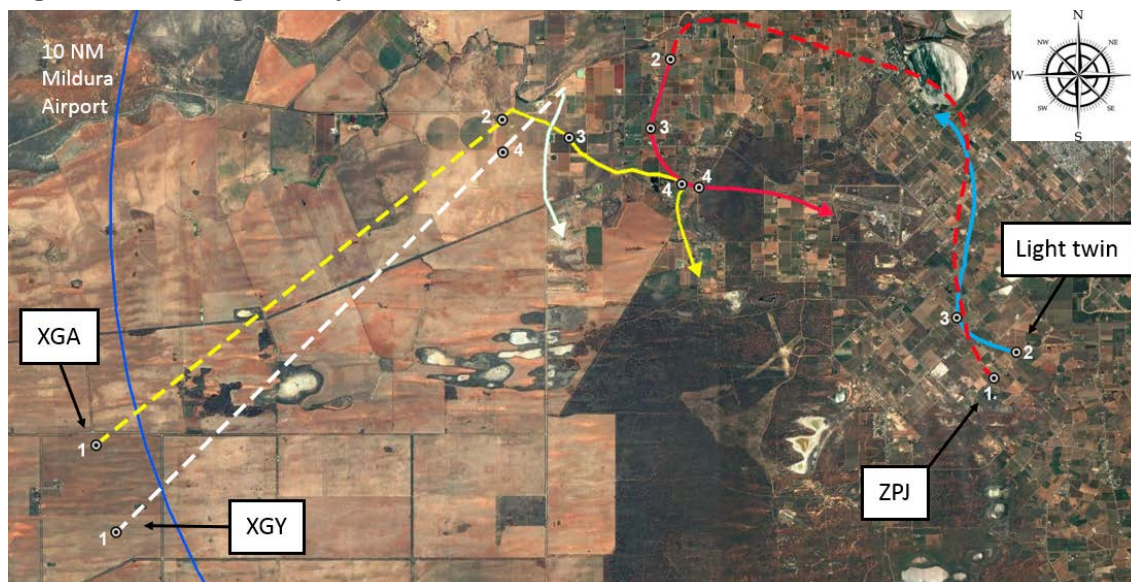
**Figure 2: Aircraft geometry from Table 2**

The following Table 2 indicates the positions of ZPJ and the conflict aircraft XGA. Figure 2 depicts the geometry of traffic in the vicinity with numbering in accordance with Table 2. The positions of the aircraft are based upon TCAS data from ZPJ.

Time	Event	VH-ZPJ	VH-XGA
1:15:27 (1)	ZPJ CTAF broadcast – joining circuit	2,237 ft, 2.5 NM SE Mildura Airport	11,130 ft, 10.5 NM WSW Mildura Airport
1:18:16 (2)	CTAF broadcast ZPJ – after turning base	1,009 ft, Base runway 09	3,209 ft, 4.5 NM final runway 09
1:18:31 (3)	Aural TA annunciation	733 ft, Base runway 09	1,300 ft, 3.5 NM final runway 09
1:18:59 (4)	Closest point of approach	442 ft, 2.0 NM W runway 09	642 ft, 2.1 NM W runway 09
