Severe turbulence involving Bombardier DHC-8, VH-LQM

30 km south of Canberra Airport, Australian Capital Territory, 10 October 2016

ATSB Transport Safety Report
Aviation Occurrence Investigation
AO-2016-132
Final – 17 January 2017

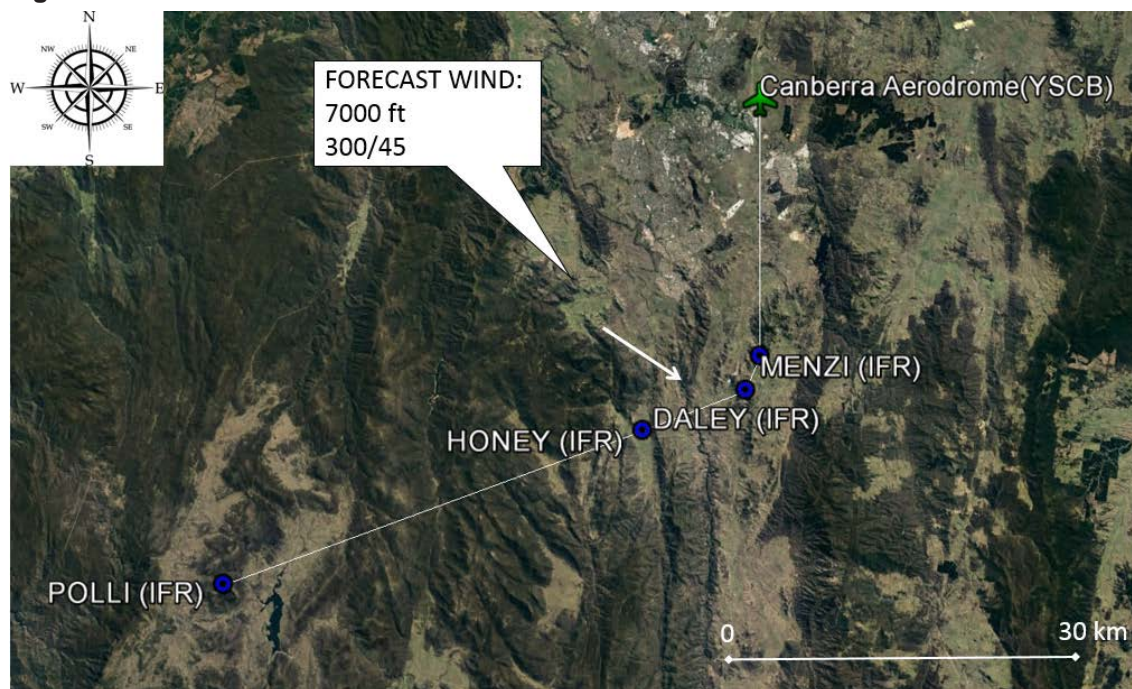
Figure 1: POLLI FOUR ALPHA arrival track of VH-LQM

The aircraft departed from Melbourne at about 1158 Eastern Daylight-saving Time (EDT) and climbed to a cruising level of FL 210.⁴ The flying conditions were smooth at FL 210 and the flight was issued with the POLLI FOUR ALPHA standard arrival route into Canberra, which started at waypoint POLLI, to the south west of Canberra (Figure 1). The flight crew instructed the cabin crew to prepare the cabin for landing several minutes before the top of descent. However, the flying conditions continued to be smooth during the descent, so the flight crew waited until about FL 130 before activating the seatbelt sign. This was shortly after passing waypoint POLLI.

Between waypoints GOMAN and HONEY, the aircraft descended below FL 110 and the PF reduced the aircraft speed to 210 kt, which is the best speed for turbulence penetration. The PM estimated that the tailwind component reduced from about 70 kt to about 40 kt after the descent below FL 110. At this point, the aircraft was tracking about 060° and passing in and out of cloud over the Brindabella Ranges, which has ridgelines orientated north-south to the south-west of Canberra.

During the descent, the flight crew did not observe any weather radar indications of potential turbulence or visible indications from the shape or movement of the clouds. Between waypoints HONEY and DALEY at about 7,000 ft AMSL, while passing through a small cloud, the aircraft dropped abruptly. The flight crew reported that everything in the flight deck became airborne, the autopilot disengaged and the PF struck the left side of their head on the overhead air-vent and light, which dislodged their headset. The captain handed control over to the first officer while they refitted their headset and re-established communications, then resumed their flying pilot role and reset the auto-pilot.

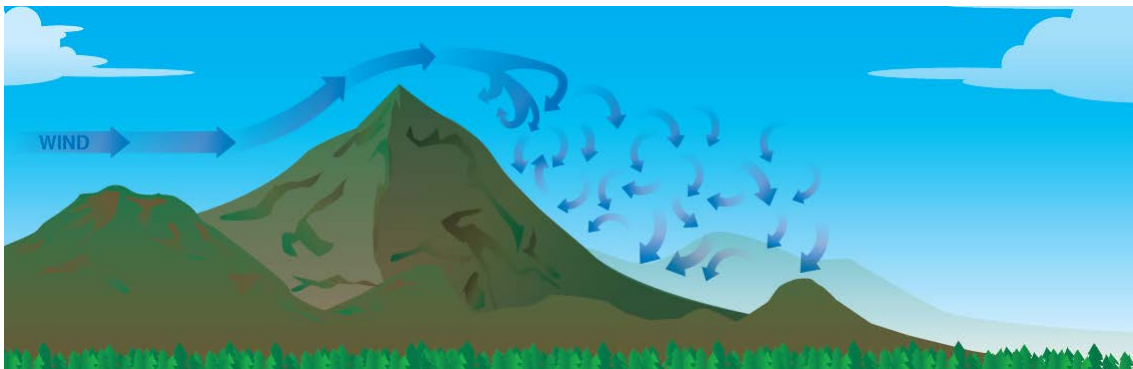
Figure 2: Mountain wave turbulence

Mountain waves may be experienced on the lee-side of mountain ranges as smooth undulating airflow or may contain turbulence in the form of breaking waves and rotors (Figure 2). They typically form when the wind direction is close to perpendicular to a ridge line (+/-30°), the wind speed is at least 15 kt⁶ and increases with height, and there is stable air above the crest of the ridge with less stable air above that and a stable layer below the ridge. The formation of clouds on the lee-side may indicate turbulent flying conditions. Further information can be found in the ATSB website safety publications: [Mountain wave turbulence](#).

As the aircraft tracked from waypoint HONEY to DALEY, it entered the lee-side of the Brindabella Ranges, tracking towards the north-east with a strong tailwind component. The wind was forecast to be 30 kt at 5,000 ft, increasing to 45 kt at 7,000 ft and within 30° of perpendicular to the ridgeline, at this location. Therefore, the abrupt encounter with turbulence was probably the result of mountain wave activity.

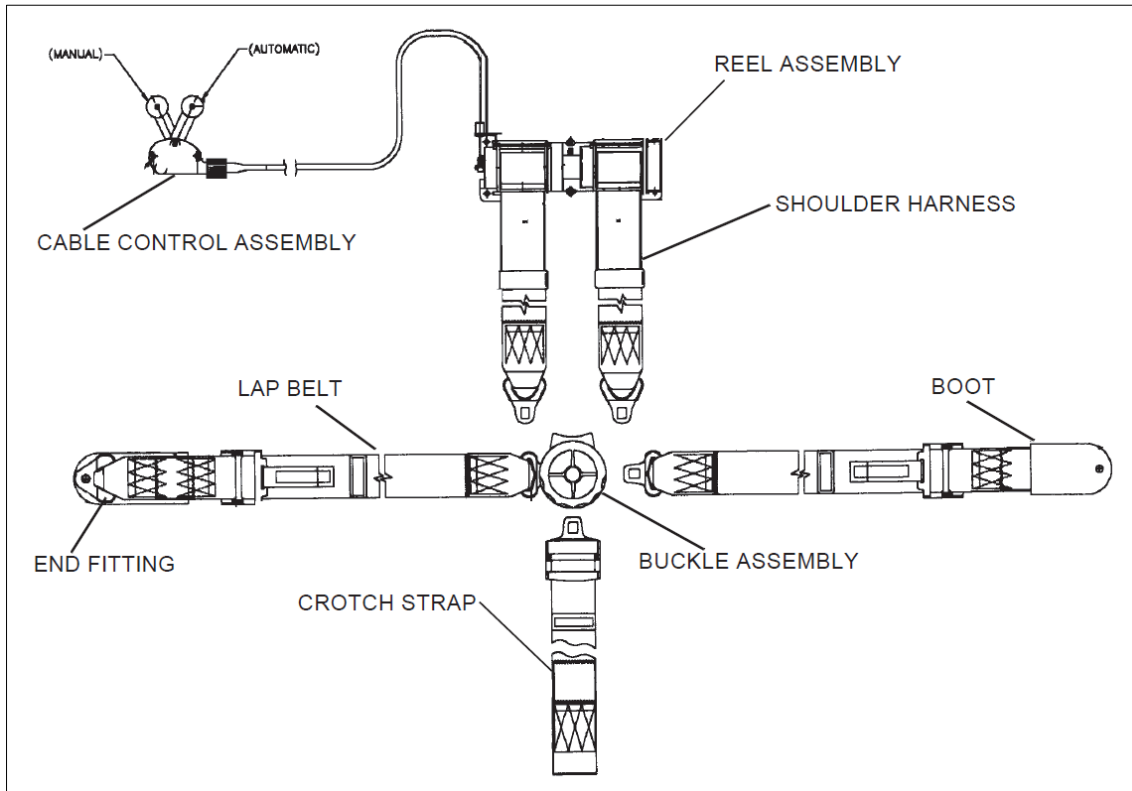
Figure 3: Aircraft flight crew harness

The aircraft’s flight crew seats are fitted with five point harnesses. The harness consists of a lap belt, a rotary buckle, a crotch strap, two shoulder straps and inertia-reel assembly with emergency locking retractors and cable control assembly (Figure 3). At the time of the turbulence, both flight crewmembers had the five points of their harnesses fitted, but with their shoulder harnesses in the AUTOMATIC position. In the AUTOMATIC position, the shoulder harness inertia-reel permits the occupant to move forward slowly, but locks when the straps are pulled at 1.5G and remains locked until the force is removed. In the MANUAL position, the shoulder straps are locked. The shoulder harness is primarily intended to mitigate forward movement of the torso and head.

The lap belt combined with the crotch strap are the primary means of restraint for turbulence encounters and exposure to negative-G forces. The crotch strap is also referred to as the ‘negative-G strap’ and its purpose is to reduce upward movement of the lap belt during negative-G aircraft motion. The length of the crotch strap should be adjusted such that no slack exists in the strap when the lap belt is properly positioned in the pelvic region. In this position, the crotch strap will resist the upward pull from the shoulder harness in negative-G.

When the aircraft encountered the negative-G turbulence, the captain felt the aircraft drop from underneath them and struck their head on the overhead air-vent and light. The captain and first officer reported that they had their lap belts tightened to ‘firm but comfortable’. The first officer reported that they may have hit their head on the ceiling of the flight deck, but received no injuries. The captain reported that some crotch straps do loosen during flight. The captain also advised that they had set their seat height so their eyes were lined up with height bar markers on the screen. They estimated that provided them with about 20-25 cm head clearance.

During the encounter, the flight crew described their movement relative to the aircraft as vertical when the aircraft dropped from underneath them. The primary method of restraint for negative-G is the lap belt supported by the crotch strap. If there is slack in the lap belt, this will permit the body to move up relative to the lap belt, and if there is slack in the crotch strap, this will permit the lap belt to move up if it is pulled upwards by the shoulder harness. The captain reported that the crotch strap can loosen with occupant movement and the aircraft was subject to minor fluctuations in G before the turbulence incident. Therefore, the captain's injury was probably the result of some measure of slackness in their crotch strap.

This incident highlights the importance of flight crew preparation for entry into an area of forecast turbulence and the importance of ensuring the correct adjustment of all harness straps. The captain planned to activate the seat belt sign early on the descent into Canberra and briefed the cabin crew accordingly. On descent into Canberra, all personnel were seated, the seat belt sign was activated and the aircraft speed reduced to turbulence penetration speed before the encounter with severe turbulence, which minimised the risk of injury to personnel and damage to the aircraft. However, despite the precautions taken by the crew, the captain received minor injuries.
