Aviation Short Investigations Bulletin

Issue 56

ATSB Transport Safety Report
Aviation Short Investigations
AB-2016-176
Final – 17 January 2017

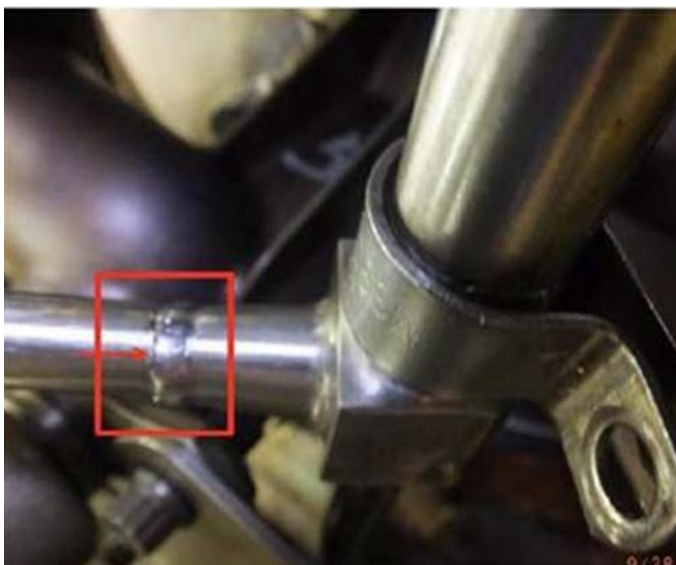
Figure 2: Fractured oil supply line

A subsequent engineering inspection found the left oil supply line to bearings numbers 4 and 5 had fractured and the associated clamp was broken (Figure 2).

- The oil supply line to bearings 4 and 5 fractured at a welded joint and its support clamp was broken, resulting in an oil leak and therefore low oil pressure and quantity in the left engine.
- Following the receipt of a left low oil pressure warning, the flight crew completed the non-normal checklist, shut down the left engine and conducted a diversion to Adelaide.

The operator performed a fleet-wide inspection and found no leaks or cracks on any other engine.

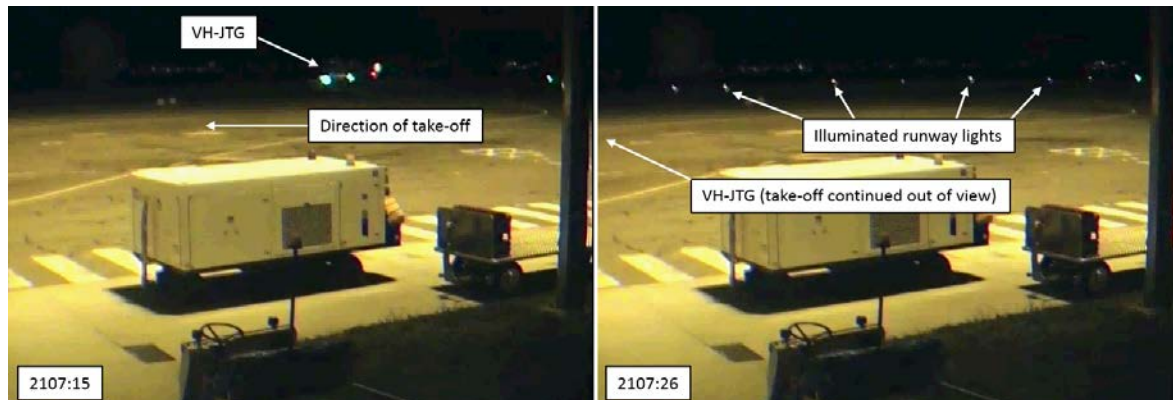
Figure 2: Take-off run of JTG on 19 August showing runway lights not activated (left) and then activated (right)

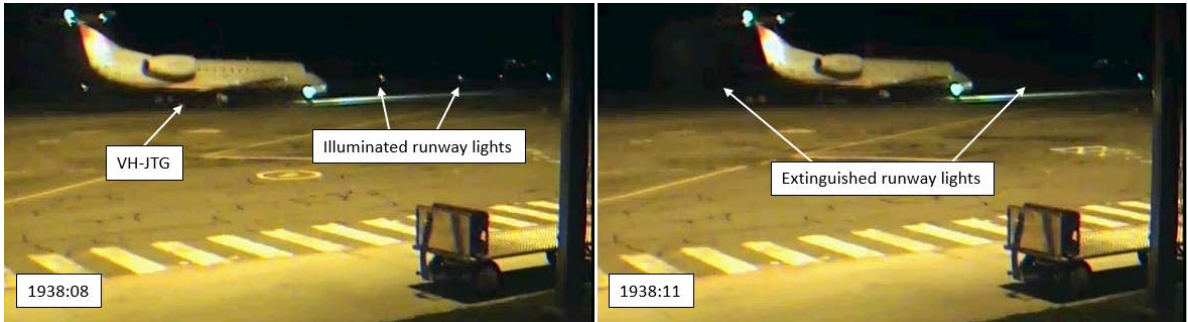
Figure 3: JTG taxiing on 28 August with runway lights illuminated (left) and then extinguished (right)

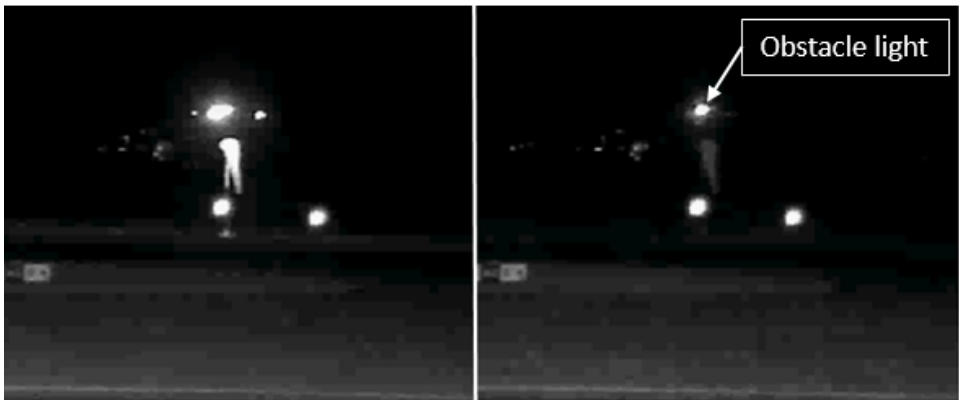
Figure 4: Flashing primary wind indicator showing the windsock illuminated when the runway lights were active (left) and not illuminated (right)

- The primary wind indicator at Tamworth is situated so that it is illuminated by light from the adjacent apron lighting and a red obstacle light is located above the windsock. On subsequent flights to Tamworth, the first officer has observed that this gives the appearance of the windsock being illuminated when the runway lighting is extinguished (Figure 4).

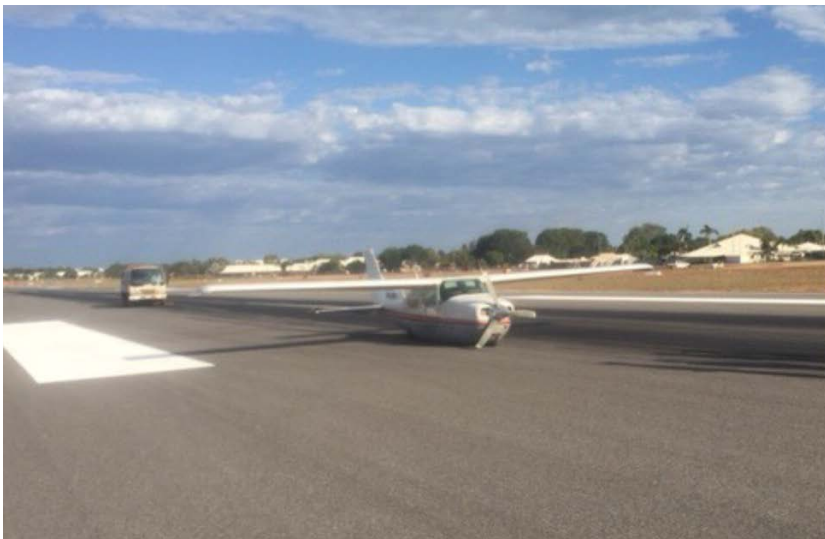
Figure 1: UPN after the wheels-up landing

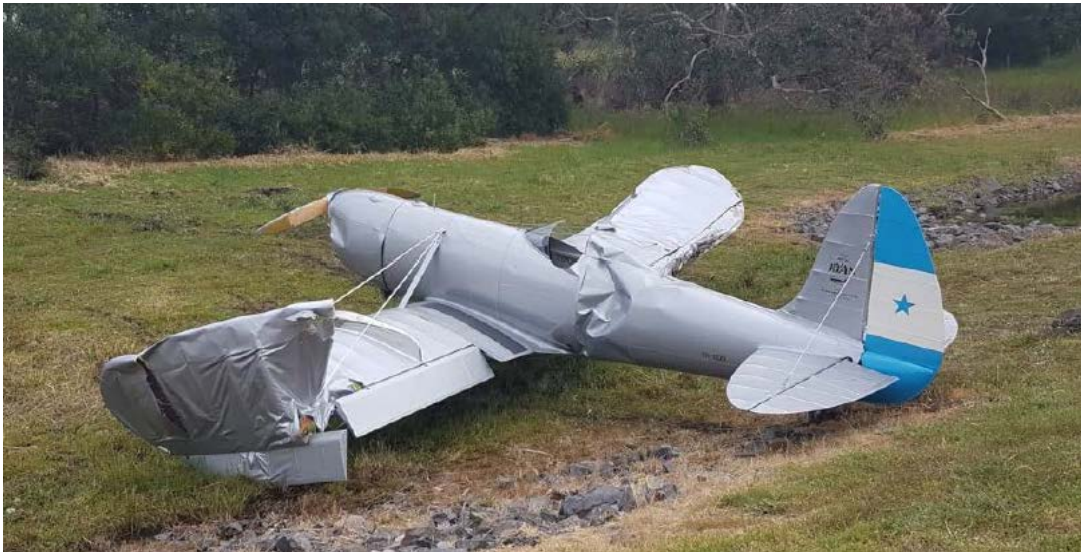
Figure 1: Accident site showing damage to VH-SQD

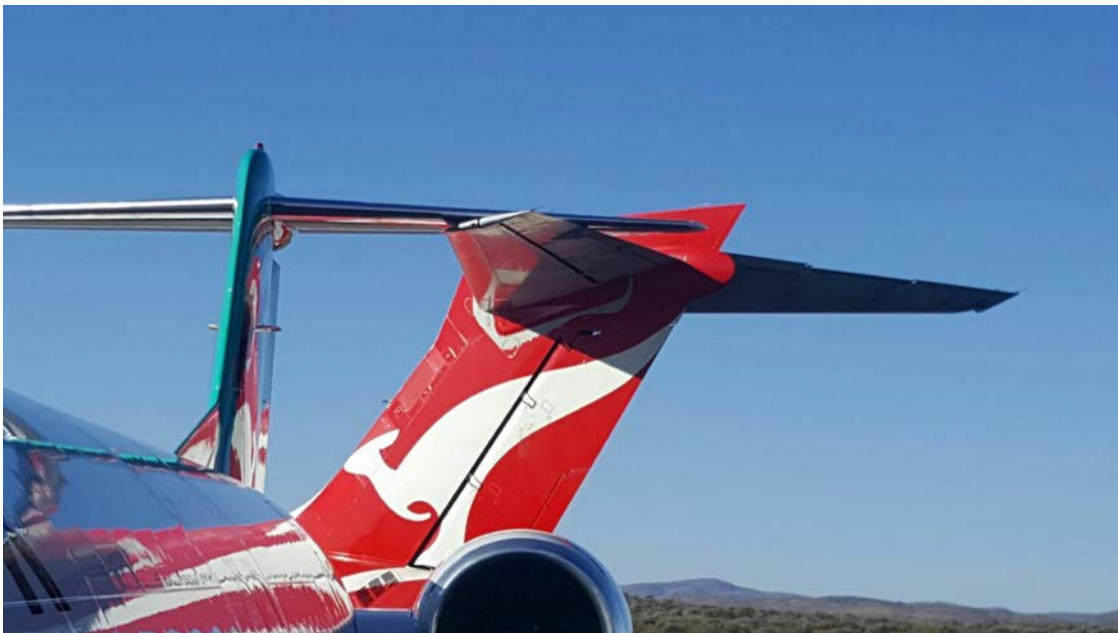
The engineer had expected NXN to taxi towards the runway rather than turning around the back of the F100. The engineer immediately assessed that the horizontal stabilisers of the two aircraft may collide, and tried to signal the captain to stop, but was near the wing of the aircraft and no longer in the captain's sight. The engineer ran towards the front of the aircraft and waved to the captain to stop. The captain braked heavily. The crew did not feel a collision. Some hours later, it was determined that the horizontal stabiliser of NXN had slid under that of NHF, scraping the surface, and both aircraft sustained minor damage (Figure 2). The passengers and crew of NXN were not injured and no one was on board NHF.

Figure 2: Horizontal stabiliser of NXN under that of NHF
