Emergency evacuation involving Fokker F28, VH-NHY

Perth Airport, Western Australia, 23 September 2016

ATSB Transport Safety Report
Aviation Occurrence Investigation
AO-2016-125
Final – 9 February 2017

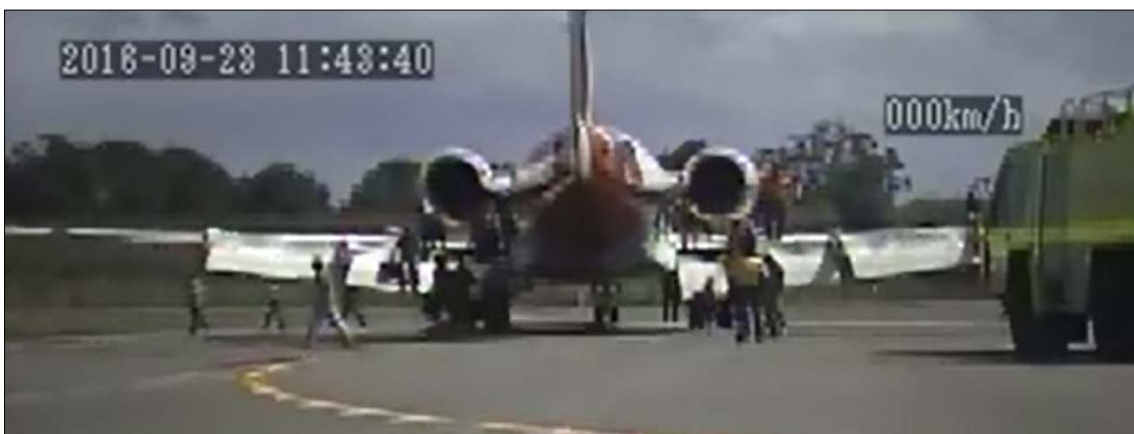
Figure 1: Emergency evacuation of VH-NHY

situation and discuss the public address requirements. While on the interphone to the captain, the CCM reported that there were fumes present in the cabin. The captain turned the APU bleed off, to prevent the APU supplying air to the cabin. However, the CCM then reported that the fumes in the cabin were getting worse. Consequently, the captain suspected the fumes could be from the engines and in consultation with the CCM they elected to conduct an emergency evacuation (Figure 1).

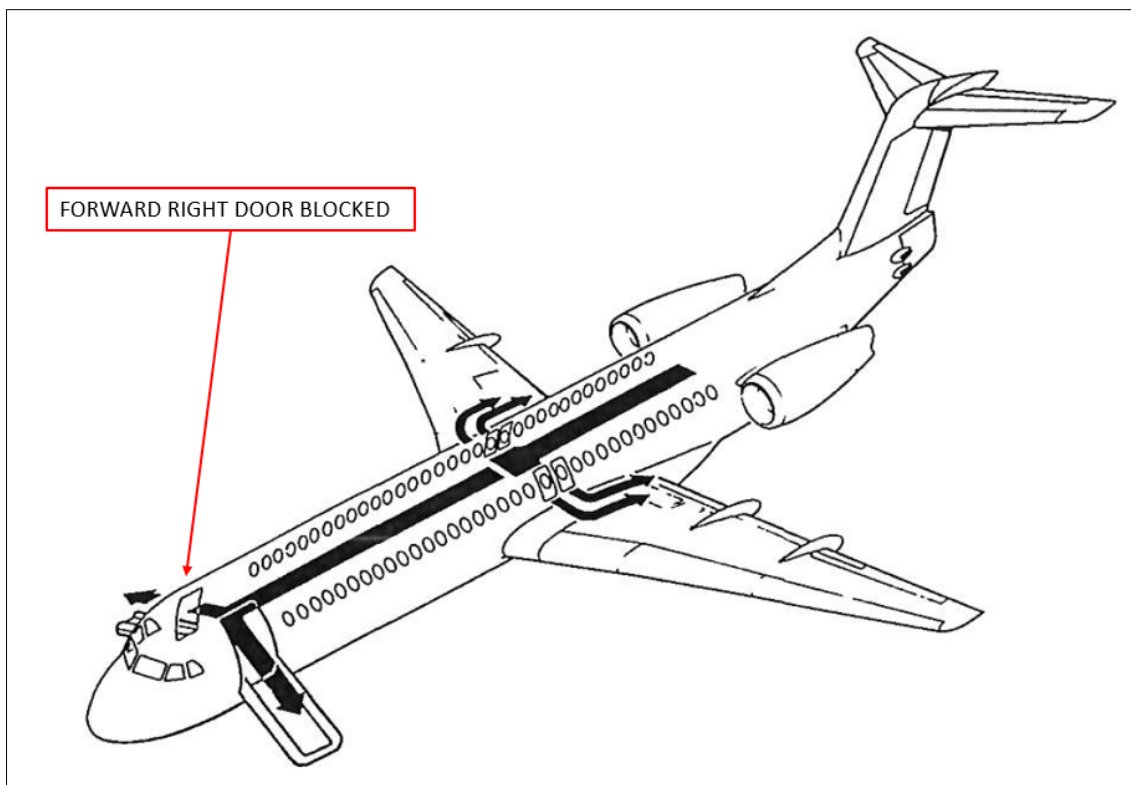
Figure 2: Aircraft emergency evacuation routes

The flight crew started the emergency evacuation checklist and the captain called for the evacuation over the public address system. The cabin crew opened the two front doors and the four over-wing emergency exits were removed by the passengers (Figure 2). The forward left door (L1) slide did not automatically inflate when the slide deployed, so the CCM manually inflated the slide. When the CCM checked on the forward right door (R1) slide they observed that it was not deployed and the cabin crewmember was blocking the exit. The passengers evacuated through the forward left door and the over-wing exits.

During the emergency evacuation, the R1 door slide did not deploy. The maintenance inspection found the R1 door was disarmed and no fault was found with the door operating mechanism. Therefore, it is likely that during the emergency evacuation procedure the cabin crewmember at the R1 door reverted to previous experience and disarmed the door prior to opening it, which prevented the slide from automatically deploying.

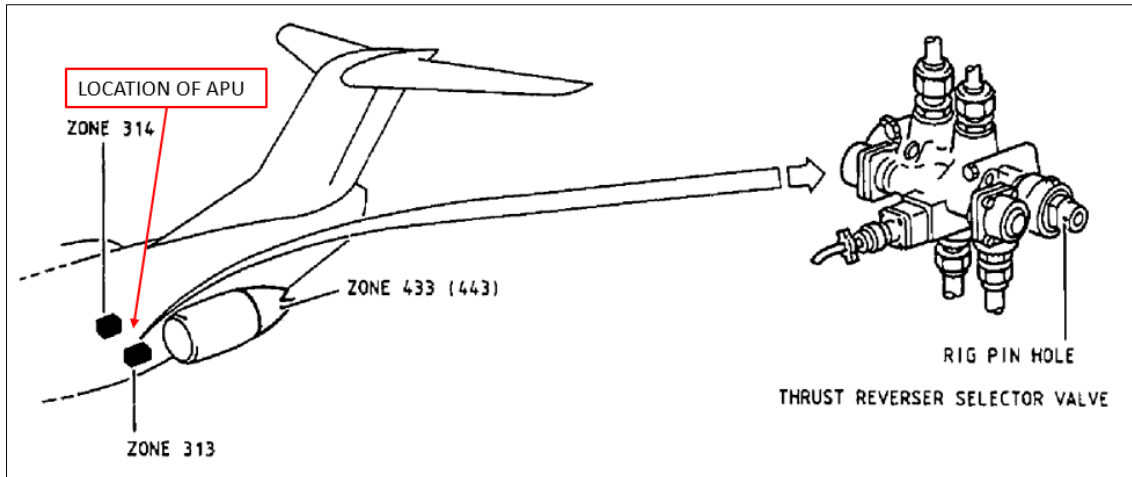
Figure 3: Location of APU and thrust reverser selector valves

The maintenance organisation found the number 1 engine thrust reverser selector valve (see *Thrust reverser selector valves*), located in the left outboard APU (see *Auxiliary power unit*) compartment (zone 313), leaked hydraulic fluid from a damaged O-ring (Figure 3). Further inspection found the APU and air-conditioning system were contaminated with hydraulic fluid.

A gap between the APU intake door actuator rod cut-outs was identified as the path for contaminated air to enter the APU inlet. When the APU inlet door is open inflight, air is scooped into the inlet creating an area of high pressure. However, when the aircraft is on the ground with the APU running, the APU inlet becomes an area of lower pressure as the APU is now ‘sucking’ air into the inlet.

- A damaged O-ring in the left engine thrust reverser selector valve resulted in a hydraulic leak.
- Hydraulic fluid, or vapour, entered the APU air intake through a gap between the APU intake door actuator rod cut-outs.

Following the replacement of parts contaminated with hydraulic fluid and cleaning of the APU area and air-conditioning system, the operator and their maintenance organisation conducted air quality checks on the aircraft before return to service.

Changes to the aircraft maintenance program have been introduced to proactively identify potential issues, such as detailed visual inspections within areas which may lead to potential air quality issues.
