# Loss of separation involving Boeing 737 aircraft, VH-YFN and VH-VZV and Robinson R44, VH-WYR

near Essendon Airport, Victoria | 26 January 2016

**ATSB Transport Safety Report**  
Aviation Occurrence Investigation  
AO-2016-005  
Final – 9 March 2017

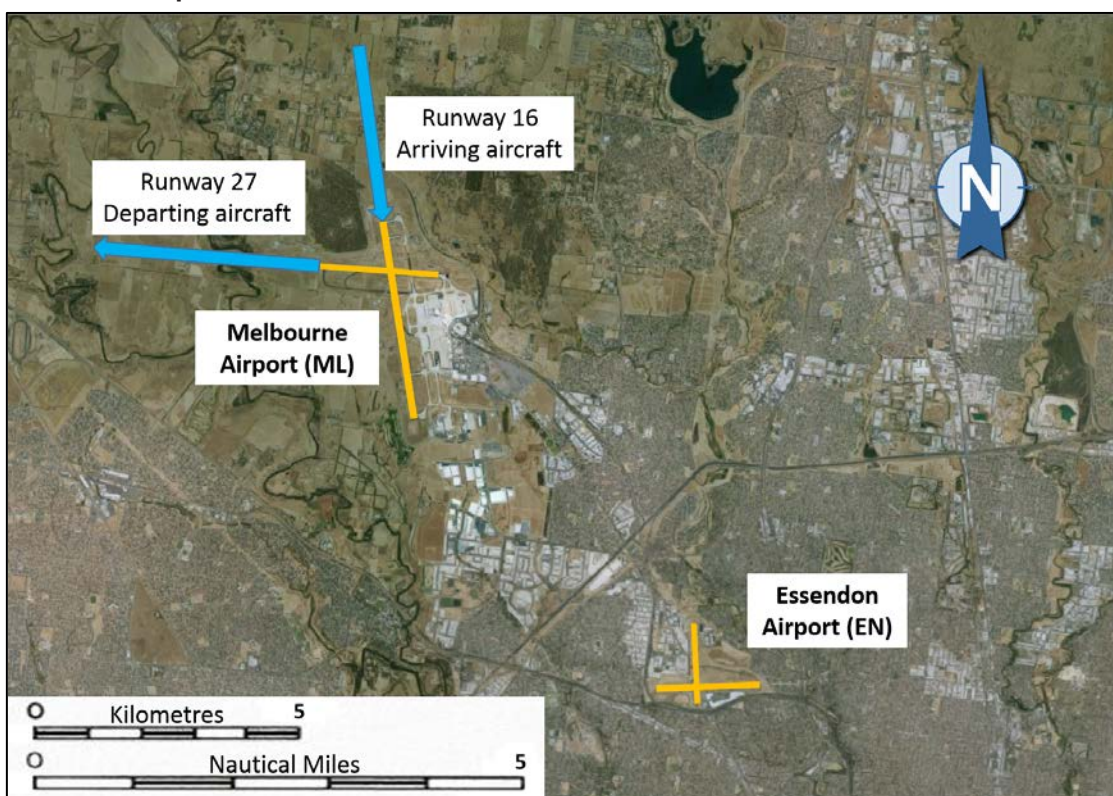
**Figure 1: The runway configuration in use at Melbourne Airport prior to the runway change, showing runway 16 for arrivals and 27 for departures, and the location of Essendon Airport**

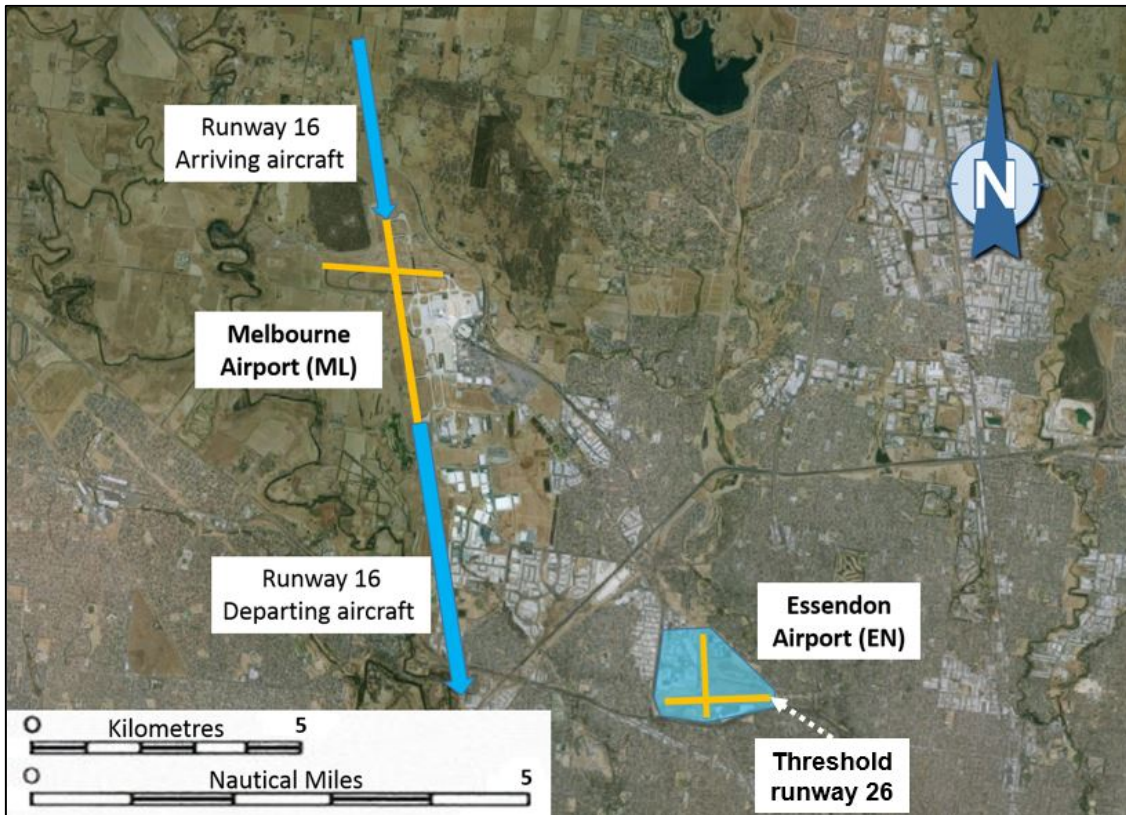
**Figure 2: Indicative flight paths for runway 16 operations at Melbourne Airport and the area overhead Essendon airport and the threshold of runway 26, where WYR was operating**

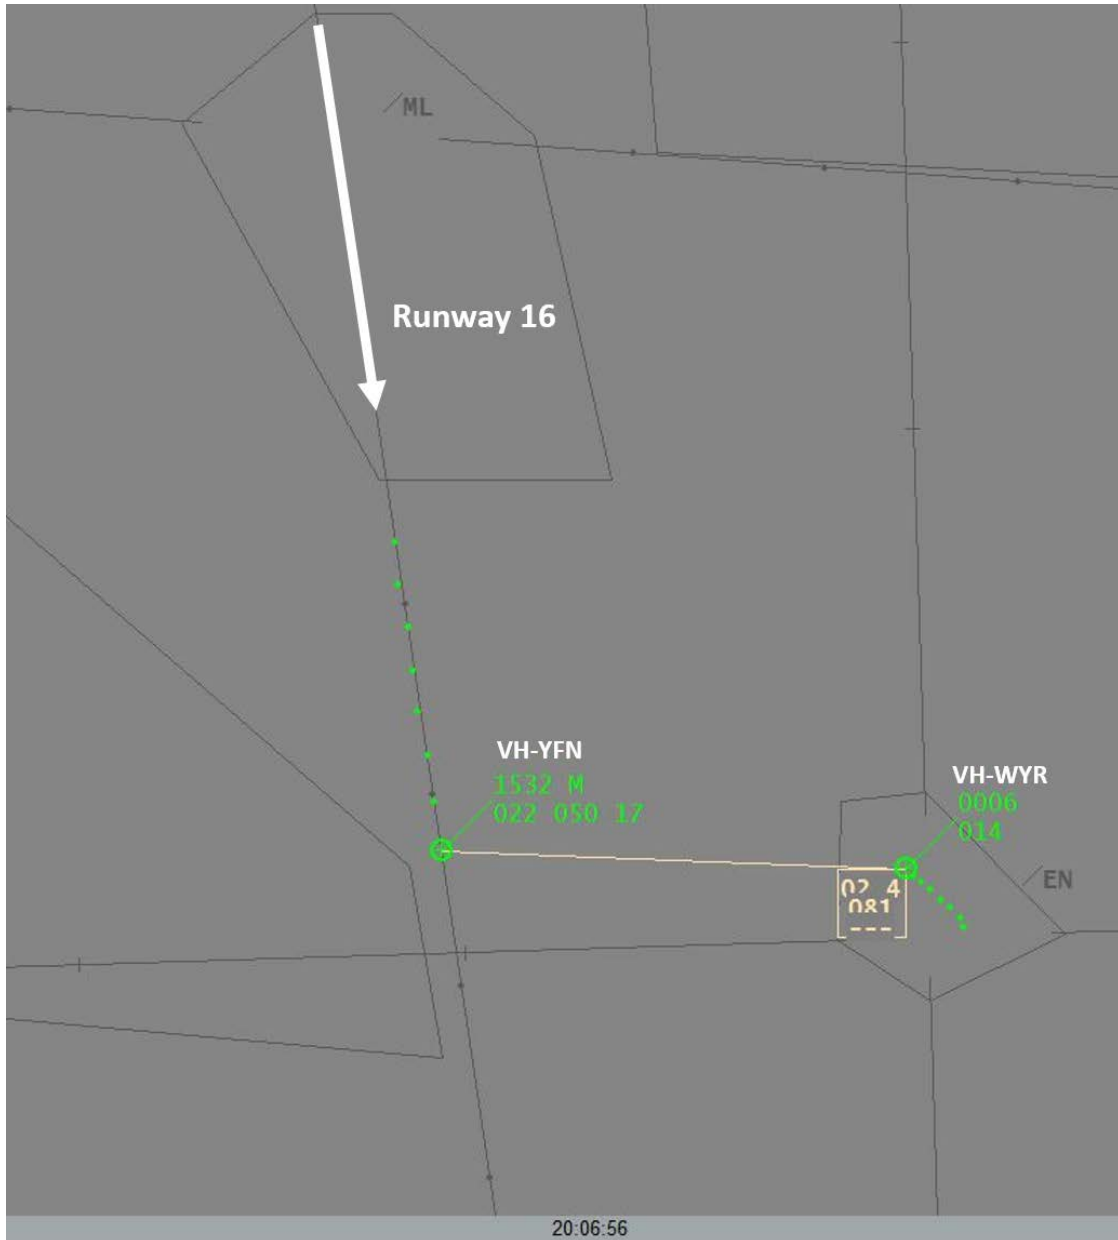
A review of the surveillance data confirmed two losses of separation between WYR and the 737 aircraft (Figures 3 and 4). The required separation was 3 NM (5.6 km) or 1,000 ft, but separation reduced to 2.4 NM (4.4 km) and 800 ft between WYR and the first 737, and 2.5 NM (4.6 km) and 800 ft with the second.

**Figure 3: Air traffic control surveillance image at 0706:56, showing VH-YFN 2.4 NM (4.4 km) from and 800 ft above VH-WYR at Essendon Airport<sup>12</sup>**

<sup>12</sup> The respective heights are VH-YFN at 2,200 ft, represented by the figure '022' and VH-WYR at 1,400 ft, represented by the figure '014'.

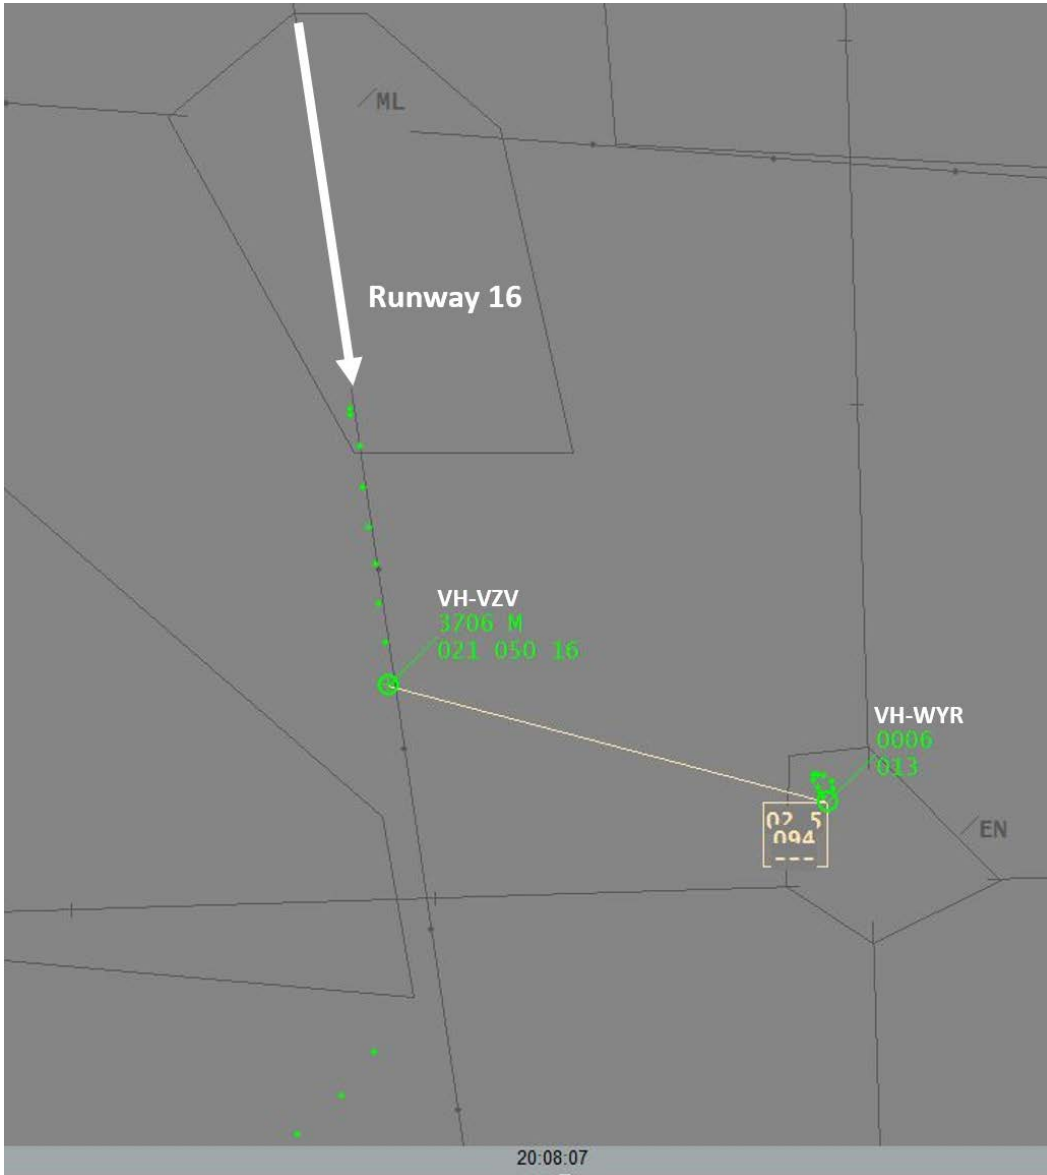
Figure 4: Air traffic control surveillance image at 0708:07, showing VH-VZV 2.5 NM (4.6 km) from and 800 ft above VH-WYR at Essendon Airport<sup>13</sup>

<sup>13</sup> The respective heights are VH-VZV at 2,100 ft, represented by the figure '021' and VH-WYR 1,300 ft, represented by the figure '013'.
