# Ground handling accident involving Cessna 172RG, VH-MKG

Parafield Airport, South Australia | 11 September 2016

**ATSB Transport Safety Report**  
Aviation Occurrence Investigation  
AO-2016-115  
Final – 24 February 2017

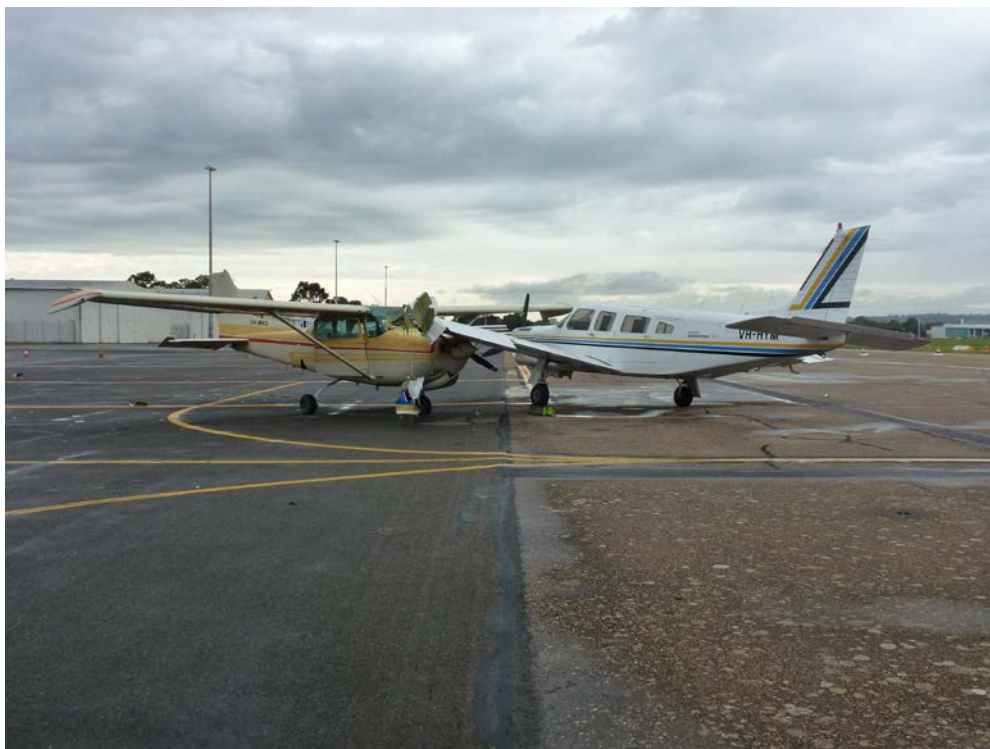
### Final position of VH-MKG against the Saratoga

The impact of the collision pushed the Saratoga about 10m from its parked location. Both aircraft came to rest approximately parallel to each other, facing in opposite directions, with MKG's propeller embedded in the underside of the Saratoga's left wing. The nose cowl of MKG was also wedged under the Saratoga's wing, lifting its left main wheel clear of the ground.

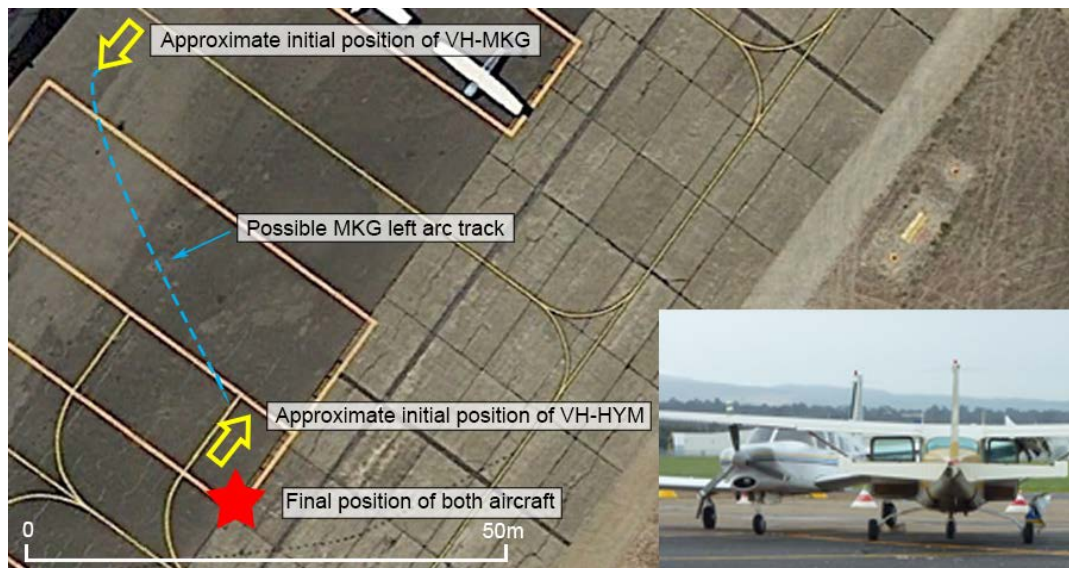
The pilot then returned to the front of the aircraft and hand swung the propeller for a second time, resulting in the aircraft engine starting. MKG then taxied without pilot control, turning approximately 45 degrees on a left arc, before colliding with a Piper PA-32 Saratoga, registered VH-HYM, that was parked on the apron, approximately 35m from MKG.

**Figure 1: The approximate initial and final positions of VH-MKG and VH-HYM, and the approximate track of MKG. Inset shows the final position viewed from behind MKG.**
