Lightning strike involving Airbus A330, VH-XFJ

Perth Airport, Western Australia | 26 November 2014

ATSB Transport Safety Report
Aviation Occurrence Investigation
AO-2014-185
Final – 8 March 2017

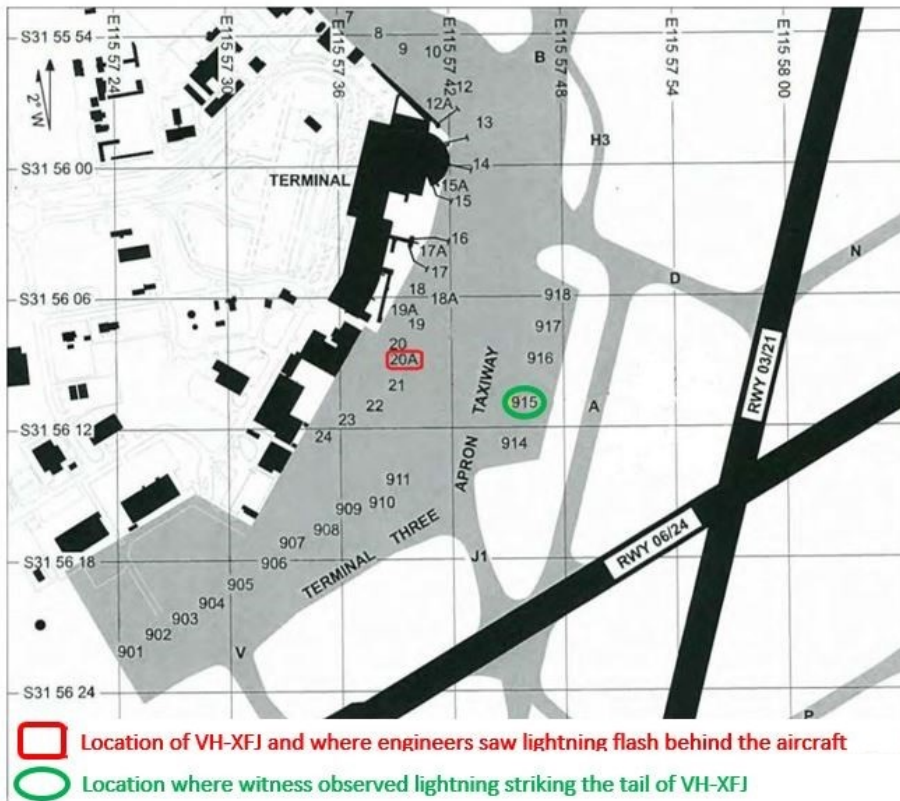
Figure 1: Terminal three at Perth Airport indicating parking bays 20A (in red) and 915 (in green) and the witness locations

After assessing the weather radar images, the RS determined that there could shortly be about a 45-minute break in the storm cell activity in the area. The Airport Movement Coordinator received a number of additional calls from the Operations Controller about the resumption of ramp duties, which were relayed to the RS. Following a discussion with other senior ground crew, and observing a reduction in the local storm activity, the RS decided to resume work on the ramp. The RS gave priority to clearing the backlog of aircraft waiting to be unloaded, then directed ground crew to move the aircraft already at bay 20A to nearby 'stand-off' bay 915 (Figure 1).

As the ground crew were parking the other aircraft on bay 915, lightning was observed to strike the tail region of XFJ. Simultaneously, engineers located at bay 20A reported observing a lightning flash to the rear-left of XFJ. As the RS depressed the 'push-to-talk' button and established contact with the flight crew, the RS received an electrical shock consistent with a high voltage electrical discharge.

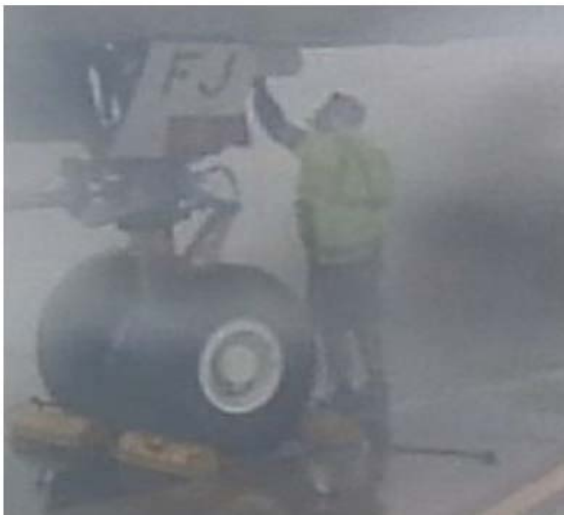
Figure 2: Perth Airport ramp closed-circuit television images showing the RS at the nose landing gear of XFJ

At about 1717, the crew of XFJ taxied to bay 20A. After they came to a stop, the RS chocked the nose wheels and connected a headset to the intercom jack at the aircraft's nose landing gear (Figure 2).

The RS staggered from the aircraft before collapsing unconscious on the ground. A second ground crew member assigned to XFJ was also subjected to the electrical discharge and sustained a burn injury. That ground crew member did not lose consciousness.

In addition, the ground-handling organisation made changes to its severe weather procedures, which include ceasing using aircraft-connected headsets when lightning activity is within 10 NM (19 km) of an airport.

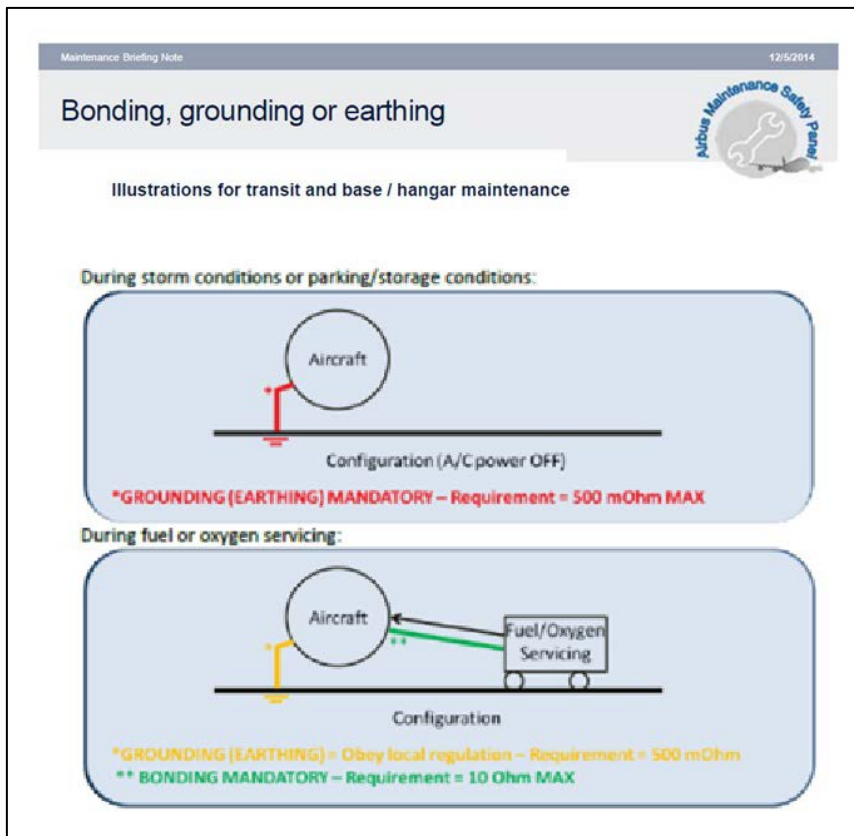
Figure 3: Airbus Maintenance Briefing Note 12/5/2014 extract showing the bonding requirements for transit, base or hangar maintenance during storm conditions

Airbus also advised that any electrical charge from a lightning strike would most probably dissipate through the landing gear to the ground. Airbus Maintenance Briefing Note 12/5/2014 provided a number of illustrations and flow charts that referenced mandatory earthing for transit, base or hangar aircraft maintenance during storm conditions (Figure 3).

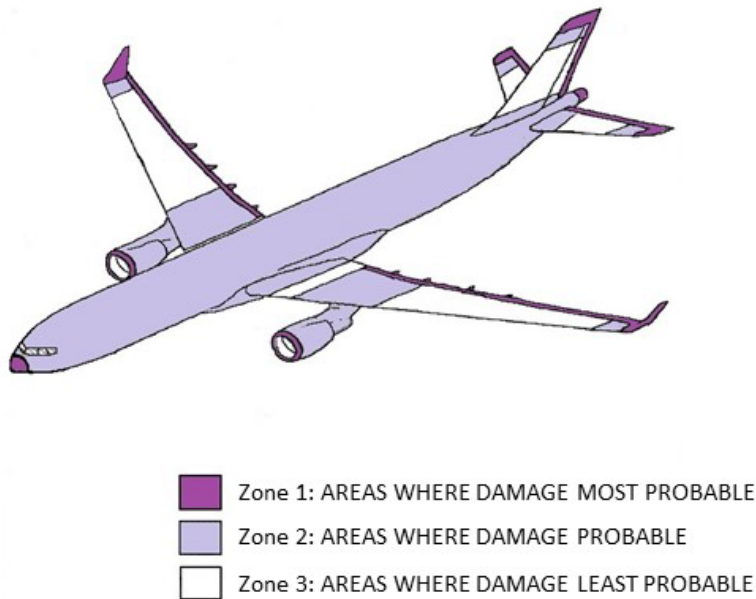
Figure 4: Airbus lightning strike inspection areas

The aircraft maintenance manual after lightning strike inspection detailed the maintenance actions after a lightning strike to the aircraft. The procedure defined lightning strike probability on the aircraft in terms of three probability zones (Figure 4).

If the phase 1 inspection did not identify any defects, the subsequent phase inspections were not required. Review of the aircraft’s maintenance documentation revealed that no defects were identified during the phase 1 inspection after the lightning strike.

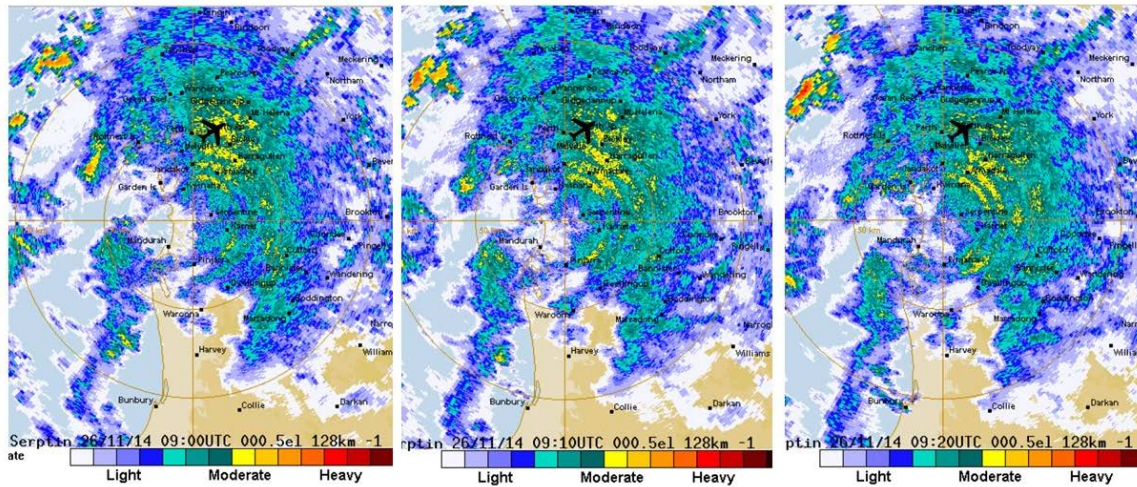
Figure 5: BoM weather radar screen captures of the weather at Perth Airport from 1700 to 1720 (0900 to 0920 UTC) on 26 November 2014 showing consistent light-to-moderate rain

The BoM provided copies of weather radar images for Perth Airport at the time of the incident. The weather radar images show only precipitation, not cloud formations, thunderstorms or lightning strikes. The images provided confirm the presence of rain in the vicinity of the airport at the time of the occurrence (Figure 5).

Consistent with the reported perception by the RS of pressure from the Operations Controller and Airport Movement Coordinator to resume work earlier than they would have liked, the RS used the Bureau of Meteorology website's weather radar information to assess the local conditions and estimate the storm's movement. The weather radar displayed areas of precipitation, but did not directly show cloud formation, thunderstorm or lightning strike activity. Therefore, the weather radar alone did not provide sufficient information to predict lightning strikes. Additionally, the use and interpretation of weather radar information without formal training increased the likelihood that the RS was not aware of this limitation.

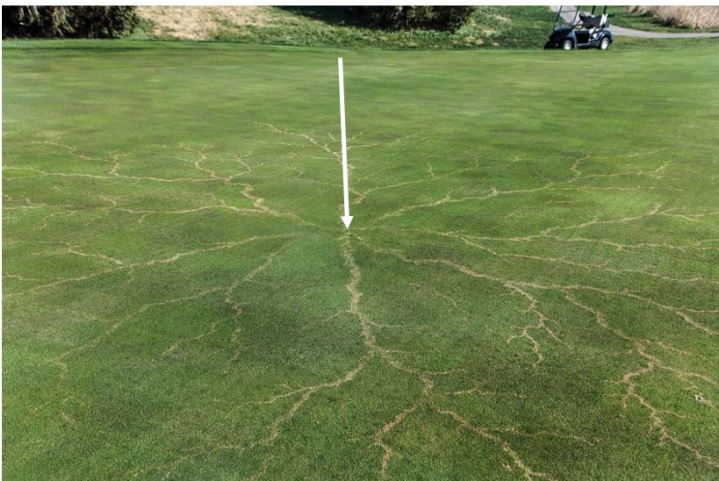
Figure 7: Ground lightning strike showing radial discharge from a central strike point (indicated by a white arrow)

The ATSB considered which of a lightning strike to the tail or to the nearby ground was more likely. In this regard, a lightning ground strike would result in radial discharge from the point of strike as shown in Figure 7.

Had a ground strike occurred at the near-rear of the aircraft, and discharged outward toward the location of the RS and second ground crew member at the nose wheel, it would have also radiated approximately the same distance behind and to the sides of the aircraft. Given the lack of reported lightning injuries/effects to other ground crew working in those areas, a ground strike is considered less likely than a tail strike.
