Near collision involving Hawker Beechcraft Corporation B300C, VH-NAO, and an airport work safety officer

Sydney Airport, New South Wales, 16 August 2016

ATSB Transport Safety Report
Aviation Occurrence Investigation
AO-2016-103
Final – 24 March 2017

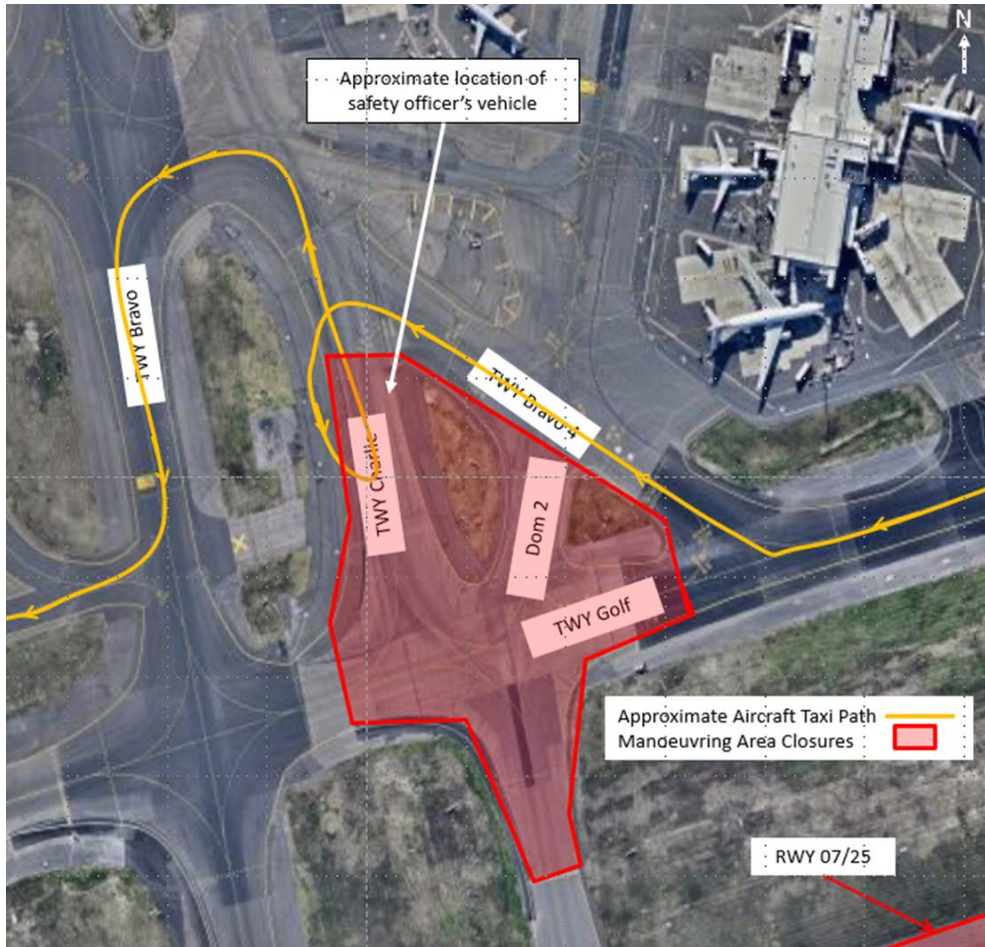
Figure 2: Approximate aircraft taxi path and location of safety officer’s vehicle

The pilot made a 180 degree turn on charlie and headed north, back towards bravo 4. The safety officer saw that NAO was returning and moved the vehicle off the centre line. The pilot passed the vehicle and taxied onto bravo 4, before making a left turn onto bravo, as initially intended. The approximate taxi path of the aircraft and the position of the safety vehicle at the time the aircraft entered charlie are shown in Figure 2.

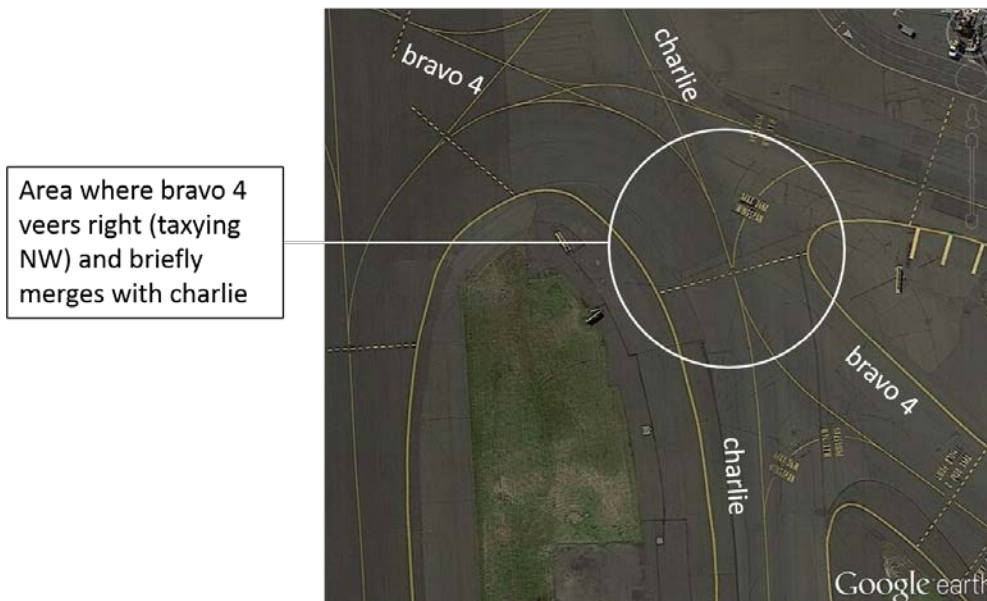
Figure 3: Taxiway intersection showing the area where bravo 4 veers right (taxying NW) and bravo 4 and charlie merge for a short distance

The taxi paths through the open space at the junction of bravo 4, charlie and charlie 2, are complex. Numerous guidance markings and lights complicate the area, and bravo 4 merges with charlie for a short distance as the two taxiways cross (Figure 3). A curve in bravo 4 as it meets charlie may have given the pilot the impression that the aircraft had arrived at the intersection of bravo 4 and bravo, being the point at which a sharp left turn was required. This expectation by the pilot may have been reinforced by the fact that the aircraft had just passed domestic 2, which the pilot may have misinterpreted as charlie.

The potentially confusing characteristics of the taxiway junction would have been exacerbated at night. At the time of the occurrence, additional vehicle lights were moving about the area, some steady (head/tail lights) and some flashing, and the partially established worksite lighting would have further complicated the environment. The pilot expected that some lights may have already been covered or turned off, which added to the potential for confusion over taxiway identification.

At the time of the occurrence, the lead-in lighting to charlie and the charlie taxiway lighting had not yet been covered. This may have given the impression that the taxiway was still available, perhaps further reinforcing in the pilot’s mind that they had already passed charlie, and reached bravo. The taxiway signage was not affected by the works and was illuminated at the time of the occurrence. The pilot commented that their mental picture of the area was different to what they encountered at the time of the occurrence.
