# Fumes event involving Bombardier DHC-8, VH-SBB

near Adelaide Airport, South Australia, 10 November 2016

**ATSB Transport Safety Report**  
Aviation Occurrence Investigation  
AO-2016-151  
Final – 24 March 2017

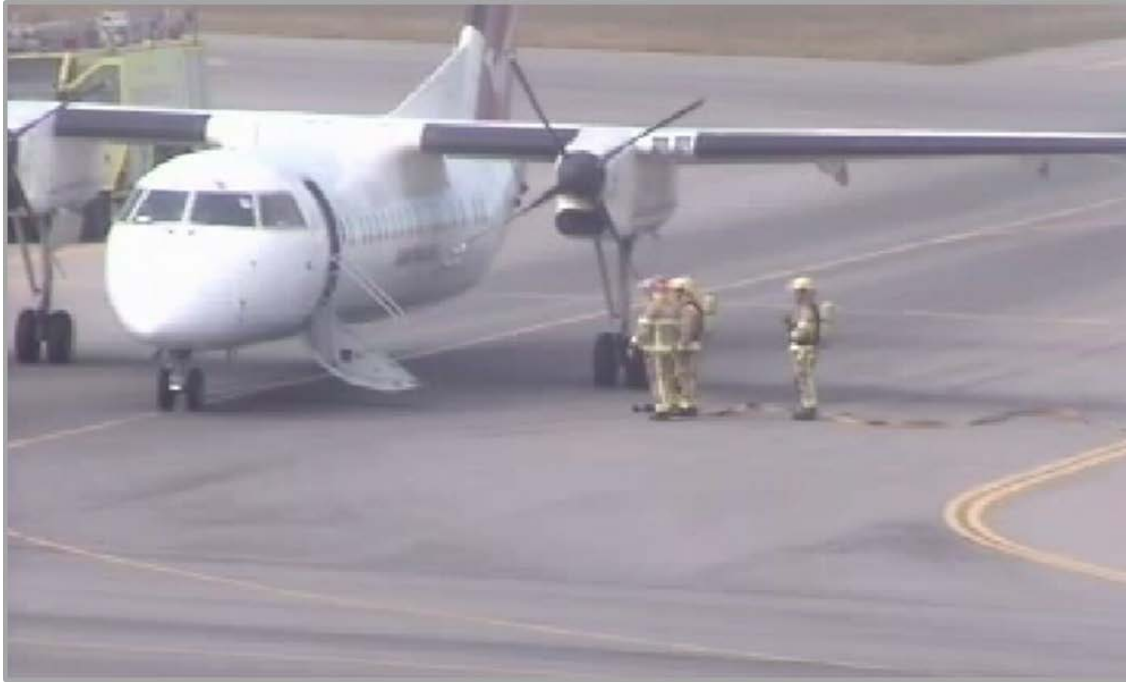
**Figure 1: SBB parked on taxiway E after the crew and passengers had disembarked**
